| <b>Reference</b> | SSM73239 |
| <b>Models</b> | LR3 / L319<br>Range Rover / L405<br>Range Rover Sport / L320<br>Range Rover Sport / L494 |
| <b>Title</b> | Engine Oil Level Sensor Concerns V6/V8 Diesel DTC P250A |

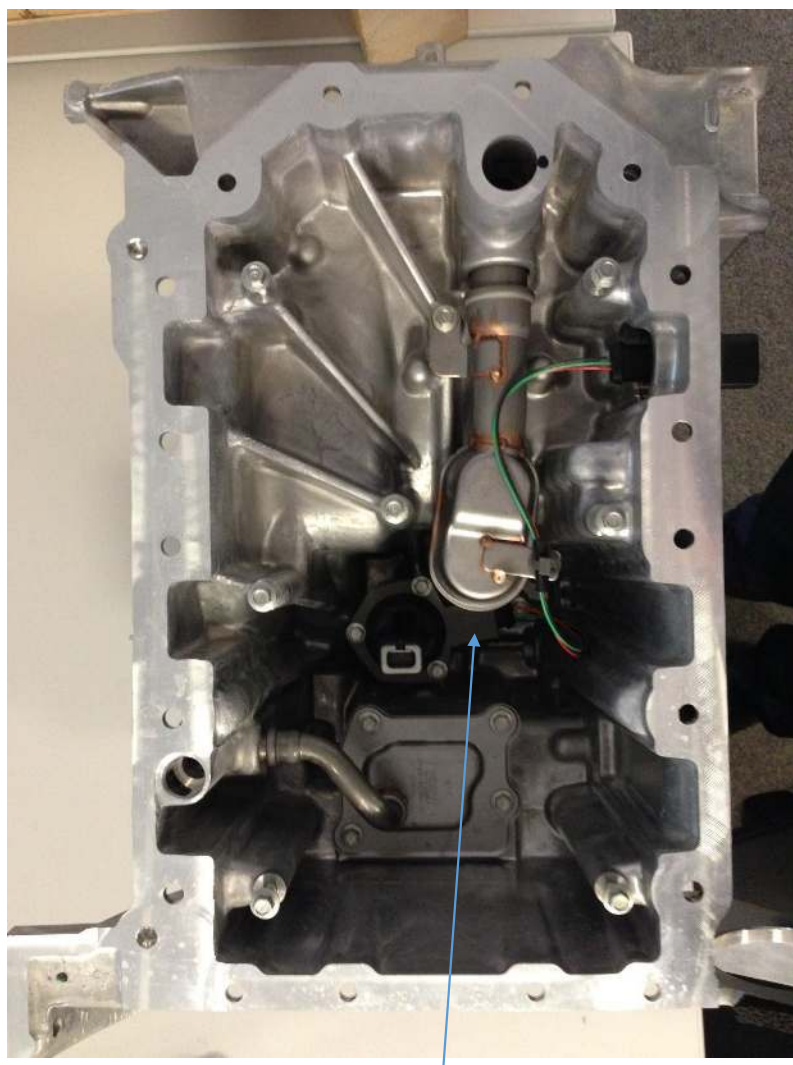
View down on top of oil pan with  
windage tray removed

Retainer plate just visible

Fit revised fly lead and retaining plate internal to the oil pan to prevent the connector becoming disconnected, this will require oil pan removal (refer to TOPIx section 303: Engine – Oil Pan) . The three bolts holding the oil level sensor in place inside the oil pan will need to be removed, the new retaining plate (LR086422) can then be fitted over the existing oil level sensor and the three bolts refitted and torqued to 10Nm (refer to attached file for further details).

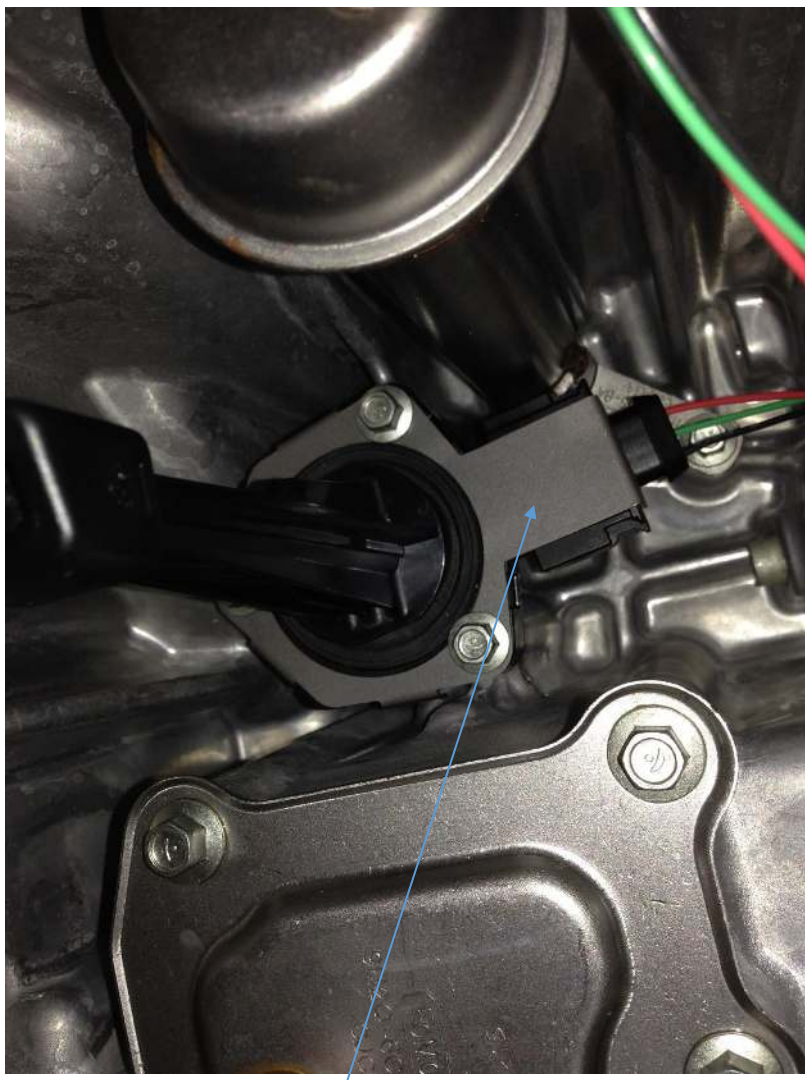
Close up of retainer plate in  
place over the oil level sensor

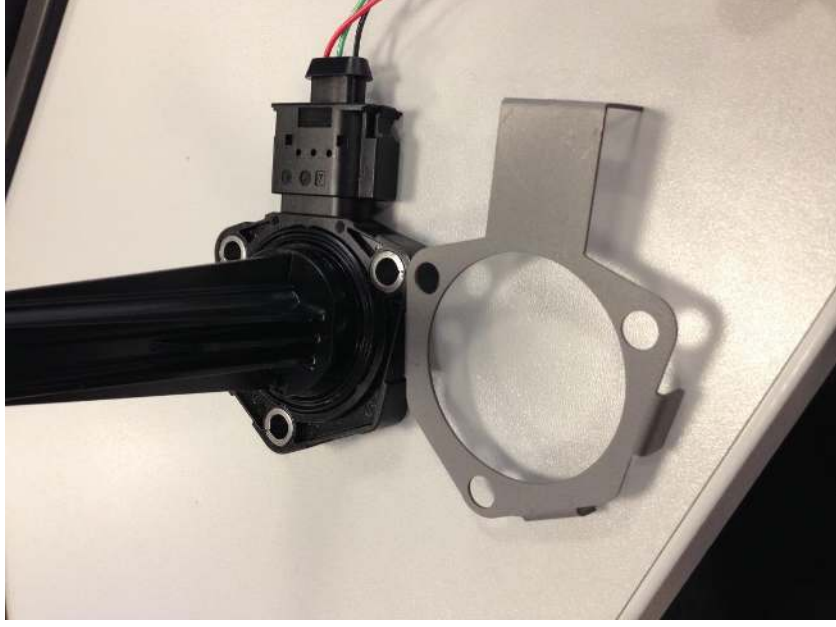
View of retainer plate with the oil level sensor behind it.
