| <b>HYUNDAI</b><br><b>Technical Service Bulletin</b> | | GROUP<br><b>AUTOMATIC<br/>TRANSMISSION</b> | NUMBER<br><b>17-AT-005</b> |
| <b>SUBJECT:</b> | <b>AUTOMATIC TRANSAXLE DIAGNOSIS (6-SPEED)<br/>INHIBITOR SWITCH DTC P0705, P0706, P0707 &amp; P0708</b> | | |

***This TSB supersedes TSB 15-AT-001 to update the Service Procedure and applicable vehicles.***

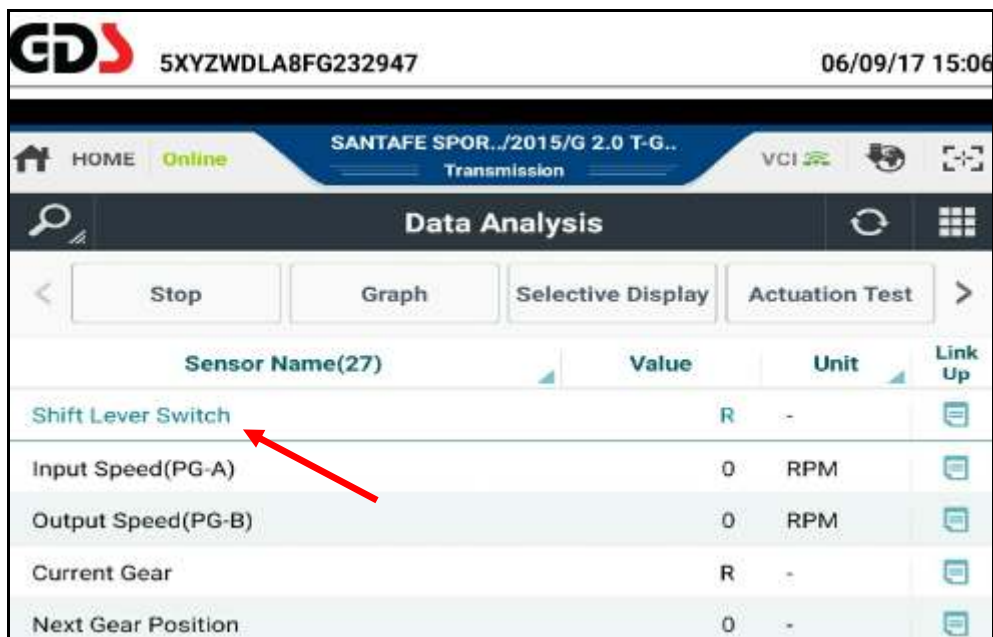
3. Select **Data Analysis**, **A/T** menu and **Shift Lever Switch**. Move the shift lever through all gears (P, R, N and D) and monitor the Shift Lever Switch.

4. If the Shift Lever Switch shows:
- The correct shift lever position, the wiring **currently** has no open/short circuits. Go to Step 6.
  - Does not show the correct shift lever position, go to Step 5.
5. Visually check the wiring harness between the PCM and inhibitor switch for a damaged wire or open circuit/short circuit to ground. Check for a damaged pin or pin not fully inserted into the connector.
- If damage is found, repair or replace the control wiring and drive the vehicle to confirm the repair.
  - If no damage or open/short circuit is found, go to Step 6.

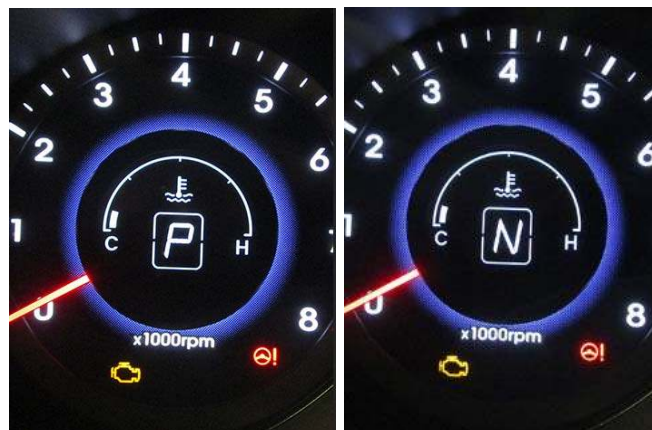
6. Turn the ignition switch to the ON position and place the shift lever in P and N. Confirm the indicator lights in the dash cluster show the correct gear in P and N.
- If P and N are displayed, go to Step 7.
  - If P or N are not displayed, go to Steps 9~12 and 15 and check the alignment of the inhibitor switch. If P and N are not displayed after adjustment, go to Step 7.

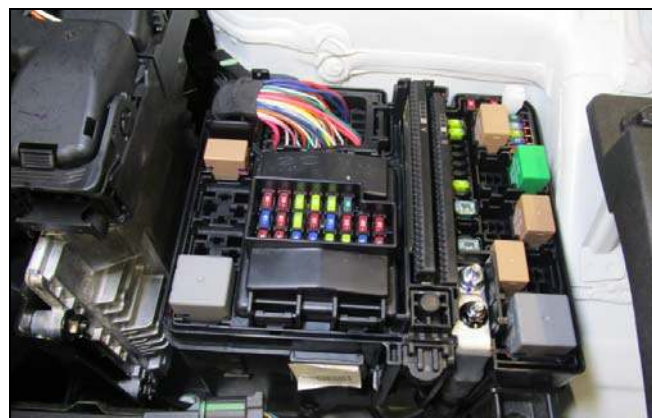
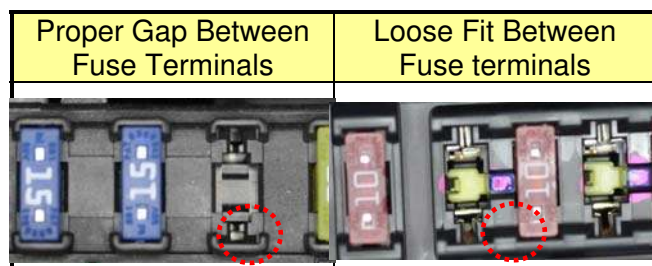
7. Check the TCU and TCU2 fuse in the junction box in the engine compartment:
- Check the fuse for an open circuit.
  - Check the fuse for correct capacity.
  - Check the fuse holder for a tight fit.
  - Check for loose or damaged wires.

If damage or intermittent open circuit is found, repair or replace the junction box and front harness.

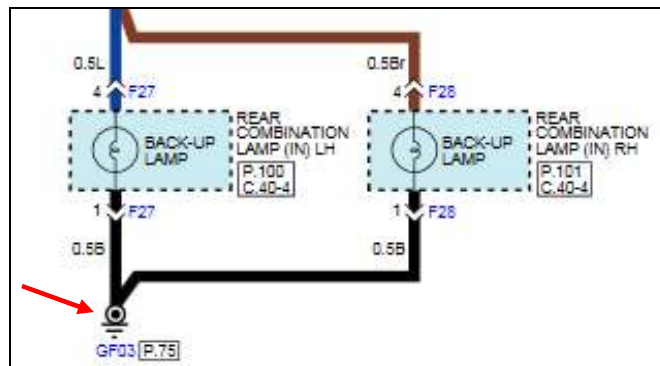
8. Check the rear combination lamp ground for tightness.

Turn the ignition and headlights on. Use a DVOM to check the voltage drop between the combination lamp wiring terminal and ground. Specification: Less than 0.2 V.

If more than 0.2V, clean the terminal and bolt threads and tighten the bolt.  
If less than 0.2V, go to Step 9.
