# Technical Service Bulletin

## 35 Gearbox warning light on (DTCs P179E00, P179F00, P0700, P060A)

35 16 19 2032211/3 January 11, 2016. Supersedes Technical Service Bulletin Group 35 number 14-17 dated September 25, 2014 for reasons listed below.

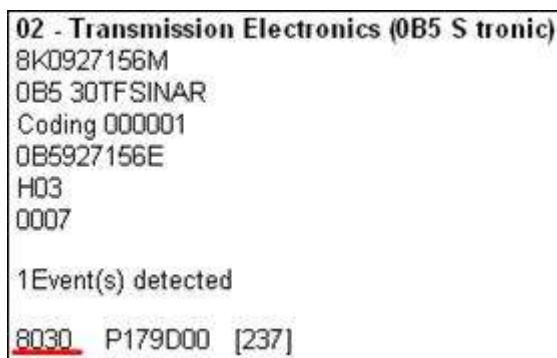
The DFCC is the 4-6 digit code that is typically listed before the fault code (Figure 1).

**Figure 1.** DFCC 4-6 digit code listed before the fault code, underlined in red.

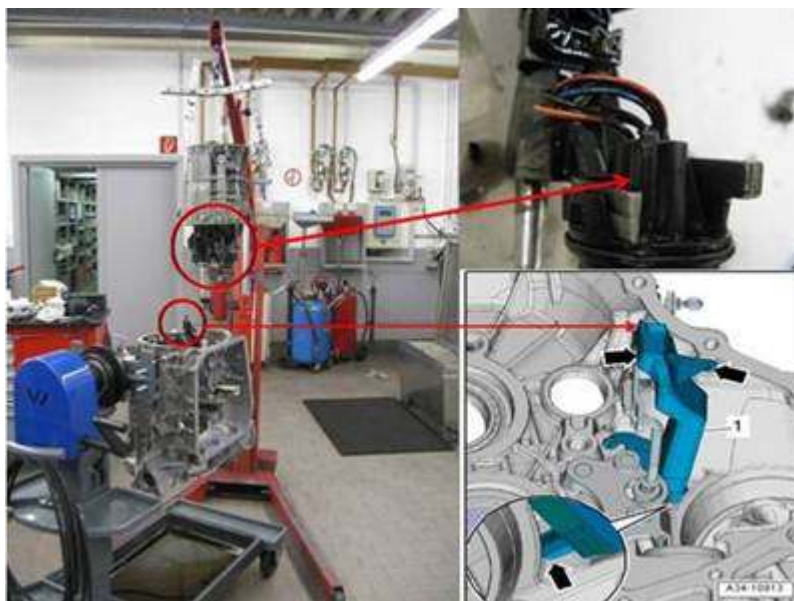
**Figure 2.** Caution points: drip tray and sensor module connector.

**Tip:** Use caution when lifting or lowering intermediate housing to avoid damage to components (Figure 2).
