# Technical Bulletin

93 16 02 March 23, 2016 2041920 Supersedes Technical Bulletin V931601 dated January 8, 2016 to add DTC P168F00 and production VIN break.

Update Programming, DTC(s) Stored in AW C6 High-Voltage Charger including B200000, P31EA00, and P168F00 (U.S. Only)

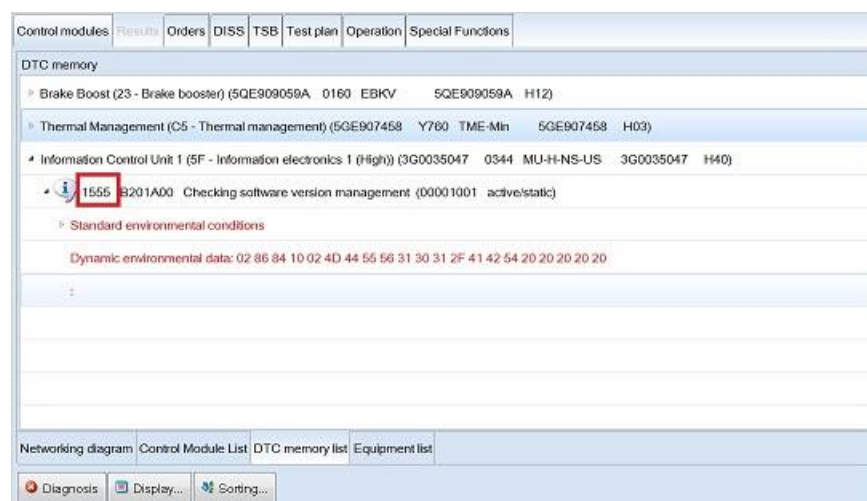
b. In Figure 1 (above), the symptom number shown inside the red box is 1555.
