# Technical Service Bulletin

## 01 MIL on (DTC P0491 and P0492), stored at the same time

26 12 15 2026528/7 November 5, 2012. Supersedes Technical Service Bulletin Group 26 number 12-10 dated March 30, 2012 for reasons listed below.

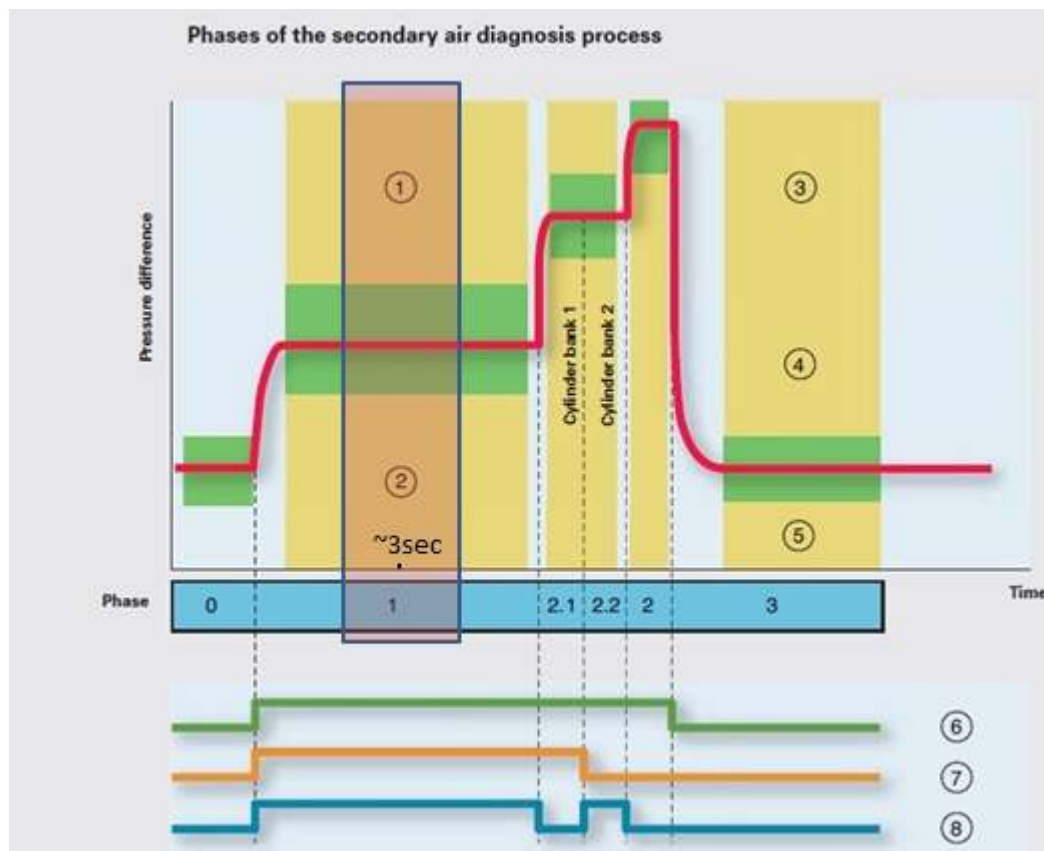
Figure 1. Pressure test graph

PRS\_SA\_DIF (note down value at 3sec of test - phase 1 of test, see *Figure 1. Pressure test graph*)
