ATS 171102 Version 1

## MIL On with DTC P0035?

2017 Civic Type R

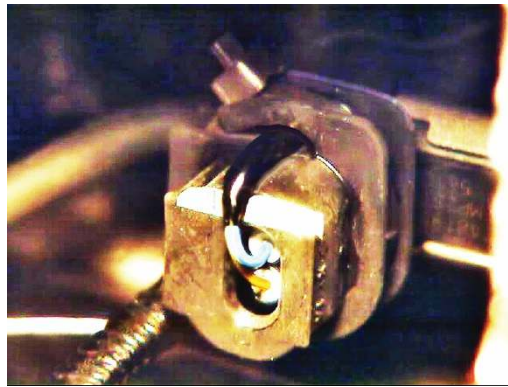
Is the MIL on with DTC P0035 (turbocharger bypass control solenoid valve circuit high), and you're seeing **Rev Match System Problem** and/or **Emission System Problem** in the driver information interface? A broken wire(s) in the turbocharger bypass control solenoid valve 2-pin connector is the likely cause.

We found that when the connector matches a natural engine frequency, it starts to oscillate. Over time, this can cause one or both of the connector wires to break, resulting in a short. And if they do break, you might not even notice it if the insulation remains intact.

If this is the case, **don't** try repairing the broken connector wire(s). Even if you manage to, they're still prone to oscillation, and you could wind up with a comeback.

Instead, replace the engine wire harness with **P/N 32110-5BF-A02**. This replacement harness has a more robust turbocharger bypass control solenoid valve connector. So far, we haven't seen any reports of comebacks from using this harness.
