# Preliminary Information

PIP5468D Check Engine Light On with Leaks in the Charge Air Cooler System.

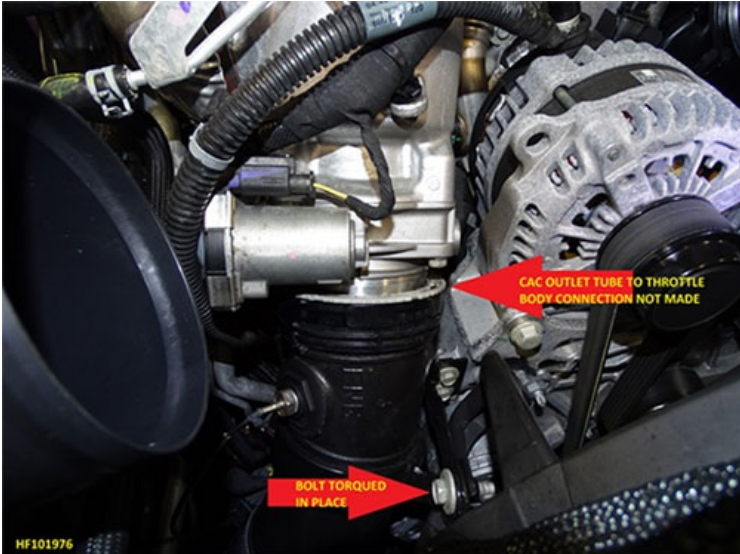
Check for non-secured connection of the charged air cooler pipe at the intake air flow valve (throttle body).  
Check for proper alignment of the charged air cooler pipe bracket and bolt hole.

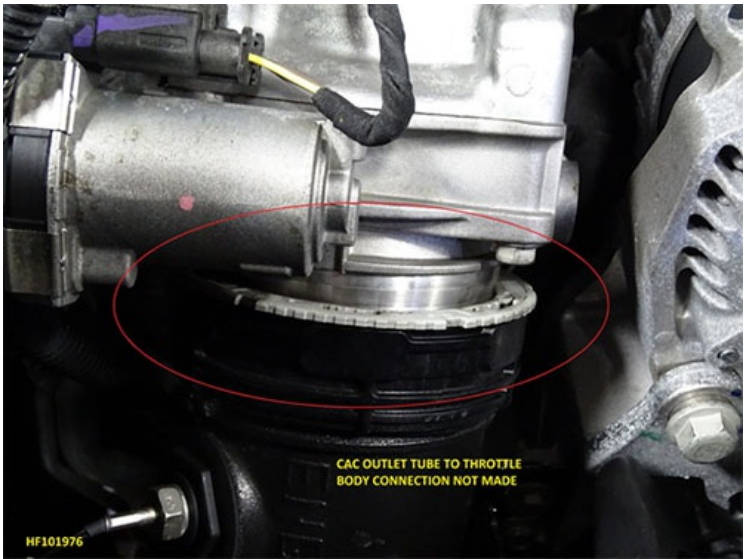
Non-secured connection.

If P2463 was not set and a charge air cooler leak or disconnect was found, after repairing charge air cooler connections, command Diesel Particulate Filter (DPF) Regeneration Enable with the scan tool before returning the vehicle to the customer.
