# Preliminary Information

PIP5468E Check Engine Light On with Leaks in the Charge Air Cooler System.

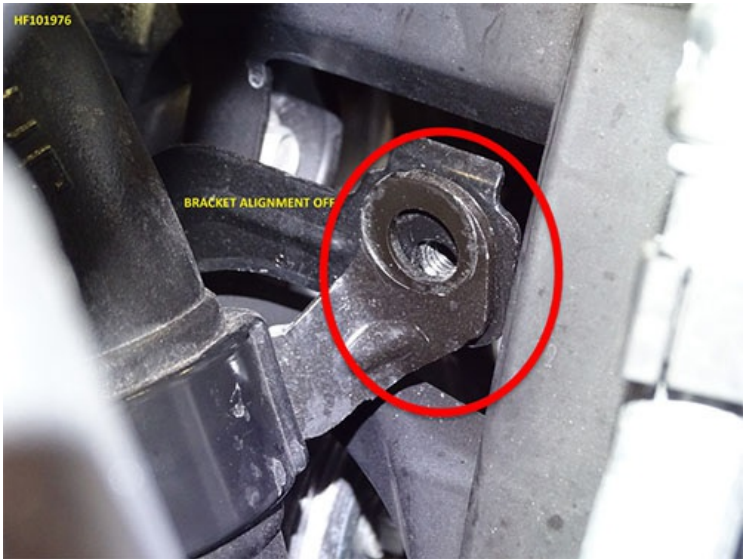
Mis-aligned charged air cooler pipe bracket and bolt hole after the charge air cooler outlet hose is connected properly to the throttle body.

If P2463 was not set and a charge air cooler leak or disconnect was found, after repairing charge air cooler connections, command Diesel Particulate Filter (DPF) Regeneration Enable with the scan tool before returning the vehicle to the customer.
