# Preliminary Information

PIP5411F SES light with DTC's P2635 and/or P018B setting in high ambient temperatures

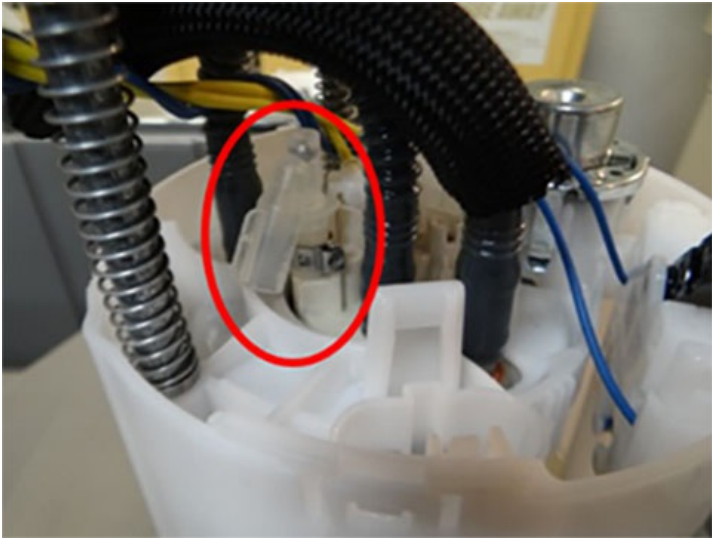
**New design**

| Brand: | Model: | Model Years: | VIN: | | Engine: | Transmissions: |
|---|---|---|---|---|---|---|
| Condition: | | In ambient temperatures 100 F (37.7 C) degrees or higher, DTCs P2635 and/or P018B may set.<br><br>The vehicle may also exhibit a hesitation or stalling condition. | | | | |
| Cause: | | Vapor buildup in fuel feed line | | | | |

This PI should only be followed if SI diagnostics have been performed with no solution found.  
Replace the in tank fuel pump module assembly with the new design part.

Important: If a new design fuel pump has already been installed and is currently meeting diagnostic pressure specifications, do not install another new design fuel pump in an effort to resolve the condition.
