# Preliminary Information

PIT5288F RKE / Passive Entry And Start / No Audio / SWC / Touch Screen / Display Blank/ Rear Wiper And Rear Power Windows Inoperative / Dead Battery / Service Tire Pressure System / SES MIL DTC B3101 B144C C0710 C0544 P0106 P0107 P2122 P2123 P2127 P2128 P2138 U0028 U0029 U0077 U0126 U0151 U0415 U1548 U1549 U154A

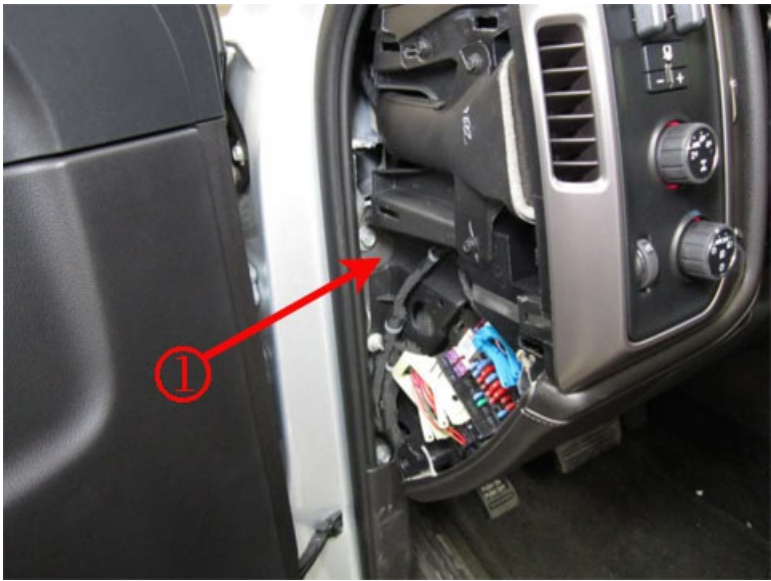
These concerns could be caused by the dash harness being pinched between the left I/P dash mounting bracket (1) and the body. Shown below, is the left I/P mounting bracket (1) as seen when the I/P fuse block cover is removed from the end of the dash. This picture is for reference only and the wiring must be inspected from under the dash.

To repair this concern, loosen the left I/P dash mounting bracket bolts and pull the harness free. Open the harness and repair any damaged wires as necessary.

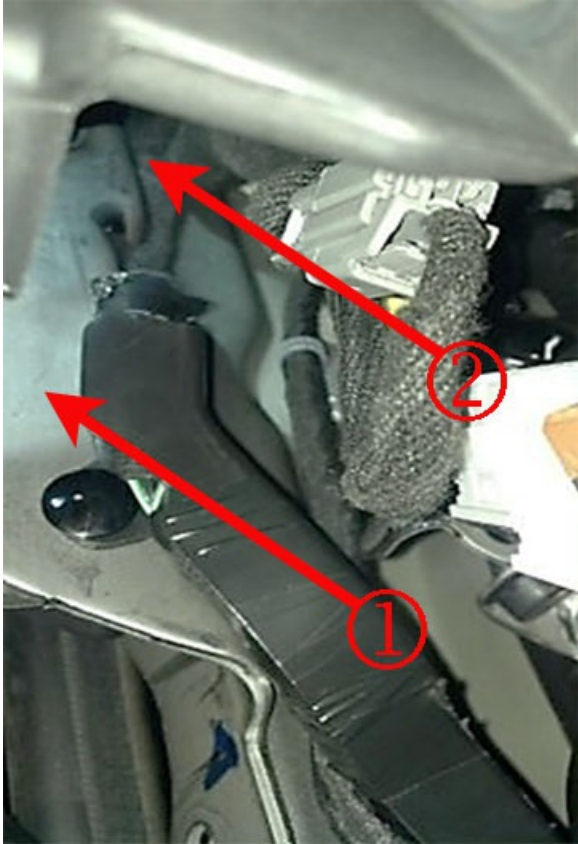
As shown below, the wiring harness (2) is pinched at the upper portion of the I/P mounting bracket (1). In many cases, the complete harness may not be pinched and it can be difficult to see that the harness is damaged. When inspecting for a pinched harness, make sure the harness can be moved freely away from the bracket to body interface.

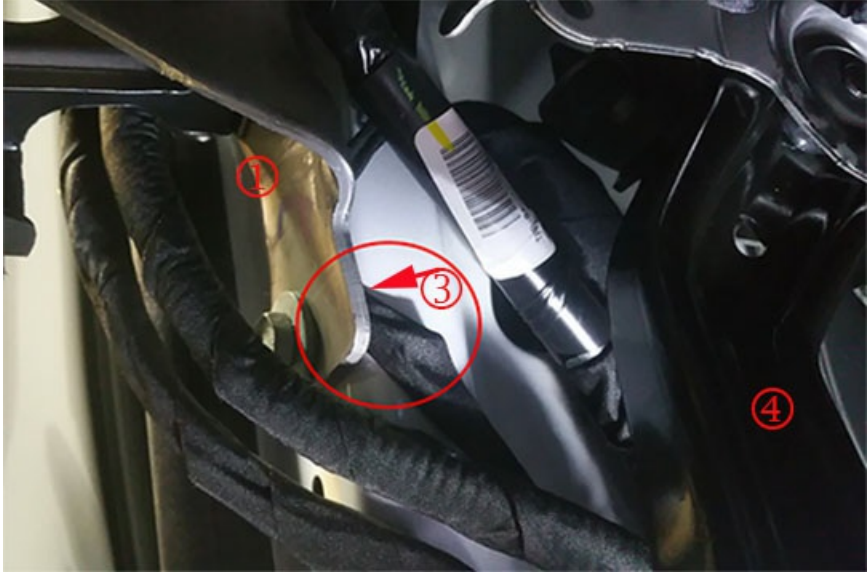
As shown below, the wiring harness (3) is pinched at the lower portion of the left I/P mounting bracket (1). For reference only, call out (4) is the parking brake pedal.
