# Preliminary Information

PIP5498C SES Lamp P050D P0300 Setting On A Cold Start And/Or a Run Rough Warm with No codes

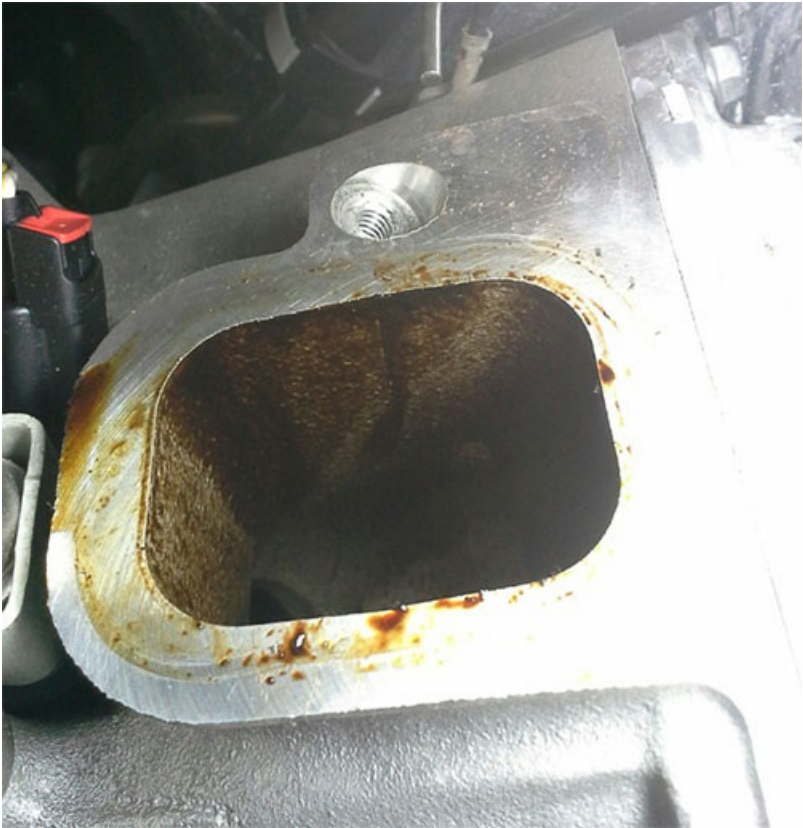
At times it may be necessary to remove the head for inspection.  
If the head casting line is the concern the intake port will be wet with a coolant oil mix.  
This could be the cause of a running rough warn concern with or without codes.  
The location of where the coolant is running down in the port will also look washed down.

If this is found the cylinder head will need to be replaced.

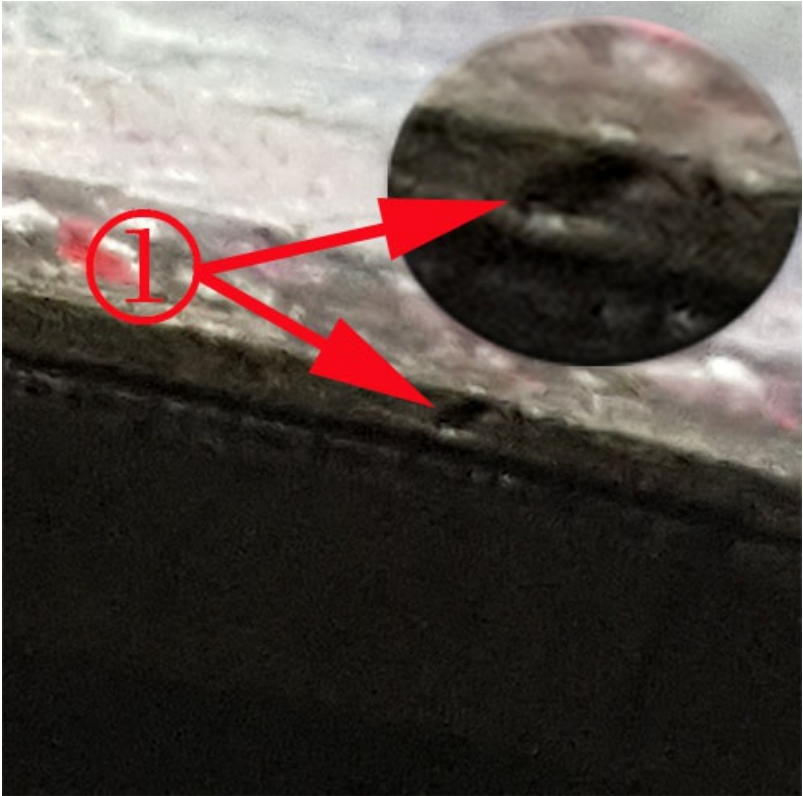
For coolant entry at the liner to deck face casting of the cylinder bore.

It is hard to see the actual source (pin hole) but it usually streams down the liner so that you can see it with a borescope.(Sometimes)  
The top of the piston will be steam cleaned.  
Do not confuse residual fuel on the piston crown / surface as coolant. Some fuel residue may be present and can be mistaken as coolant (reason for the cooling system Dye to be added). Use black light to confirm the liquid is coolant. If this concern is present, do not replace the cylinder head because that will not repair this concern. Call PQC per the latest version of [16-NA-338](#), if required, reference this PI and replace the engine.  
Small surface pock marks or pitting appearance on the deck surface is normal and engines should not be replaced for such appearance as they do not connect to coolant passages and cause a leak path that generate engine misfires. During engine warranty analysis studies, engines are being replaced for small pitting in the deck face as described above, when the subject cylinder / piston is saturated with fuel and not coolant

Engines replaced for light / shallow pitting conditions will be returned to the dealership as non-defective.
