# Technical Service Bulletin

## 91 MIB MMI cannot be turned on, or other sporadic MMI concerns

91 15 27 2038073/2 December 9, 2015. Supersedes Technical Service Bulletin Group 91 number 14-57 dated August 11, 2014 for reasons listed below.

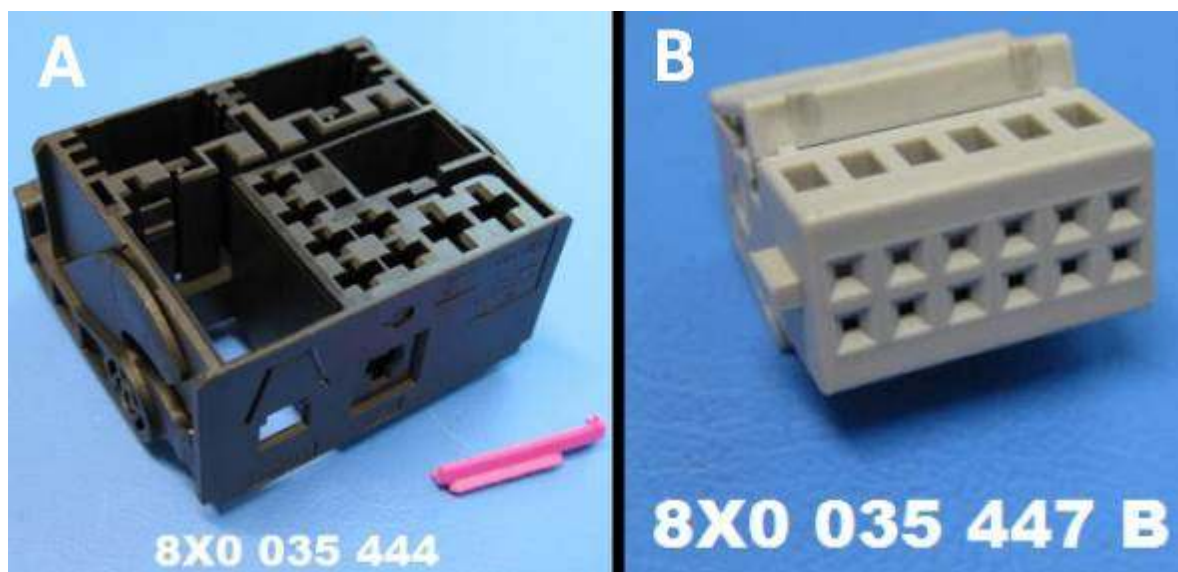
The grey 12-pin flat contact lock (Figure 1, B) is not correctly slotted in the quad lock housing (Figure 1, A).

**Figure 1.** Quad lock housing (A) and 12-pin flat contact lock (B).

4.
  - If the grey 12-pin flat contact lock is correctly slotted into the quad lock, this TSB does not apply. Continue diagnosis outside of this bulletin.
  - If the grey 12-pin flat contact lock is not (and cannot be) correctly slotted into the quad lock, replace both the quad lock and the grey 12-pin flat contact lock.
5. Make sure that all contacts and locks are in the correct position.

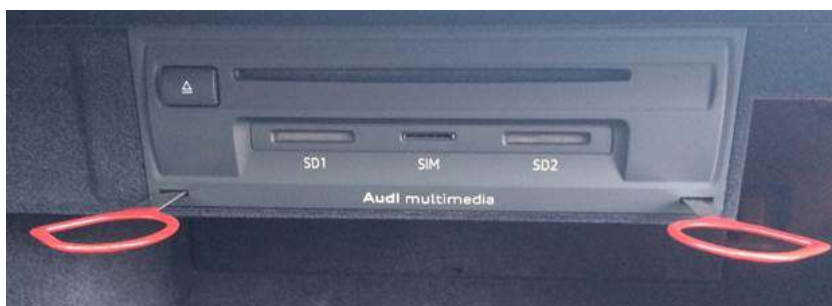
**Figure 2.** Remove the J794 module.

1. Perform GFF to confirm that both **DTC U111000** and **DTC U006500** are found. If both faults are not found, this TSB does not apply. Continue diagnosis outside of this bulletin.
2. If both faults are found, open the glove box and remove the information electronics control module 1 (J794) (Figure 2).

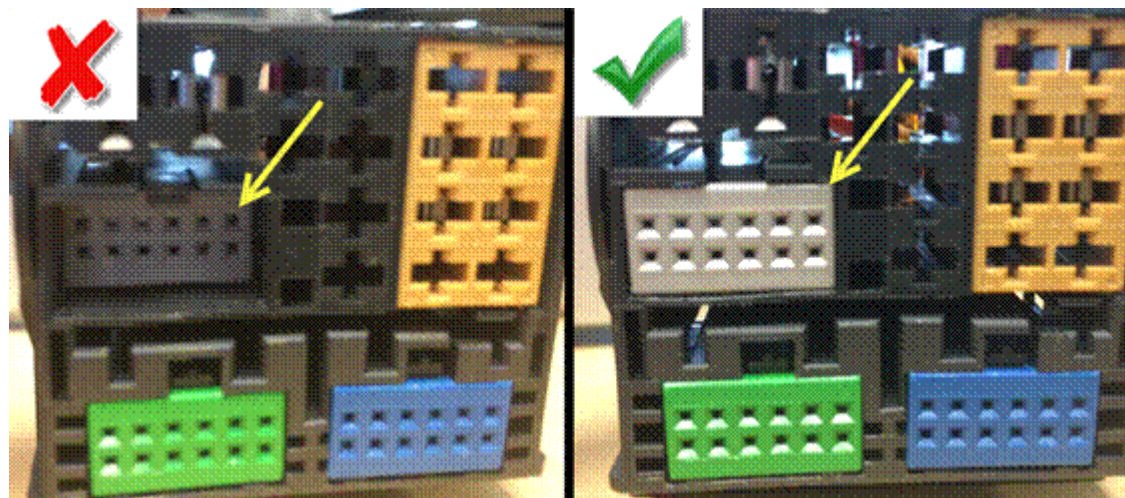
**Figure 3.** Grey 12-pin flat contact lock incorrectly slotted (left) and correctly slotted (right).

3. Remove the quad lock. Check the grey 12-pin flat contact lock to see if it is correctly slotted in the flat contact housing (Figure 3).
