# Technical Service Bulletin

## 21 Mil on - P0299 Negative pressure deviation, turbocharger excessive wastegate play

21 13 13 2031245/4 April 4, 2013. Supersedes Technical Service Bulletin Group 21 number 13-12 dated April 1, 2013 for reasons listed below.

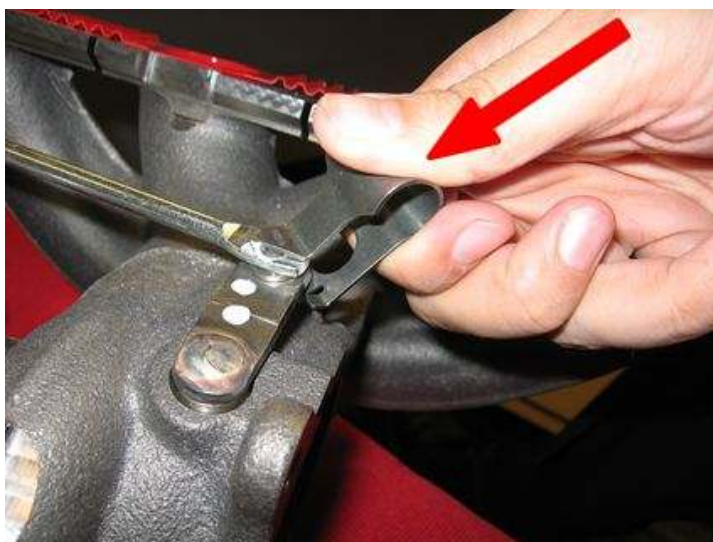
**Figure 1.** Fit the clip from the side.

1. Remove turbocharger as per ELSA instructions: *Repair Manual >> Engine / Engine Mechanical >> 21 Turbocharger, G-Charger >> Removal and Installation >> Turbocharger.*
2. Install clip **06J145220B** on a replacement turbocharger's link plate and actuating rod joint as illustrated (Figures 1 and 2).

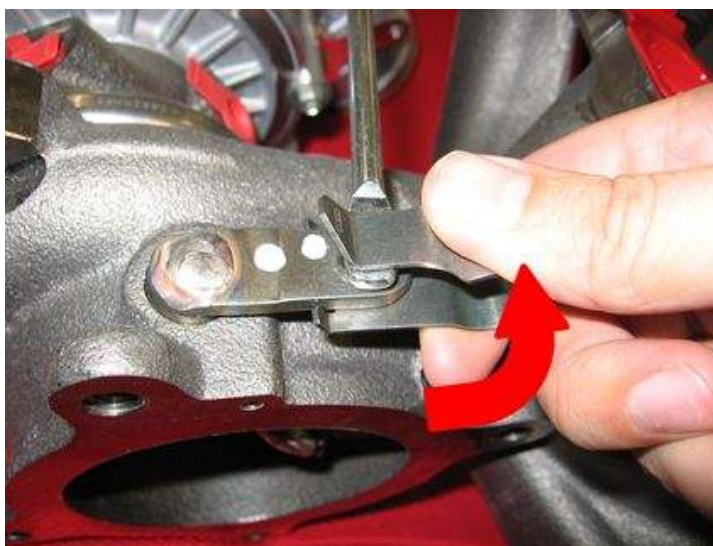
**Figure 2.** Turn the clip counter clockwise till the lugs slot in.

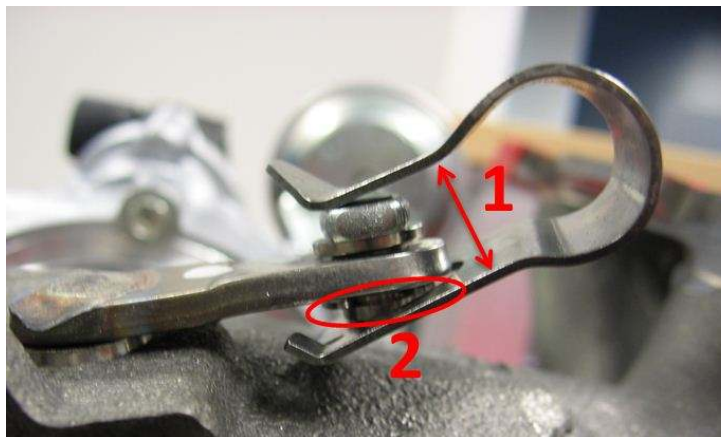
**Figure 3.** (1) Maximum opening of clip, (2) Position of original circlip

- The spring clip must not be overstretched. The maximum opening of the spring clip is 14 mm (Figure 3, 1).
- The spring clip must be replaced after every removal.

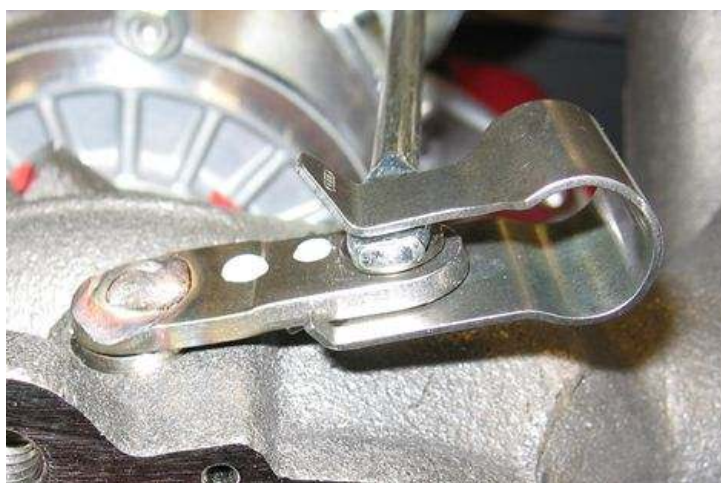
**Figure 4.** Correctly-fitted clip.

3. After fitting the spring clip, check for correct fit (Figure 4).

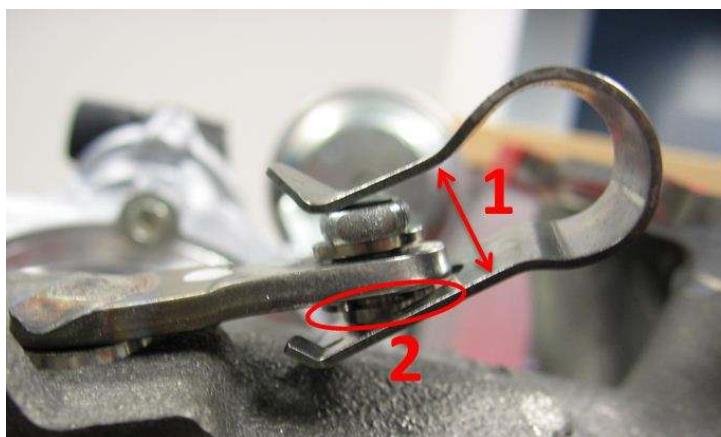
**Figure 5.** (1) Maximum opening of clip, (2) Position of original circlip

4. After fitting the spring clip, check the position of the original circlip (Figure 5, 2) and correct it if necessary.
