# Technical Service Bulletin

## 21 Mil on (DTC P0299 - negative pressure deviation); turbocharger excessive wastegate play

21 13 16 2031245/6 July 9, 2013. Supersedes Technical Service Bulletin Group 21 number 13-14 dated June 7, 2013 for reasons listed below.

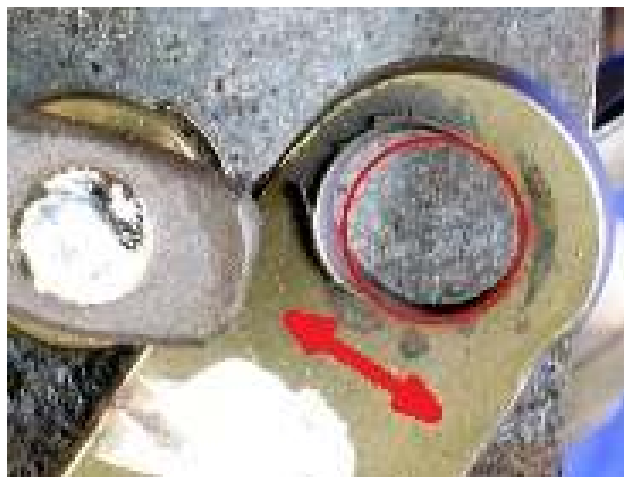
Under certain driving conditions, the linkage for the waste gate actuation can encounter excessive wear which leads to play at the waste gate flap. This leads to boost escaping through a loose flap, which sets **DTC P029900** (Negative Pressure Deviation).

**Figure 1.** Worn eye on wastegate link plate allowing excessive play.

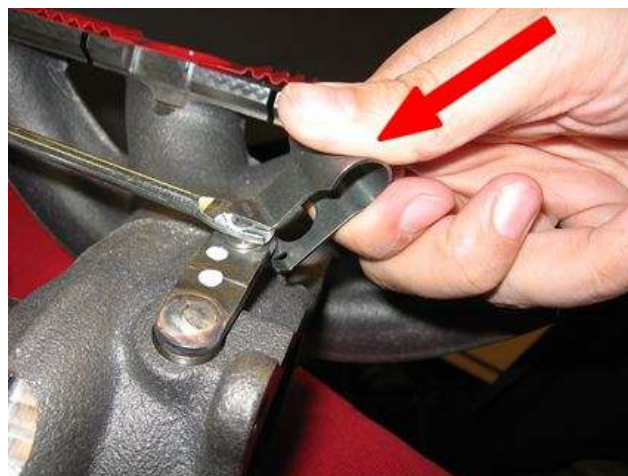
**Figure 2.** Fit the clip from the side.

3. Install clip **06J145220B** on a new, replacement turbocharger's link plate and actuating rod joint as illustrated (Figures 2 and 3).

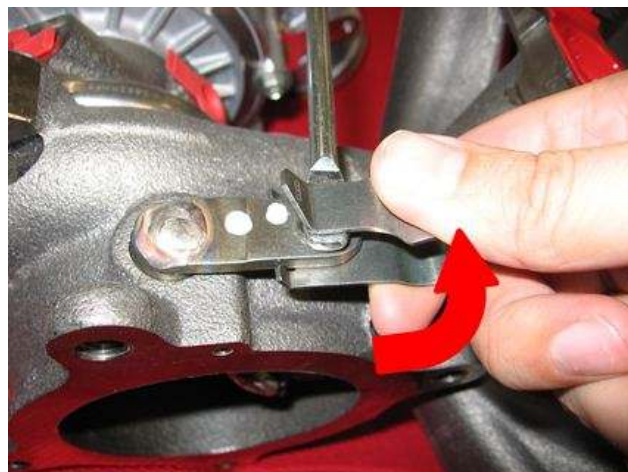
**Figure 3.** Turn the clip counter clockwise till the lugs slot in.

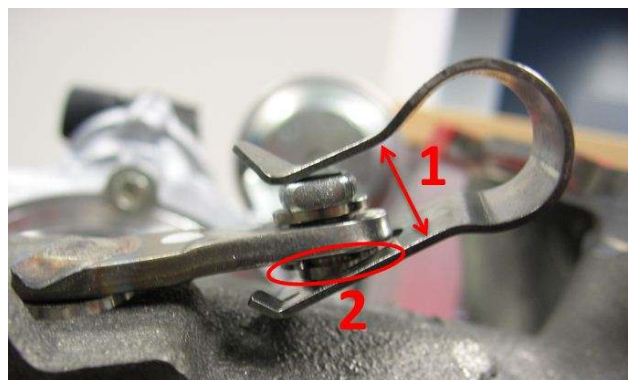
**Figure 4.** (1) Maximum opening of clip, (2) Position of original circlip

- The spring clip must not be overstretched. The maximum opening of the spring clip is 14 mm (Figure 4, 1).
- The spring clip must be replaced after every removal.

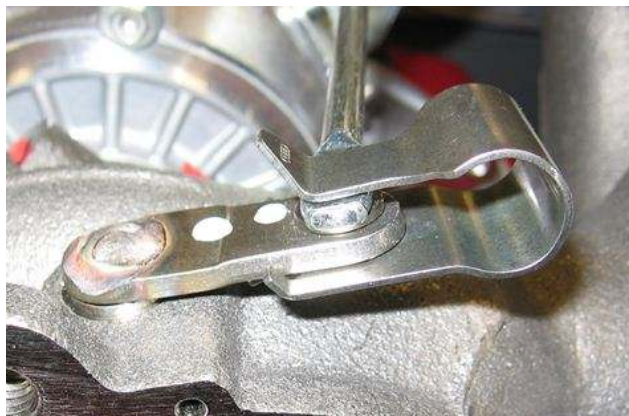
**Figure 5.** Correctly-fitted clip.

5. After fitting the spring clip, check for correct fit (Figure 5).

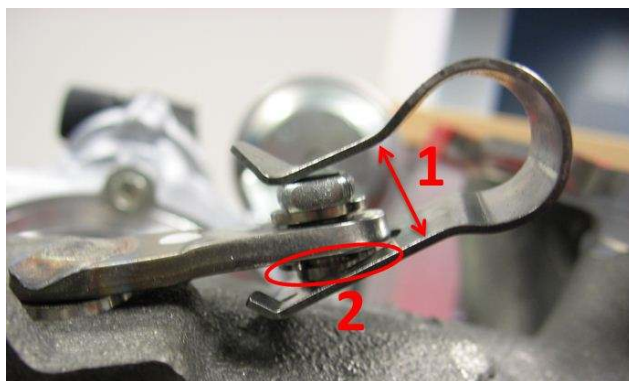
**Figure 6.** (1) Maximum opening of clip, (2) Position of original circlip

6. After fitting the spring clip, check the position of the original circlip (Figure 6, 2) and correct it if necessary.
