# Technical Service Bulletin

## 35 Gearbox warning light on (DTCs P179E00, P179F00, P0700, P060A)

35 14 17 2032211/2 September 25, 2014. Supersedes Technical Service Bulletin Group 35 number 12-08 dated December 21, 2012 for reasons listed below.

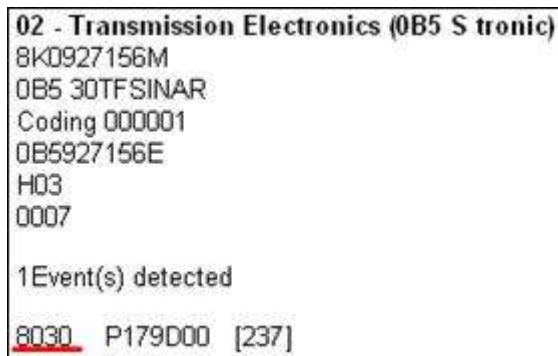
The DFCC is the 4-6 digit code that is typically listed before the fault code (Figure 1).

**Figure 1.** DFCC 4-6 digit code listed before the fault code, underlined in red.

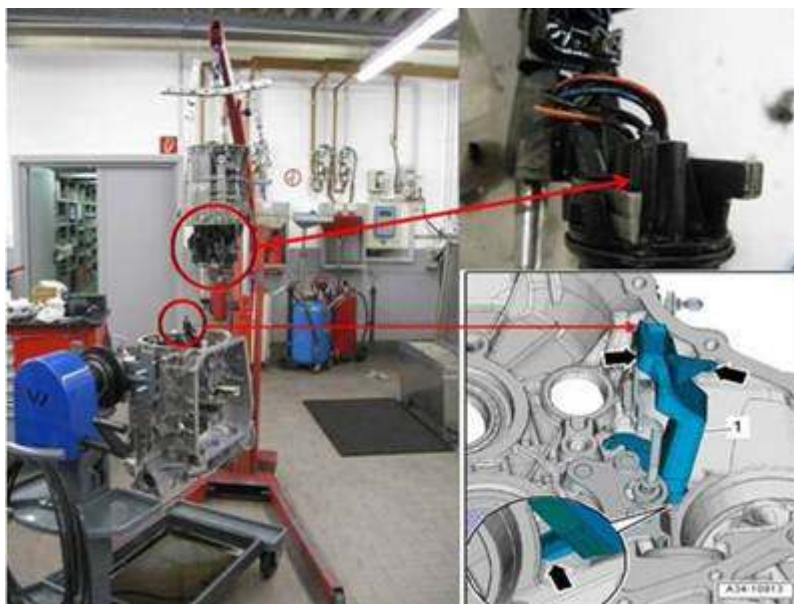
**Tip:** Use caution when lifting or lowering intermediate housing to avoid damage to components (Figure 2).

**Figure 2.** Caution points: drip tray and sensor module connector.

1. If the *Condition* matches exactly, replace the G676 sensor module with circuit board by following instructions in *Elsa* >> *Repair manual* >> *Transmission* >> *S Tronic Transmission Internal Components* >> *35 Gears, Shafts* >> *Removal and Installation* >> *Sensor Module with Transmission Input Speed Sensor -G612-, -G632-, -G676- and Circuit Board 3*.

When replacing the sensor module, its wiring loom must also be replaced.
