Technical Service Bulletin

Transaction No.: 2054202/8

96 Audi adaptive light system malfunction, DTC C12B3FA stored in the control module  
for driver assistance systems

Release date: Sep 15, 2026

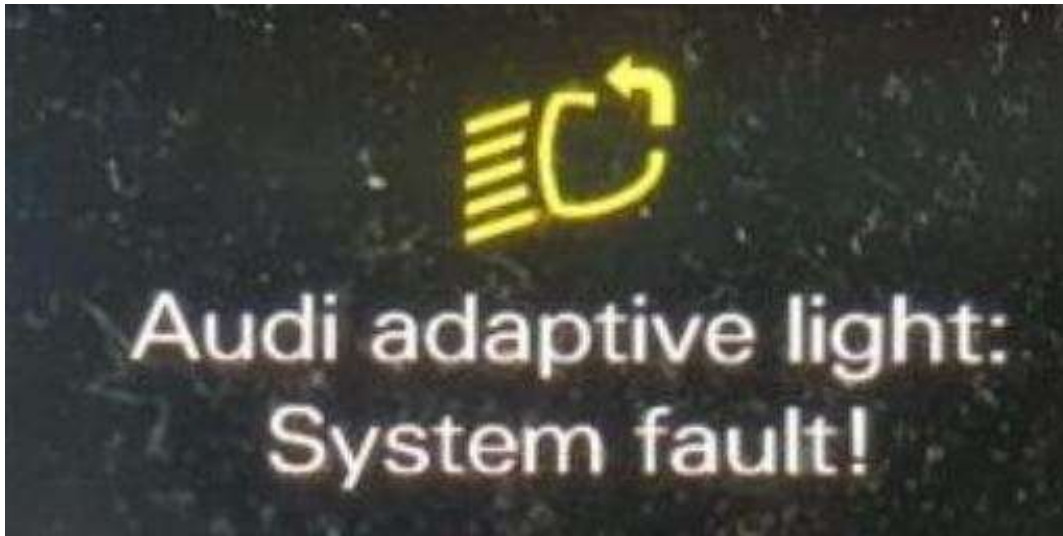
- Audi adaptive light: system fault (Figure 1).
- Audi pre sense: system fault
- Adaptive cruise assist: restricted
- Adaptive cruise assist: predictive control currently restricted

**Figure 1.** Instrument cluster message.

- **DTC C12B3FA:** (front camera for driver assist systems - communication fault) with symptom code 221189.

DTC “**C12B3FA:** Driver Assistance Systems Front Camera – communication error (symptom number 221189)” may appear intermittently in certain circumstances. External influences (e.g. electromagnetic compatibility) can cause this complaint.

Check the software version of the driver assist systems control unit -J1121- (diagnostic address 00A5).

Please follow TSB 2063497, 90 Driver assist systems with various malfunctions (aLDW performance, ACC inop when towing etc.) B200FF9 B200FF3 C123FB.

No further measures are necessary/available. The issue will be resolved after a bus sleep cycle and restart of the driver assist systems control unit -J1121- (00A5).
