## Technical Service Bulletin

Transaction No.: **2073858/13**

93 e-tron GE various warning messages in the cluster, electric motor leaking  
P0AA600

Release date: Sep 24, 2026

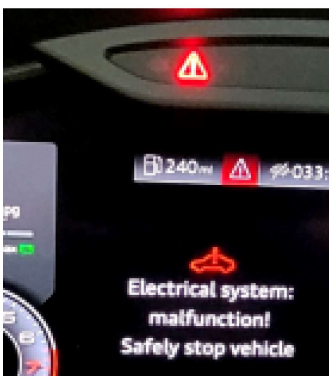
- A Drive System/Electrical System Malfunction message (Figure 1) appears in the instrument cluster.

**Figure 1.** Warning lamp associated with message.

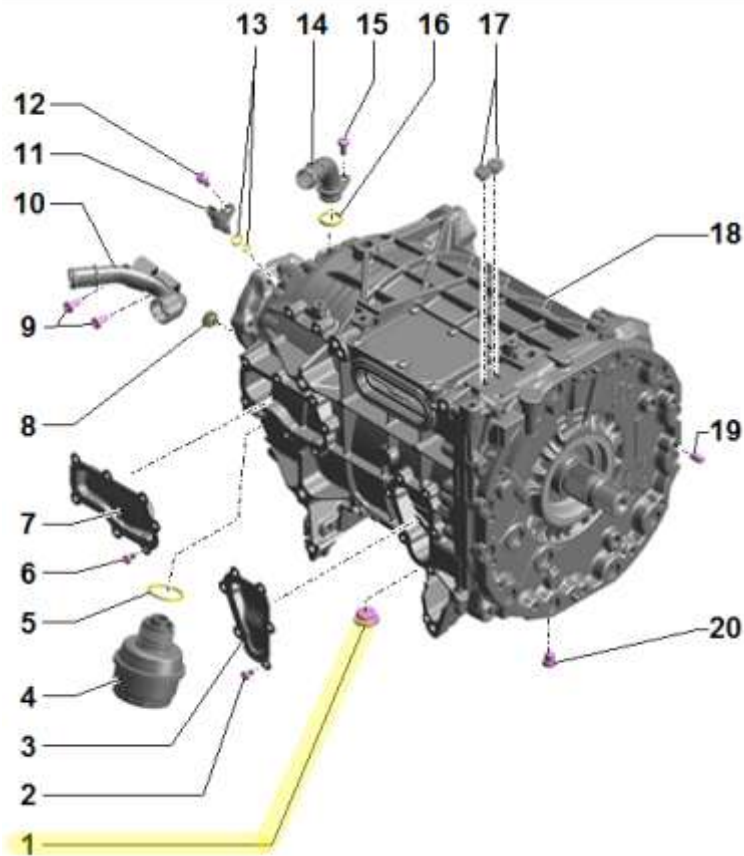
**Rear axle (Figure 2):**

Drip container is overflowing:

- Coolant leaking from active chamber.

Drip container is empty:

- Coolant leaking from active chamber, particularly on vehicles with low mileage.

**Figure 2.** (1) Drain plug.

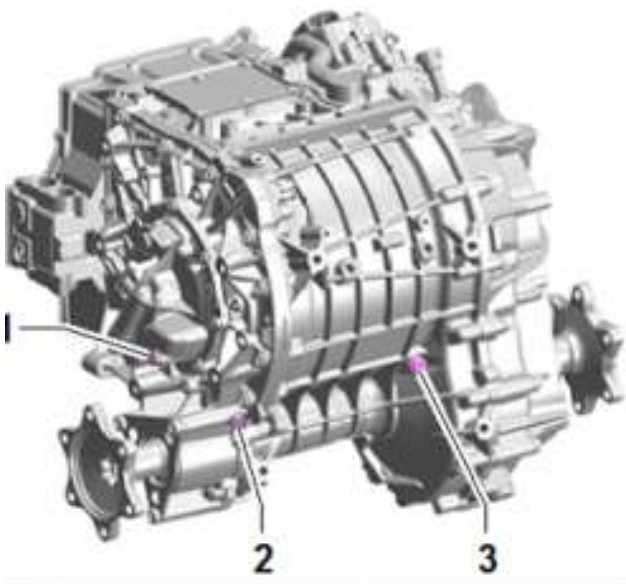
**Front axle (Figure 3):**

- Coolant leaking from active chamber.

**Figure 3.** 1) *Resolver cover:* A few milliliters of coolant leakage is not an issue from a technical perspective. 2) *Active chamber:* No coolant may escape from the bores.

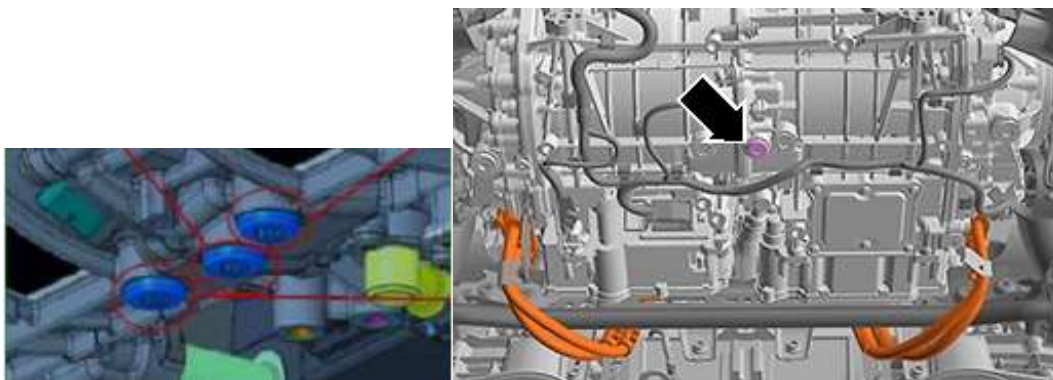
**Dual motor rear axle (refer to Figure 4):**

**Figure 4.** The drain plug is located between the two rear electric motors (Center drain plug)..

A few milliliters of coolant leakage is not an issue from a technical perspective.

The drain plugs for the active chamber are located on the left and right.

No coolant may leak.
