## Technical Service Bulletin

Transaction No.: **2079294/2**

37 Message in instrument cluster: "Drive system: fault. Please contact workshop", DTC B114E13 or B114F13 in DA 8119

Release date: Sep 25, 2026

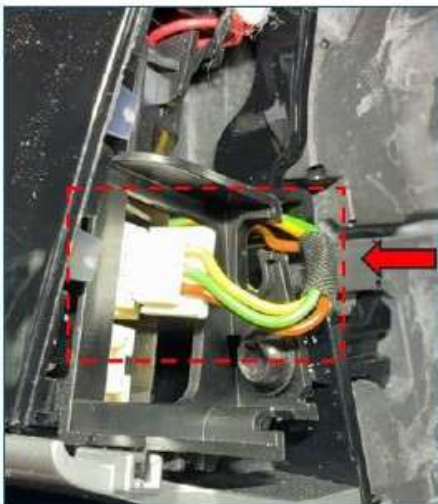
Incorrect wire routing in steering wheel and oversensitive diagnostic parameters in multifunction steering wheel control unit 3 -J453- (diagnostic address 8119).

Figure 1 shows an example of incorrect wire routing.

**Figure 1.** *Incorrect wire routing.*

Unplug the connector and check the wiring harness for damage.

Route the wires on the left and right sides of the steering wheel so that they are guided through the corresponding retaining lug (refer to Figures 2 and 3).

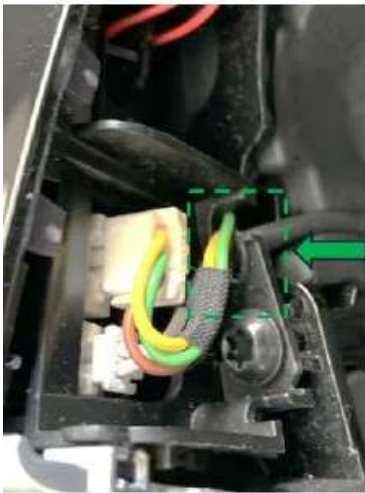
**Figure 2.** Correct wire routing on left side.

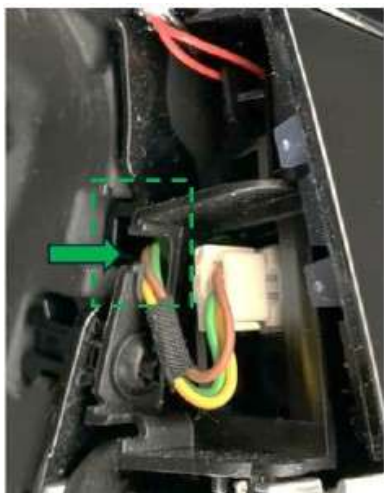
**Figure 3.** Correct wire routing on right side.
