**Technical Service Bulletin (TSB)**  
**Engine Runs Rough**

| REFERENCE: | TSB: 09-013-26 REV. A<br>GROUP: 09 - Engine | Date: | September 30, 2026 | REVISION: | 09-013-26 |
| VEHICLES AFFECTED: | 2026 (WL) Jeep Grand Cherokee / Grand Cherokee L<br>This bulletin applies to vehicles built on or before July 02, 2026 (MDH 0702XX) equipped with the 2.0L Hurricane 4 Turbo W/ESS (Sales Code EC7). | | | MARKET APPLICABILITY:<br><div><input checked="" type="checkbox"/> NA<input type="checkbox"/> IAP</div> <div><input type="checkbox"/> EE<input type="checkbox"/> CH</div> <div><input checked="" type="checkbox"/> **SA**</div> <div><input checked="" type="checkbox"/> **MEA**</div><br><div>NOTE: **This bulletin applies to Middle East &amp; Africa, North America, and South America markets.**</div> | |

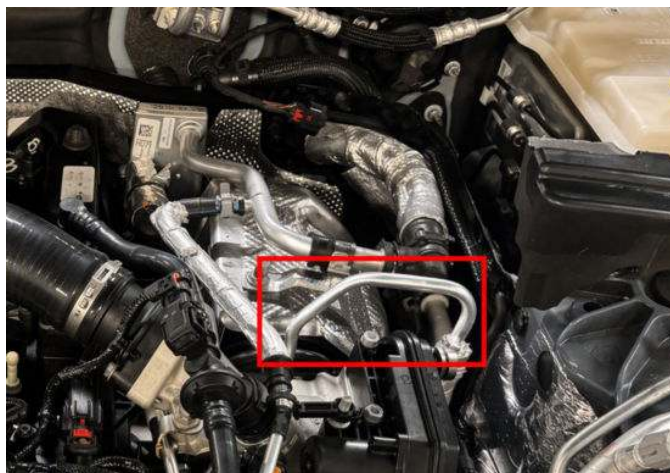
**Fig. 1**

Do not grab or lean on the turbo oil feed line. Doing so can damage the tube [Fig. 1](#).

Turbo Oil Feed Line
