EC17-006

## MIL ON WITH DTC P0101, P010B, AND/OR P0106

APPLIED VEHICLES: 2016-2017 Q50 (V37)  
2017 Q60 (V37)

APPLIED ENGINE: VR30DDTT (V6 twin turbo engine)

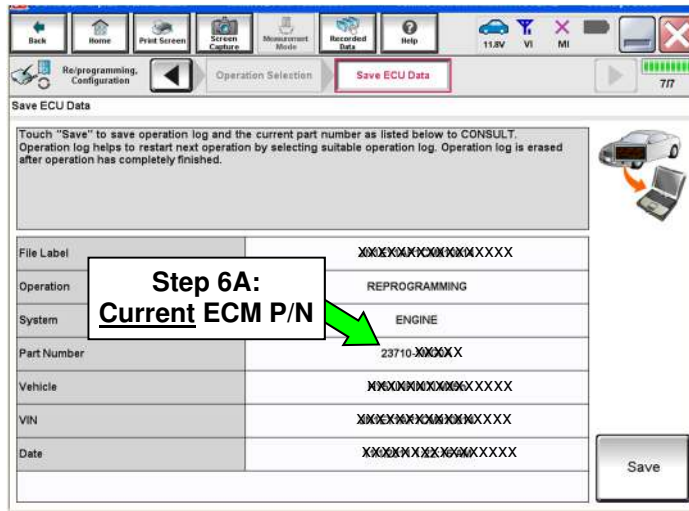
Figure 2

6. When you get to the screen shown in Figure 2, confirm this bulletin applies as follows.

A. Find the ECM Part Number and write it on the repair order.

NOTE: This is the current ECM Part Number (P/N).

B. Compare the P/N you wrote down to the numbers in the Current ECM Part Number column in Table A below.

- If there is a match, this bulletin applies. Continue with the reprogramming procedure.
- If there is not a match, this bulletin does not apply. Close C-III plus and refer to ASIST for further diagnostic information.

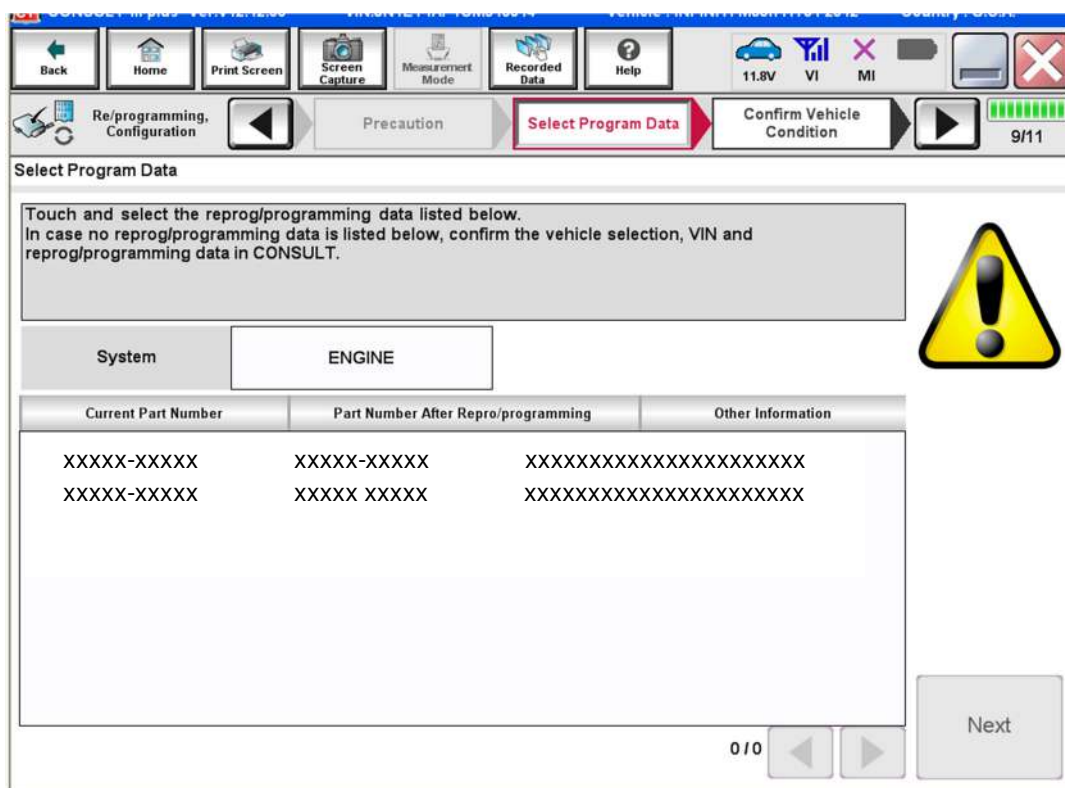
- In some cases, more than one new P/N for reprogramming is available.
  - If more than one new P/N is available, the screen in Figure 3 displays.
  - Select and use the reprogramming option that does not have the message “Caution! Use ONLY with ITBXX-XXX”.
- If you get this screen and it is blank (no reprogramming listed), it means there is no reprogramming available for this vehicle. Close C-III plus and refer back to ASIST for further diagnosis.

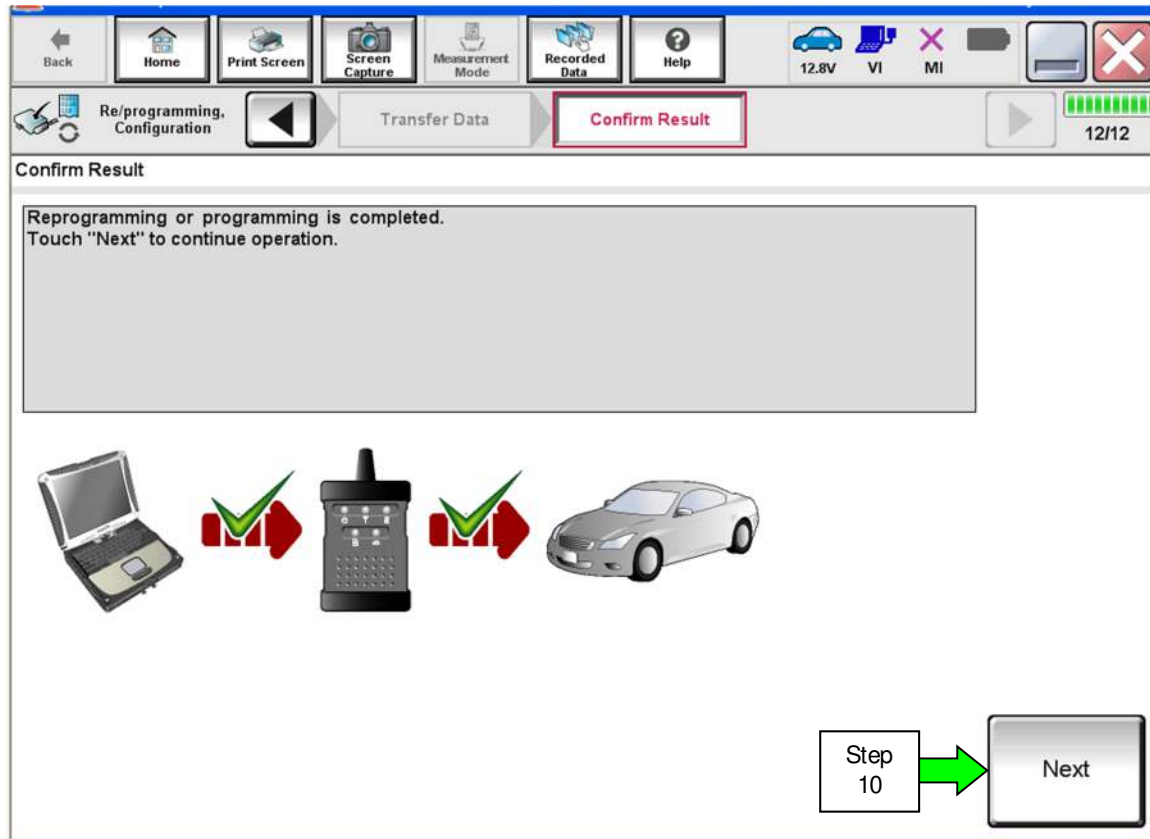
8. When the screen in Figure 4 displays, reprogramming is complete.

NOTE: If the screen in Figure 4 does not display (reprogramming does not complete), refer to ECM recovery on the next page.

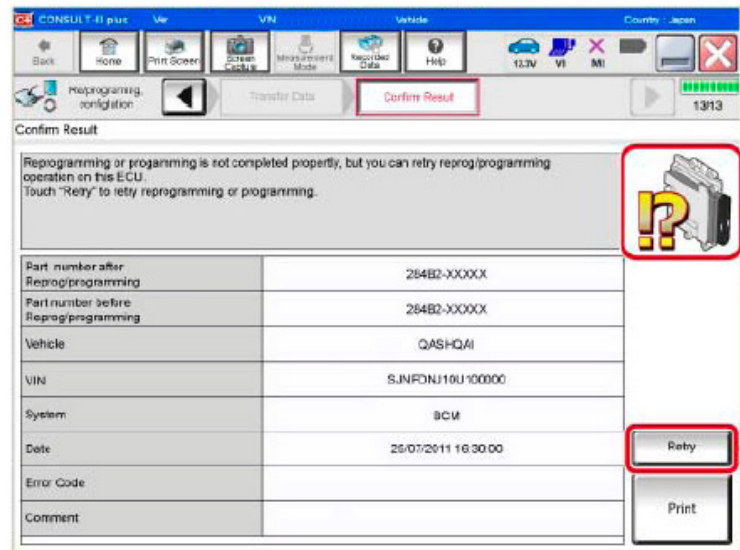
Figure 5

If reprogramming does not complete and the “!” icon displays as shown in Figure 5:

- Check battery voltage (12.0 - 15.5 V).
- Ignition is ON, engine OFF.
- External Bluetooth® devices are OFF.
- All electrical loads are OFF.
- Select retry and follow the on screen instructions.
- “Retry” may not go through on first attempt and can be selected more than once.

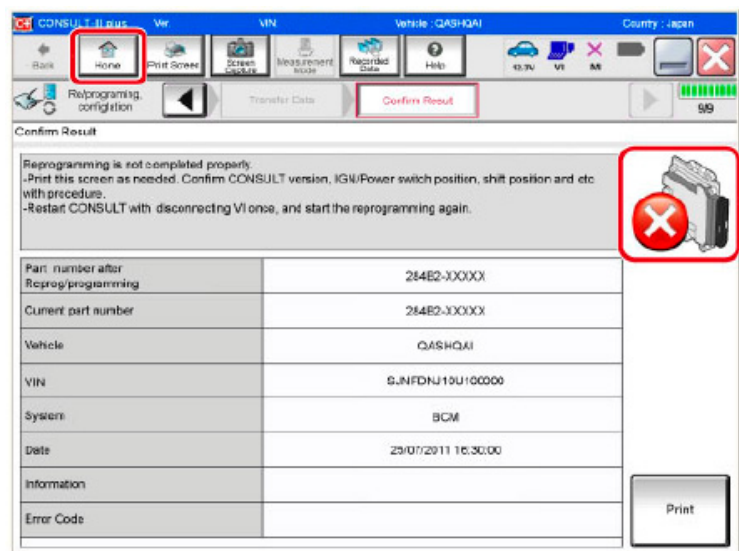
Figure 6

If reprogramming does not complete and the “X” icon displays as shown in Figure 6:

- Check battery voltage (12.0 - 15.5 V).
- CONSULT A/C adapter is plugged in.
- Ignition is ON, engine OFF.
- Transmission is in Park.
- All C-III plus / VI cables are securely connected.
- All C-III plus updates are installed.
- Select Home, and restart the reprogram procedure from the beginning.

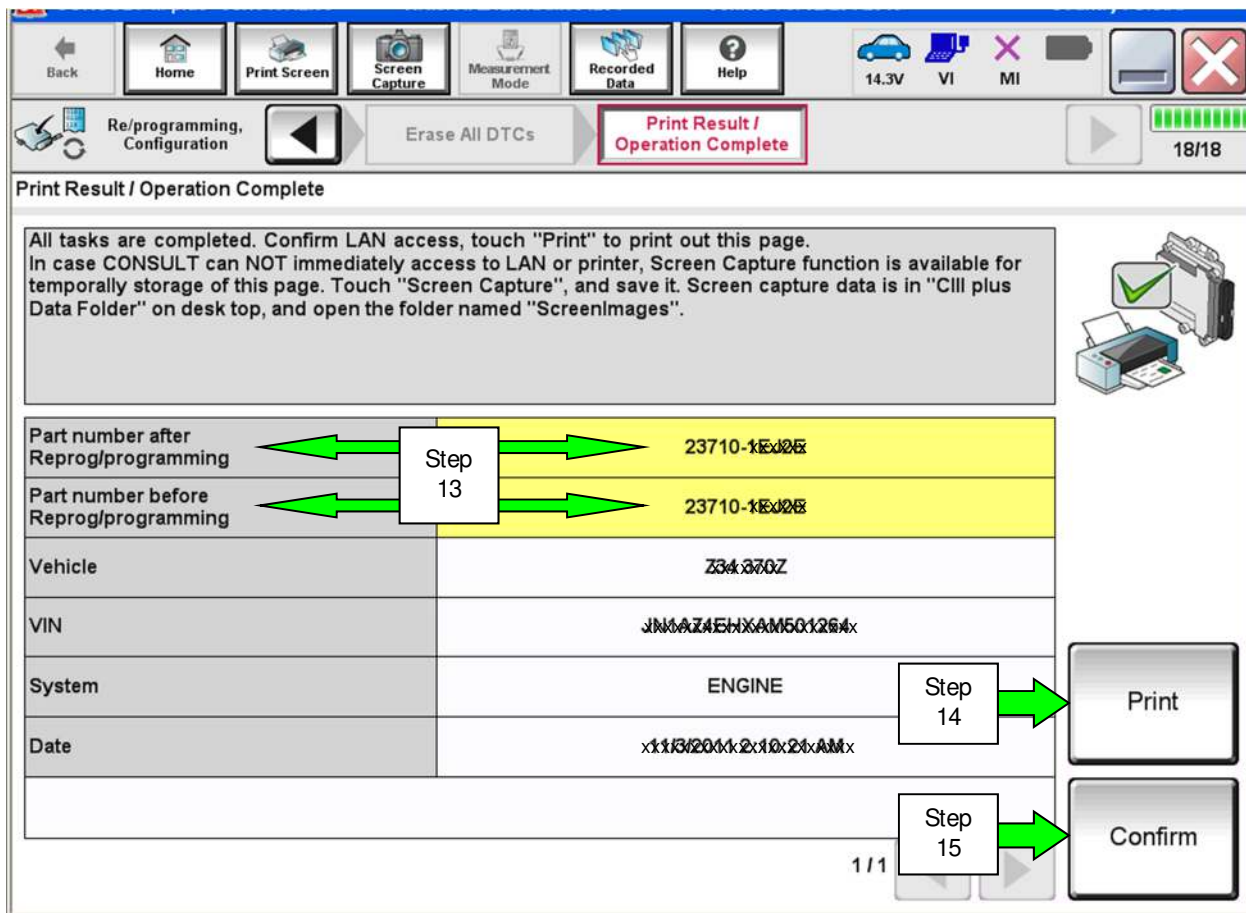
12. When the entire reprogramming process is complete, the screen in Figure 7 will display.
13. Verify the before and after part numbers are different.
14. Print a copy of this screen (Figure 7) and attach it to the repair order for warranty documentation.
15. Select Confirm.
