2014-2016MY  
Soul (PS)

PS476

March 2017

### INTERMITTENT LACK OF POWER OR HESITATION UPON ACCELERATION – RESTRICTED FUEL LINE

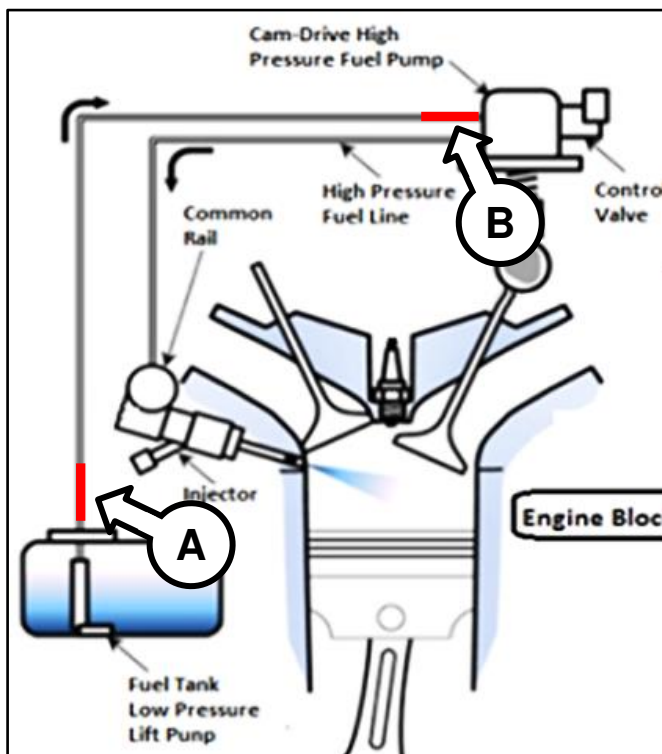
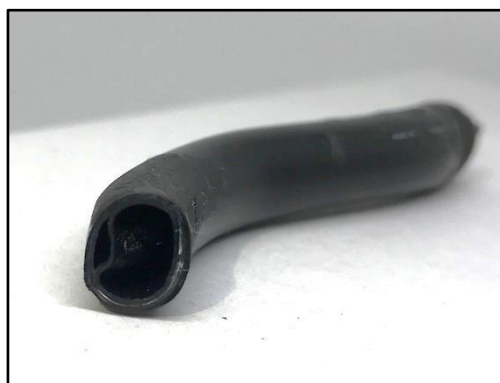
Customers may experience an intermittent lack of power or hesitation upon acceleration. The malfunction indicator lamp may not illuminate or DTC P0087 may be stored (history). This is possibly due to a restricted low pressure fuel line.

Restricted Fuel Line

Begin by checking the fuel pressure at the low pressure pump fuel output line (A) in the fuel tank using a fuel gauge kit, tool number: FPG2200. The gauge should display above 71 PSI if there is no restriction in the low pressure pump. When the lack of power/hesitation occurs and the fuel pressure at the fuel tank is within specifications, disconnect the fuel pressure gauge from the low pressure pump and connect it at the high pressure pump fuel feed line (B). When the lack of power/hesitation occurs and the gauge drops below 71 PSI, the fuel feed line from the low pressure pump to the high pressure pump may be restricted. Replace the low pressure fuel line from the tank to the high pressure pump by referring to the “Engine Control / Fuel System → Fuel Delivery System → Fuel Line → Repair procedures” chapter in the applicable Shop Manual on KGIS.
