## SERVICE BULLETIN

**APPLICABILITY:** All Models Equipped with CVT Transmissions

**NUMBER:** 16-102-16

**SUBJECT:** DTC P0841 Diagnostics

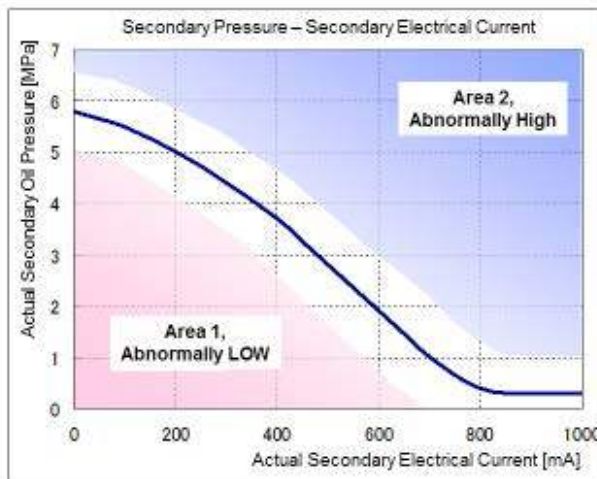
### How To Identify the Condition Causing DTC P0841 to Set by Reviewing the Stored FFD

The condition causing P0841 is either:

1. The Secondary Oil Pressure is abnormally low (lack of necessary pressure)
2. The Secondary Oil Pressure is abnormally high (excess pressure occurs as compared to necessary pressure).

Check the Actual Secondary electrical current [mA] and Actual Secondary oil pressure [MPa] stored in the FFD then determine if P0841 has set because of:

1. abnormally low
2. abnormally high Secondary Oil pressure.

**TIP:** Consider performing the pressure testing using a mechanical pressure gauge **BEFORE** electrical testing and compare the test results (between the gauge and SM4 displayed values). Both test results should be very close. If there is a significant discrepancy between them (e.g. the (known good) gauge results are significantly higher than the SM4-supplied values), the pressure sensor would be suspect.

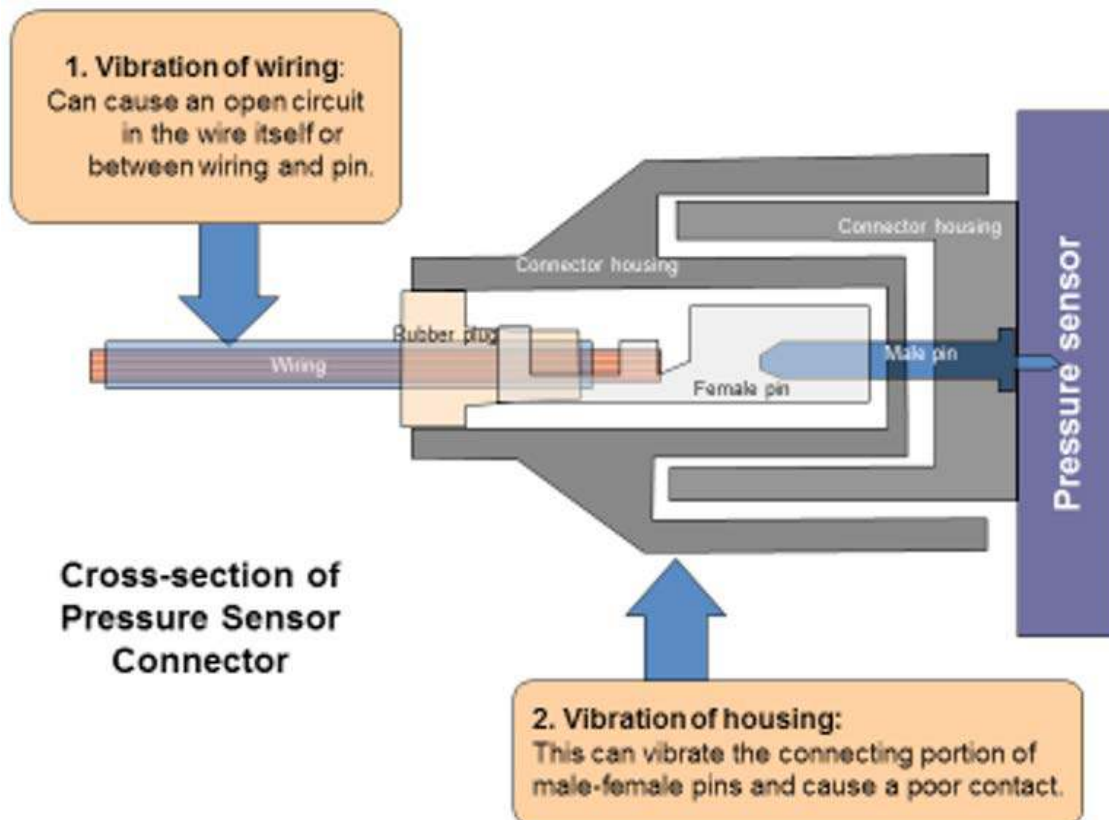
## Effects of Vibration on Connectors / Terminals:

(1) The pin for the secondary oil pressure sensor is located at the end of connector and can be affected by ambient temperature. The sensor wiring can develop an open circuit when cold caused by freezing but be normal at normal temperatures. Keep temperature conditions in mind when testing. Always wiggle test the wiring and connections when testing and watch for any fluctuations.

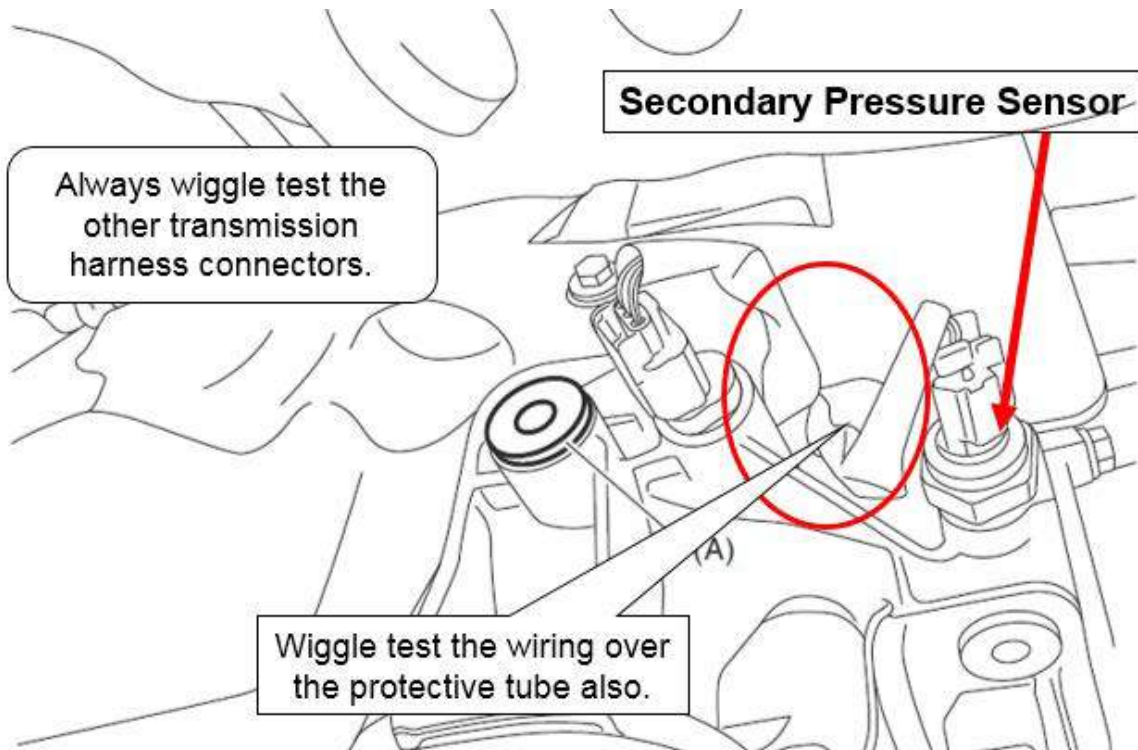
## “Wiggle-Testing” Wiring:

(2) Check, record and confirm the "Secondary Oil Pressure A/D Value" is correct with SSM while wiggling the T/M wiring, TCM connectors and the Secondary Oil Pressure sensor harness connector.

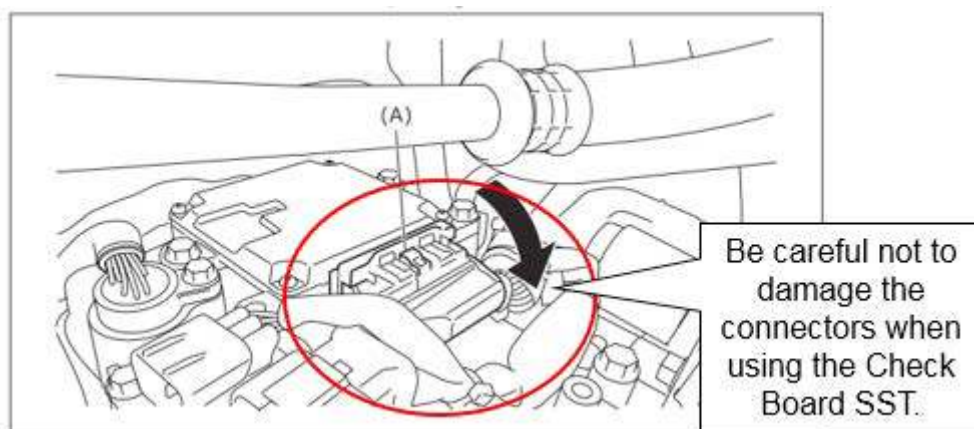
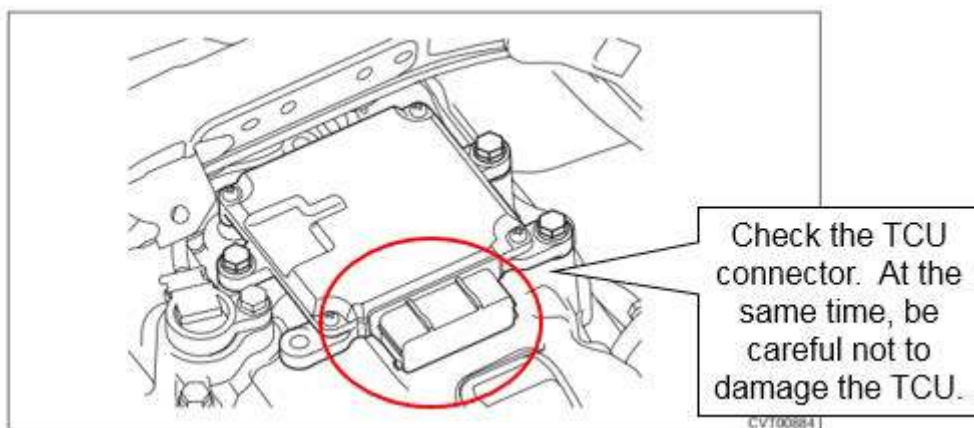
## Other Points to Inspect:

(1) Inspect for any abnormalities with the pins like: deformation, scratches, discoloration or evidence of any foreign materials inside them or the connectors.
