# Power Back Door Does Not Close Properly

| YEAR(S) | MODEL(S) | ADDITIONAL INFORMATION |
|---|---|---|
| 2008 – 2013 | Highlander, Highlander HV | |

The information contained in this bulletin supersedes SB No. T-SB-0091-12.

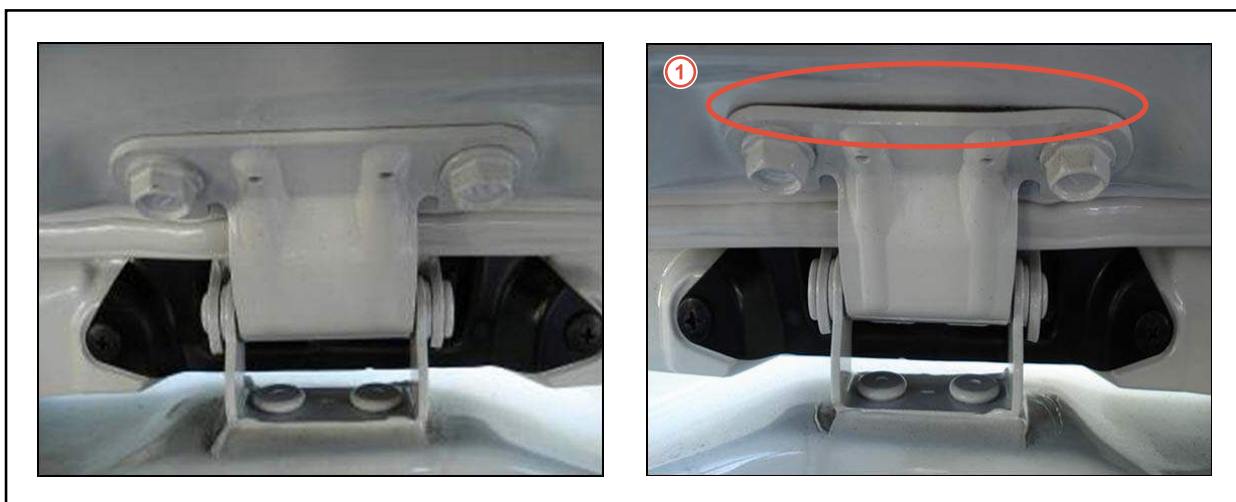
**Figure 1.**

1. Inspect the upper hinges for any gaps present by placing a 0.05 mm (0.002 in.) or greater feeler gauge between the 2 bolts mounted to the back door as shown in Figure 1. If a gap exists, replacement of both Back Door Hinges AND the Back Door Panel Sub-assembly is required. Proceed to step 2.

| 1 | Gap Location |

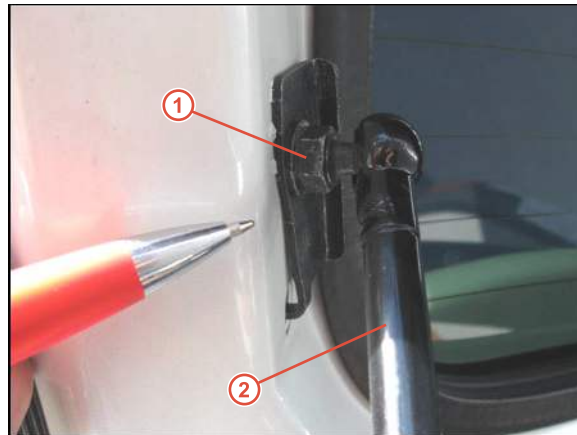
Figure 2.

2. Visually inspect the Back Door Upper Rod and Lift Arm Stud for bends or damage. If the Back Door Upper Rod and Lift Arm Stud are damaged, then replace as necessary.

| 1 | Lift Arm Stud |
| 2 | Back Door Upper Rod |

The Back Door Upper Rod and Lift Arm Stud are available as separate service parts from the Back Door Motor Unit if found damaged or bent.

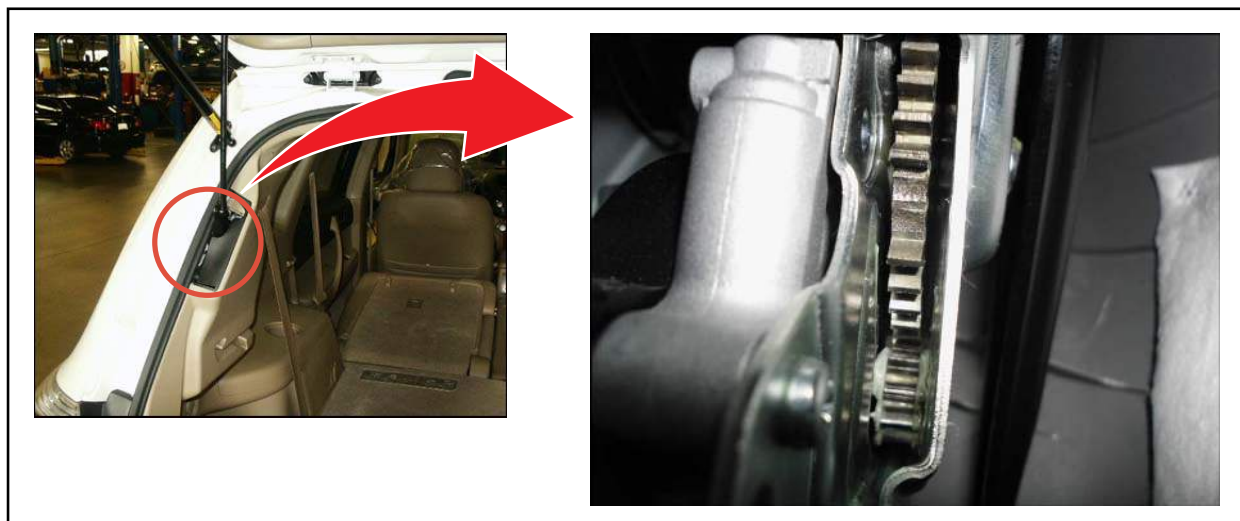
3. Visually inspect the back door motor teeth for damage by opening the back door and manually moving the door towards the half-closed position while observing the large gear teeth for damage, as shown in Figure 3. If damage is found, replacement of the Back Door Motor Unit and Back Door Stay Plate is required.

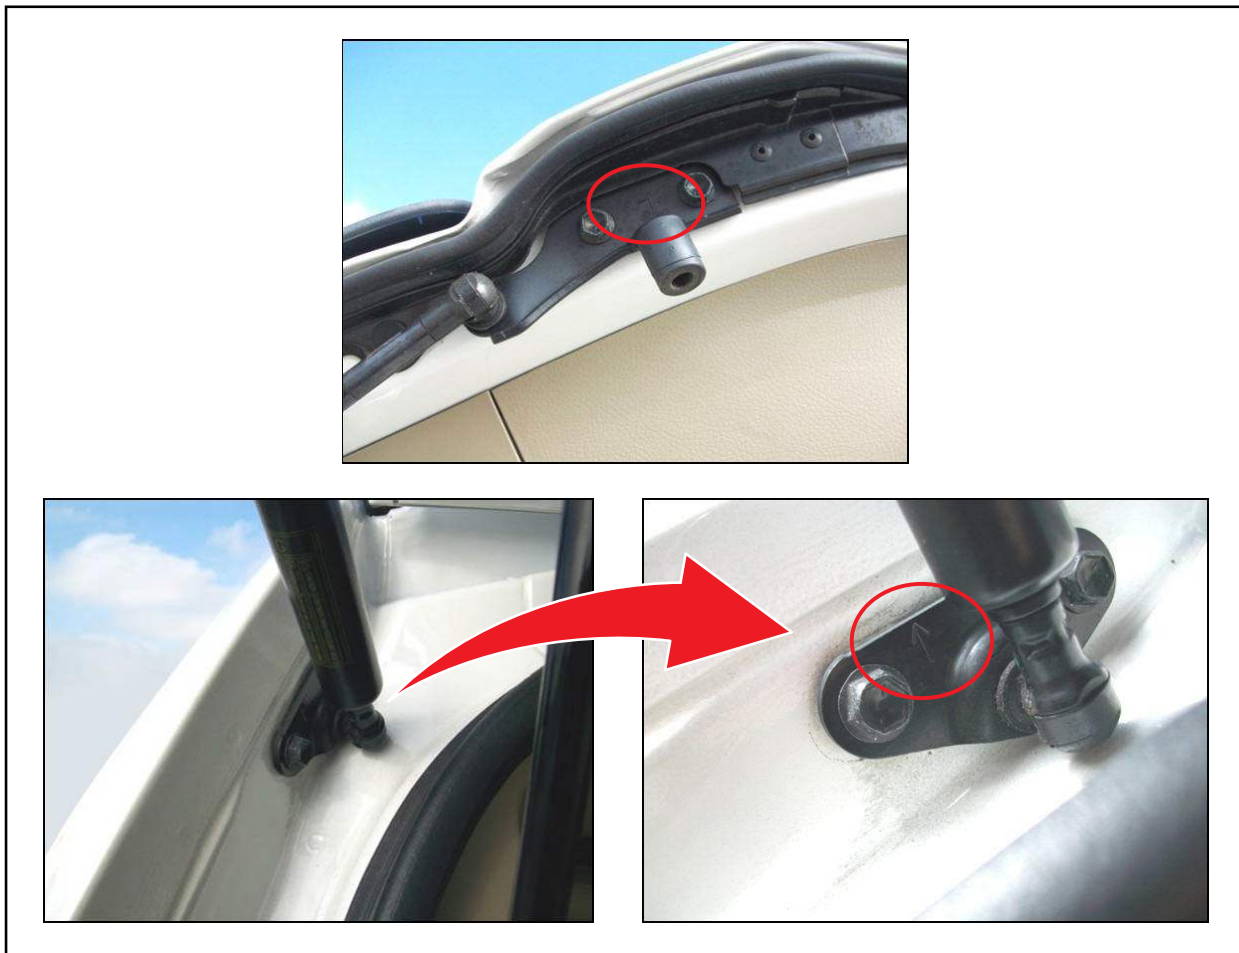
Figure 4.

To ensure correct installation of the back door struts, note the markings on the assembly (Figure 4). The markings indicate on which side of the car the strut should be installed, and the direction of the braces on the strut.
