# Service Bulletin

**Subject:** Service Front Camera / Service Lane Departure Warning / Service Lane Keep Assist Message with DTC B1008 SYM4B

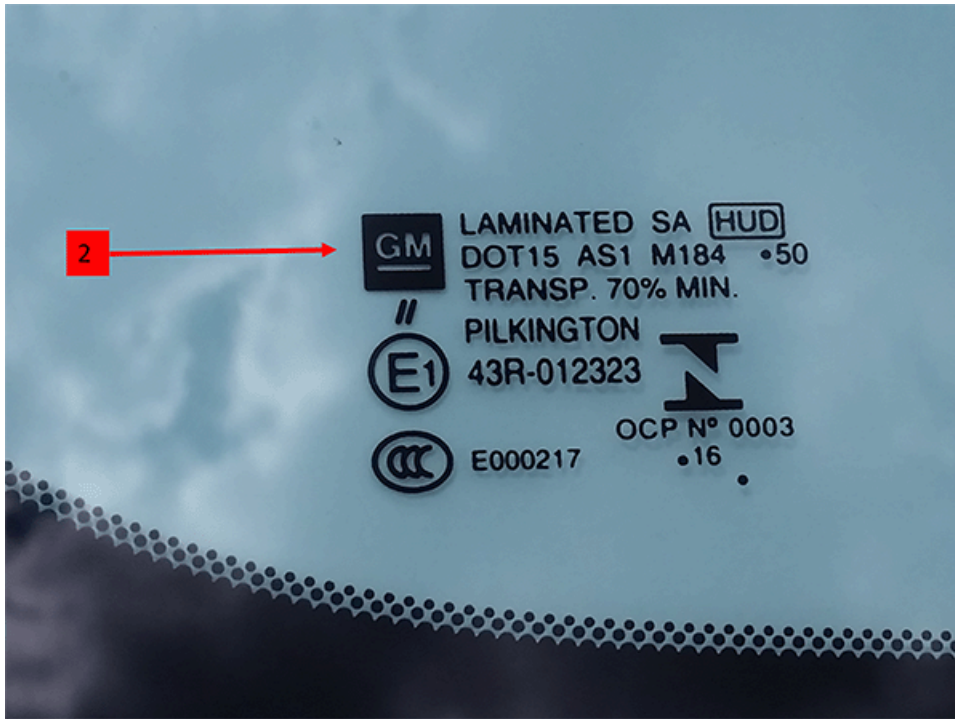
If, after performing the checks listed above and the root cause of the camera not completing the calibration/learn is not found, inspect for an aftermarket windshield being installed in the vehicle. To determine whether or not the windshield is an aftermarket or factory windshield, inspect for the "GM" Logo in the lower right corner of windshield, as shown below (2). If the "GM" Logo is not present, then the windshield is aftermarket.

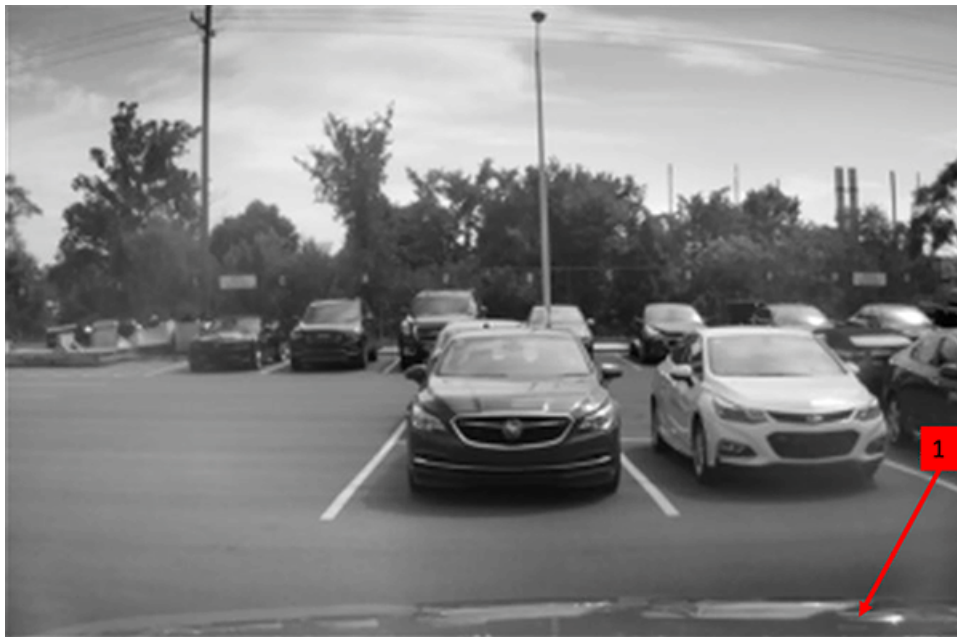
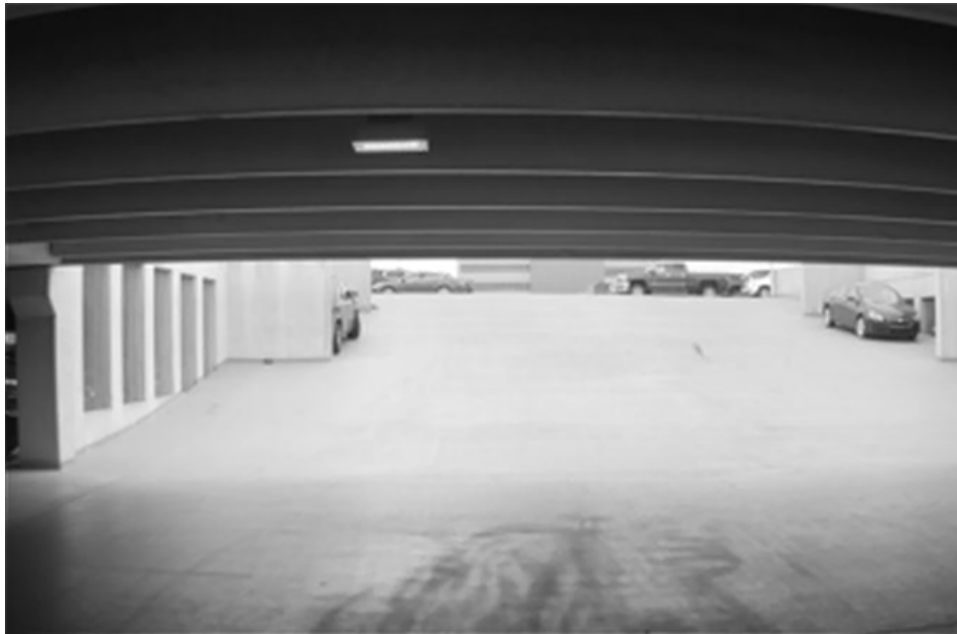
It has been found that some aftermarket windshields do not properly mount/position the front view camera. Shown below are some images, taken with engineering tools (see note below), of what the front view camera is actually seeing. The first image is taken from a truck with an aftermarket windshield. As shown below, the camera is seeing part of the hood (1). Because of this, the camera is not seeing movement in the area of the hood and can not complete the learn. The second image below is from a truck with a factory windshield and there is no hood seen by the front view camera.
