# Service Bulletin

## PRELIMINARY INFORMATION

**Subject:** Poor Engine Performance P0089 P228D P0171 Whine Noise From High Pressure Fuel Pump

**Models:** 2010-2011 Buick LaCrosse  
2011 Buick Regal  
2010 - 2011 Chevrolet Equinox  
2010-2011 GMC Terrain  
Equipped with 4 cylinder engine (RPO LAF)

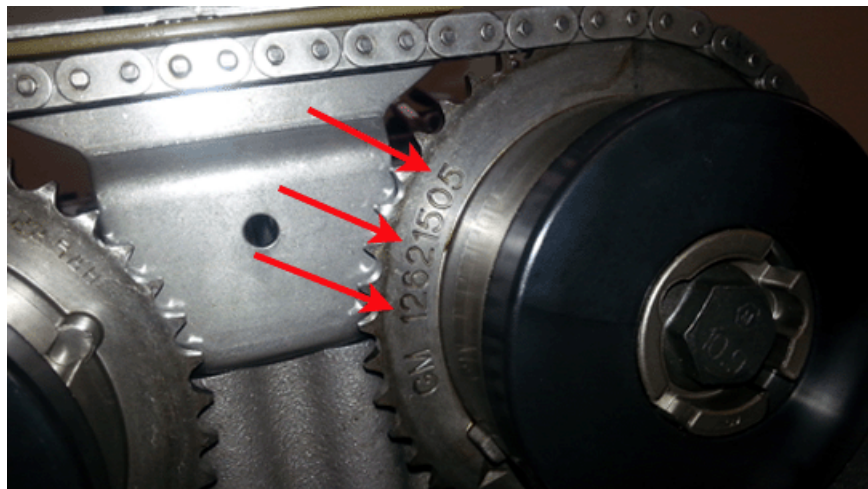
A 2010 engine has a black exhaust actuator sprocket and a gray intake actuator sprocket. Each camshaft actuator sprocket will have a different part number. A 2011 engine has black camshaft actuator sprockets for both the intake and exhaust camshafts. Both camshaft actuator sprockets will have the same part number.

Below is an example of a 2011 intake camshaft actuator part number 12621505 and black in color (plastic cover piece).

If the symptoms above are noted after engine, intake camshaft or intake camshaft actuator replacement. It is likely the incorrect parts have been installed. This can be confirmed by removing the camshaft cover and noting the CMP actuator sprocket colors or part number on the actuator sprockets.

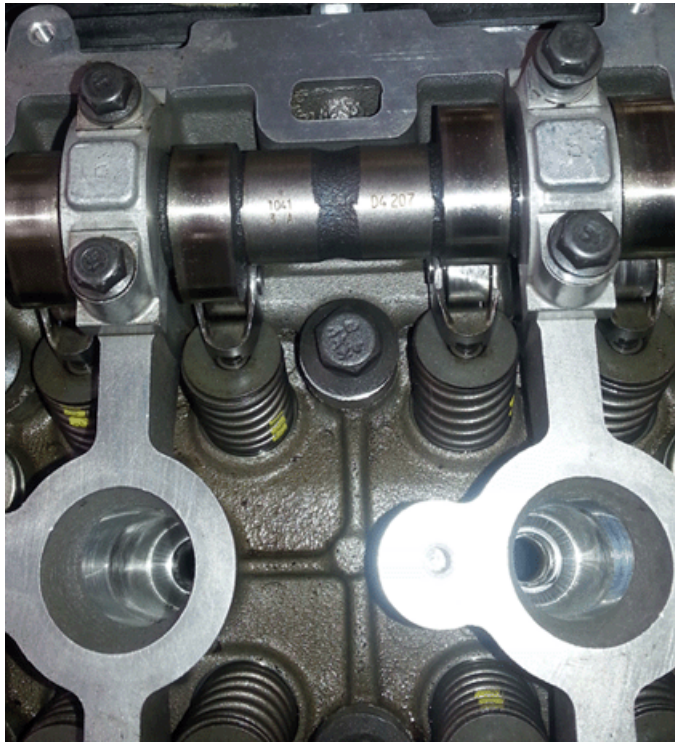
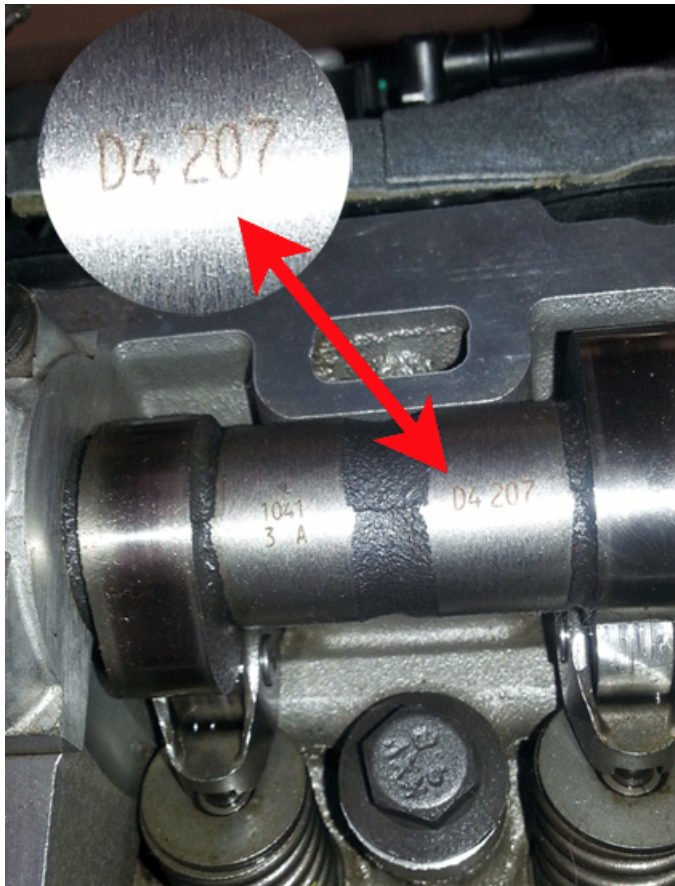
The camshafts can be identified by the last four digits of the part number located on a machined surface between the number 2 and number 3 cylinder camshaft lobes.

Below is an example of a 2011 intake camshaft part number 12634207.

Before a 2010 service engine was available, technicians were directed to install a 2011 service engine into a 2010 vehicle. It was necessary to swap parts from the old engine to the new engine to make it a 2010 build. These parts included the intake camshaft and actuator sprocket, and the fuel rail assembly with injectors. If these parts from the original engine were damaged, new parts designed for a 2010 vehicle were installed. When the intake camshaft and actuator sprocket are swapped, dealers should reference timing procedures for a 2010 model year vehicle. This is important because the intake actuator locating notch in the camshaft moves from about the 10:00 starting position on a 2011 engine to about the 5:00 starting position on a 2010 engine.
