# Service Bulletin

**Subject:** SES Lamp On With DTC P2270

**Models:** 2013 Chevrolet Silverado

2013 GMC Sierra

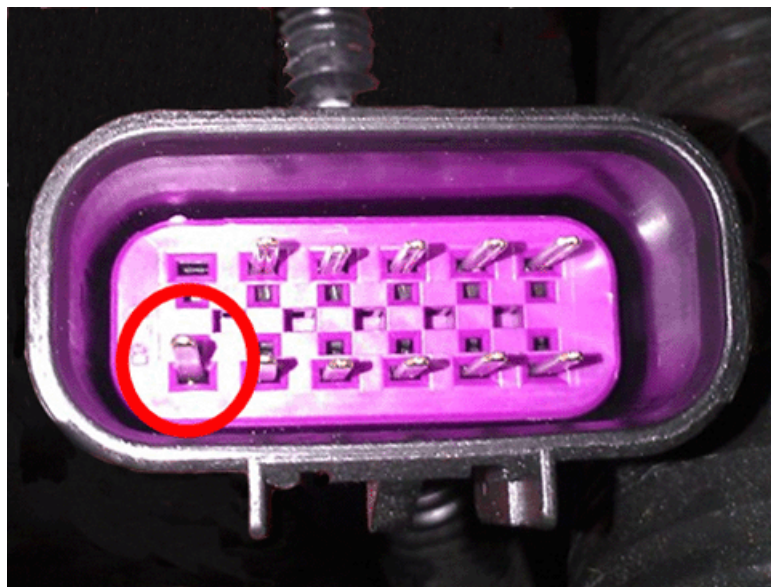
Concern of DTC P2270 setting along with any of the following codes P0140, P0139, P0138, P0137, P013A, P013B on vehicles built at the Fort Wayne assembly plant during February 2013.

Check connector X131 for a bent terminal F as indicated in the attached PIC and repair per SI procedures.

If no connector issue is found, follow SI diagnostics.
