# Service Bulletin

**Subject:** Diagnostic Tip for DTC P305F

**Models:** 2014-2015 Chevrolet Malibu  
Equipped with Start/Stop System (RPO KL9)

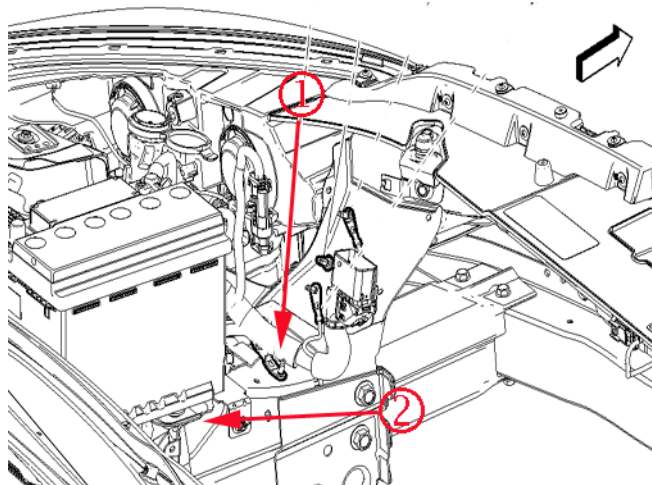
Technicians may find the diagnostic trouble code (DTC) P305F: Dual Battery Control Module Performance has been set in the Engine Control Module (ECM). There may be several different causes of this code setting and before any component replacements, please follow the recommendations below.

- Inspect for loose unsecured electrical ground at G103 (1).
- Verify the engine harness is not pinched underneath the main battery tray (2).
- Inspect both main and auxiliary battery cables for being secured.
- Perform the battery inspection/test in SI (Document ID# 3469663) to the auxiliary battery.

**Important:** Do NOT replace the ECM for this DTC.
