# Service Bulletin

**Subject:** Diagnosis and Repair - Malfunction Indicator Lamp (MIL) Illuminated, Reduced Engine Power Message Displayed, DTC P2135 Set

**Models:** 2009-2011 Buick Lucerne  
2006-2008 Chevrolet Malibu  
2006-2011 Chevrolet Impala  
2006-2009 Pontiac G6  
Equipped with Engine RPO LGD, LZ4, LZ8 or LZE

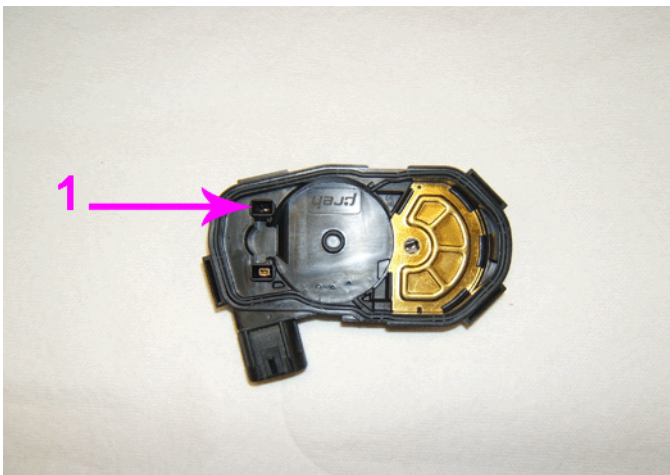
12. Inspect the TP sensor cover and verify that the TP sensor cover gasket **has remained** in the TP sensor cover as shown. Ensure that the gasket is accounted for and remains with the old TP sensor cover.

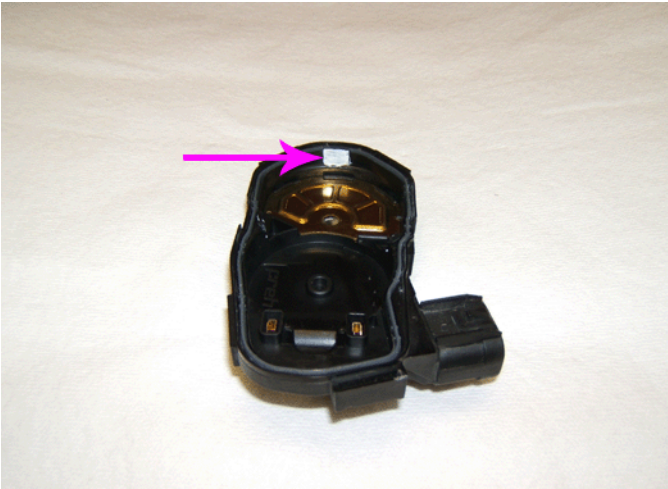
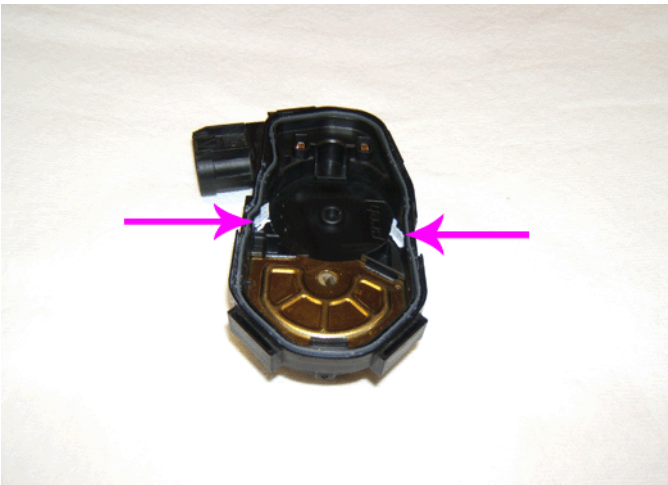
16. Verify that the TP sensor cover gasket is secure and properly positioned.

**Notice:** The three TP sensor cover alignment tabs are highlighted in white for identification purposes only.

17. Verify that all three of the TP sensor cover alignment tabs are present and are not damaged.
