# Preliminary Information

## PIP5490 Malfunction Indicator Lamp Illuminated With DTC P0300

| Brand: | Model: | Model Years: | VIN: | | Engine: | Transmissions: |
|---|---|---|---|---|---|---|
| Chevrolet | Cruze | 2016 - 2017 | All | All | 1.4L LE2 | All |
| Buick | Encore | 2016 - 2017 | All | All | 1.4L LE2 | All |

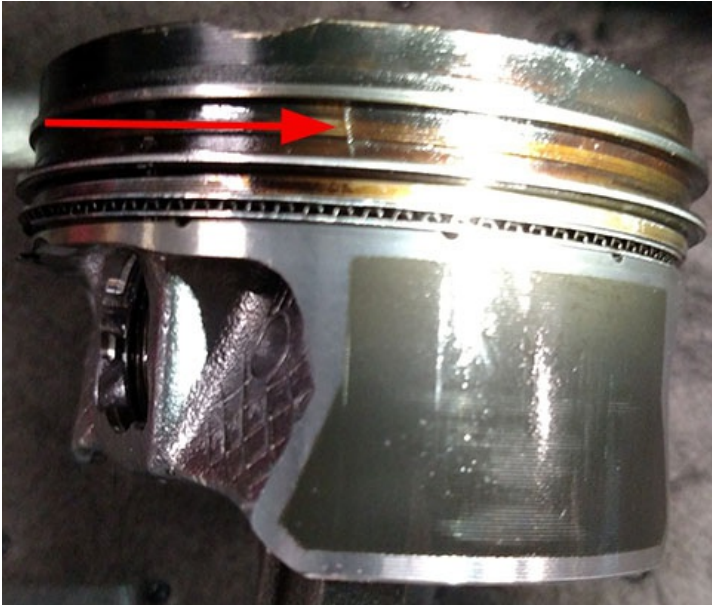
| Brand: | Model: | Model Years: | VIN: | | Engine: | Transmissions: |
|---|---|---|---|---|---|---|
| Condition | | Some customers may comment on a rough running engine with the Malfunction Indicator Lamp on.<br><br>Upon inspection, a technician may find DTC P0300 set along with a misfire and low compression in one or more cylinders. | | | | |
| Cause | | This condition may be caused by a damaged piston requiring replacement. | | | | |

Shown below are examples of pistons with varying levels of damage.

If the cylinder wall surface has not been compromised, replace only the damaged piston and fill the crankcase with only current specification Dexos 1 oil.
