# Service Bulletin

## PRELIMINARY INFORMATION

**Subject:** Harsh Shift 1/2 and 2/3 and Sputter Applying Throttle Between 0 and 30% Rough idle P0101 P0171 P0172 P0174 P0175

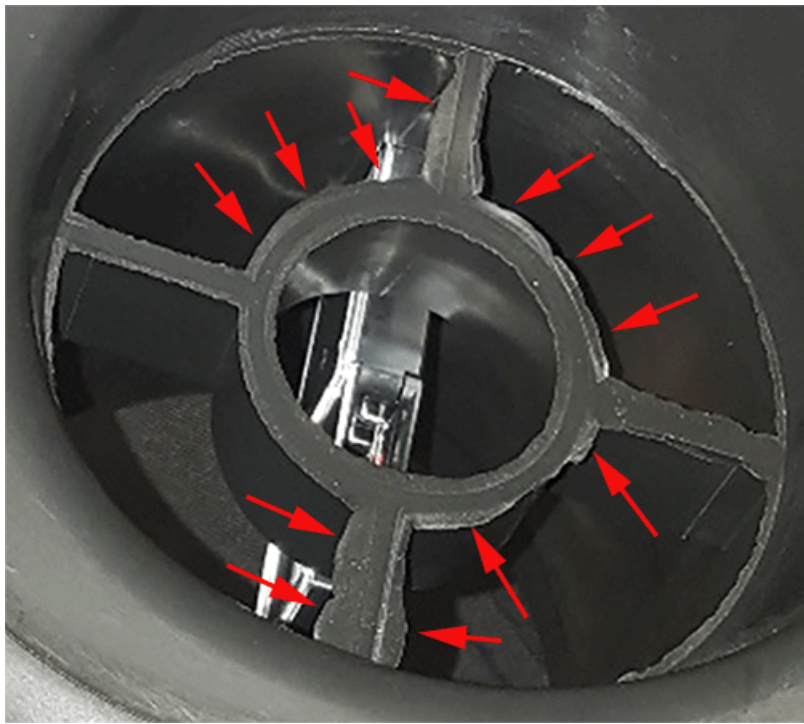
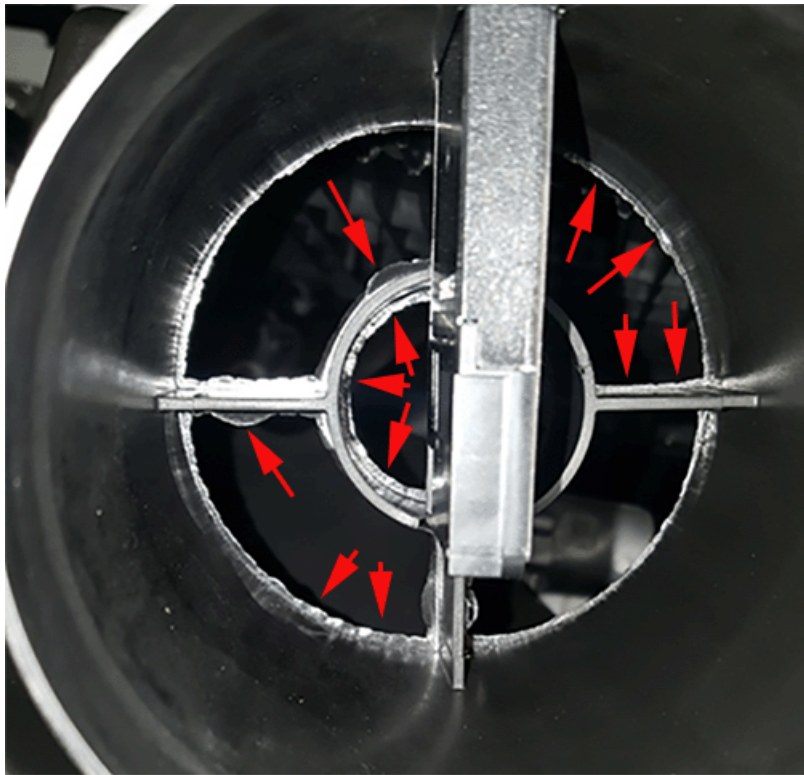
| <b>Cause</b> | Excessive casting flash in air filter housing near MAF sensor. |

Inspect for cast flashing near the MAF sensor as seen below

If this is found replace the air filter housing lid, be sure to check for flashing in the new lid.
