# Service Bulletin

## PRELIMINARY INFORMATION

**Subject:** SES Lamp With Camshaft Position Codes

**Models:** 2015-2016 Cadillac Escalade  
2014-2016 Chevrolet Silverado 1500  
2015-2016 Chevrolet Suburban, Tahoe  
2014-2016 GMC Sierra 1500  
2015-2016 GMC Yukon Yukon XL  
Built with RPO's 4.3L 5.3L 6.2L L83 L86 LV3

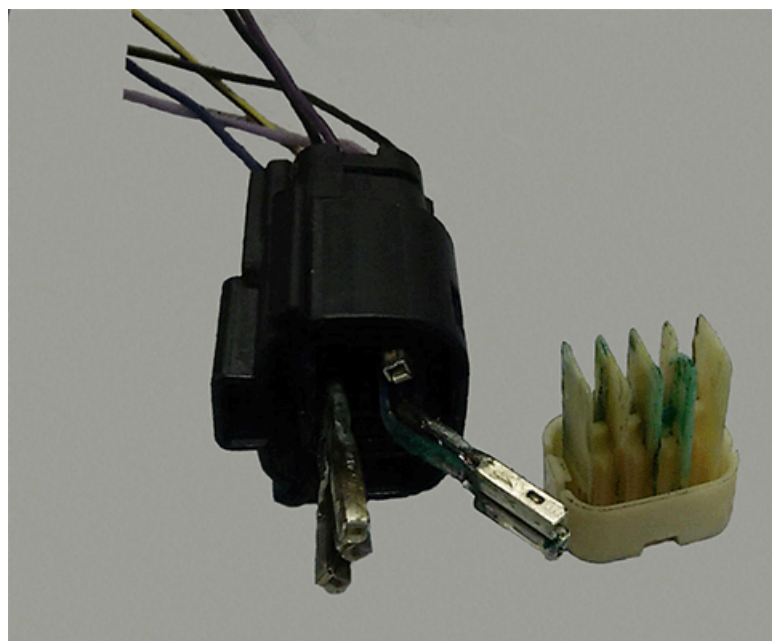
A vehicle may be setting DTC's P0340 and P0341 at times

If normal SI Diagnostics does not isolate the concern, inspect for corrosion in connector X154 located on the front cover next to the vacuum pump.

If this condition is encountered repair as needed.
