## SERVICE BULLETIN

| EC16-032 | NTB17-060 | June 8, 2017 |

### 2016 TITAN XD; MIL ON WITH P207F STORED

**APPLIED VEHICLES:** 2016 Titan XD (A61)  
**APPLIED ENGINE:** Cummins 5.0L V8 Diesel

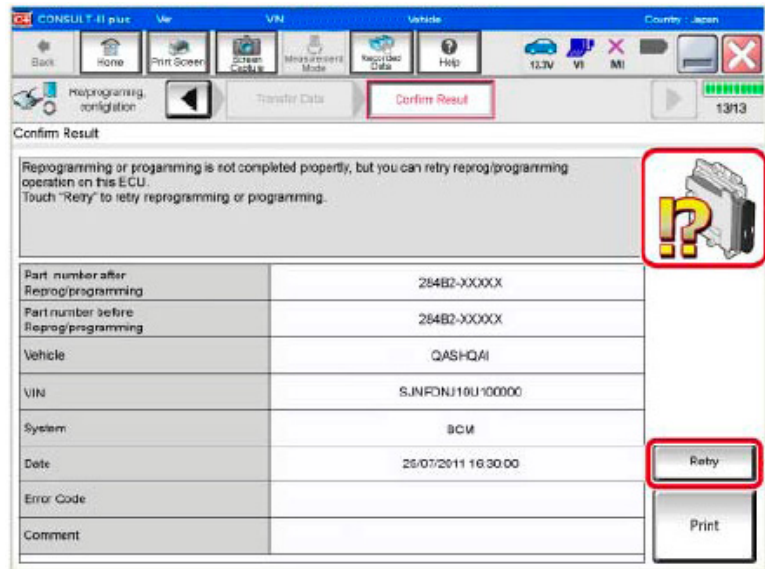
Figure 5

If reprogramming does not complete and the “!?” icon displays as shown in Figure 5:

- Check battery voltage (12.0 - 15.5 V).
- Ignition is ON, engine OFF.
- External Bluetooth® devices are OFF.
- All electrical loads are OFF.
- **Select retry and follow the on screen instructions.**
- “Retry” may not go through on first attempt and can be selected more than once.

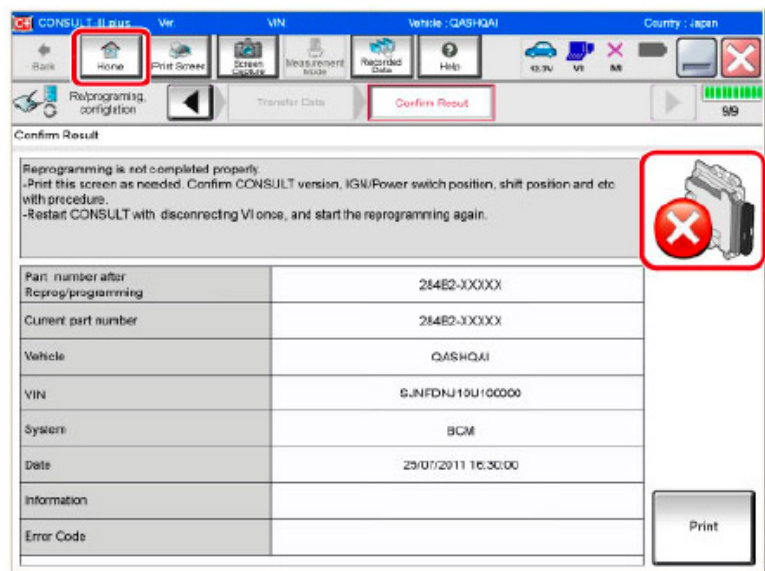
Figure 6

If reprogramming does not complete and the “X” icon displays as shown in Figure 6:

- Check battery voltage (12.0 - 15.5 V).
- CONSULT A/C adapter is plugged in.
- Ignition is ON, engine OFF.
- Transmission is in Park.
- All C-III plus / VI cables are securely connected.
- All C-III plus updates are installed.
- **Select Home, and restart the reprogram procedure from the beginning.**
