## PIC6285 Diagnostic Aid for DTCs P1AEE and P1AEF, Control Module Hybrid/EV Battery System Voltage High Voltage (Over-Voltage)

| Brand: | Model: | Model Years: | VIN: | | Engine: | Transmissions: |
|---|---|---|---|---|---|---|
| Chevrolet | Volt | 2016 - 2018 | All | All | All | All |
| Buick | Velite | 2018 | All | All | All | All |

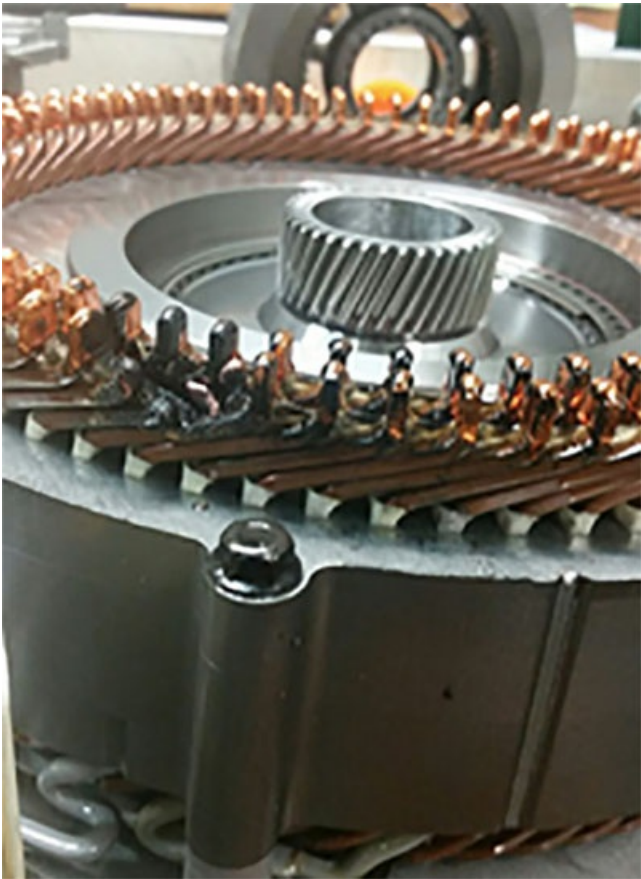
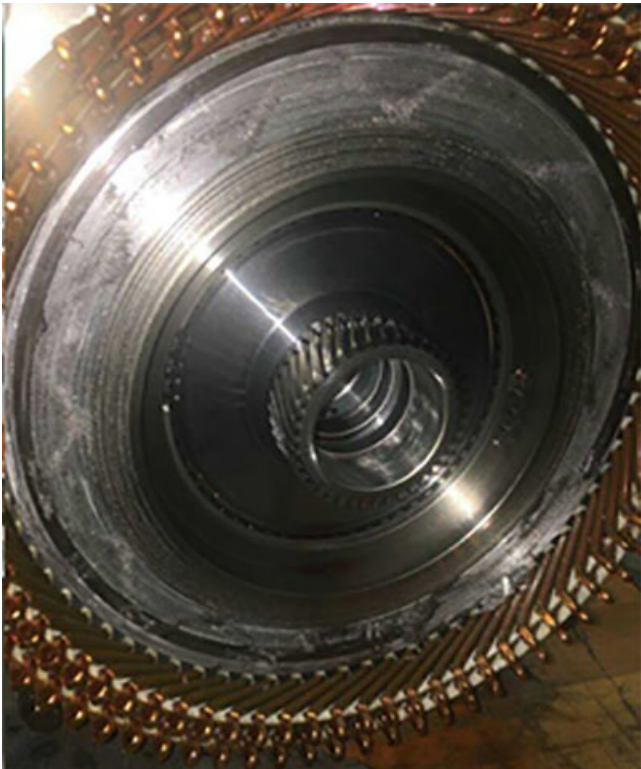
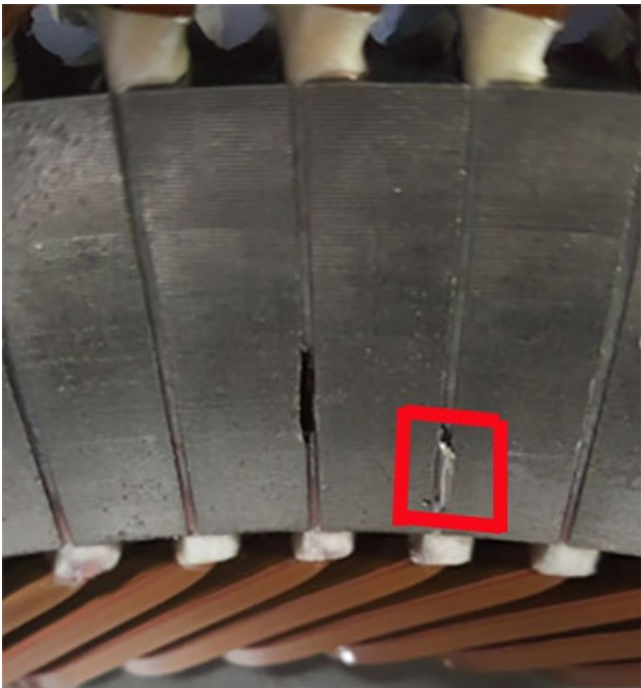
If one of these parameters is 0 volts in the freeze frame, then it is likely the vehicle has a loss of isolation condition. If accompanied by DTCs P1AF0/P1AF2/P1E22 or P0C01/P0C04, then the loss of isolation will be located within the transmission, usually due to debris in the motor stators from a failed internal component. Without the accompanying DTCs, the loss of isolation could be anywhere within the high voltage system, but the transmission is still suspect. Use the *Loss of Isolation on the High Voltage Main Bus* procedure in SI to help pinpoint which subsystem is causing the loss of isolation. Using the vehicle data to help determine the loss of isolation is preferred to troubleshooting with an insulation multimeter due to the intermittent nature of most failures.

Examples of debris causing stator problems:

**Note:** Any loss of isolation will not self-heal and needs to be repaired for vehicle safety. Clearing codes without repair is not an acceptable remedy of this category due to the vehicle hazards created by P1AEE and P1AEF.

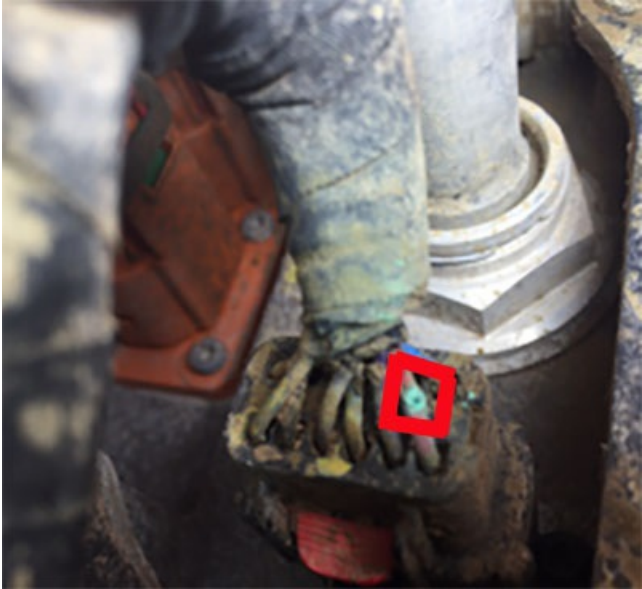
**Category 2: P1AEE and P1AEF were caused by the high voltage contactors opening unexpectedly**  
Find the following parameters in the HPCM freeze frame:  
Auxiliary Transmission Fluid pump motor Negative supply Isolation Voltage  
Auxiliary Transmission Fluid pump motor Positive supply Isolation Voltage  
If the value for Negative Supply Isolation Voltage in the freeze frame is within 40 volts of 165v, then the high voltage contactors in the

battery opened unexpectedly while the vehicle was driving. The vehicle may also have a P0AA1 and P0AA4 set for this category. If the HPCM2 also stored DTC P0A0C at the same time as P1AEE and P1AEF, then follow published Service Information for P0A0C first. The HPCM2 has direct control of the contactors. Issues with the HPCM2 or wiring could lead to P1AEE and P1AEF. Inspect circuits 3961 and 3959 for contactor control as well as B+ 5240 and ground circuit 2050 (G302). Any compromise in these circuits may cause the contactors to open unexpectedly. If no trouble is found, replace the K114B HPCM2 module for a possible internal fault with contactor control.

Example of connector X357 with stone impingement and corrosion on wiring:

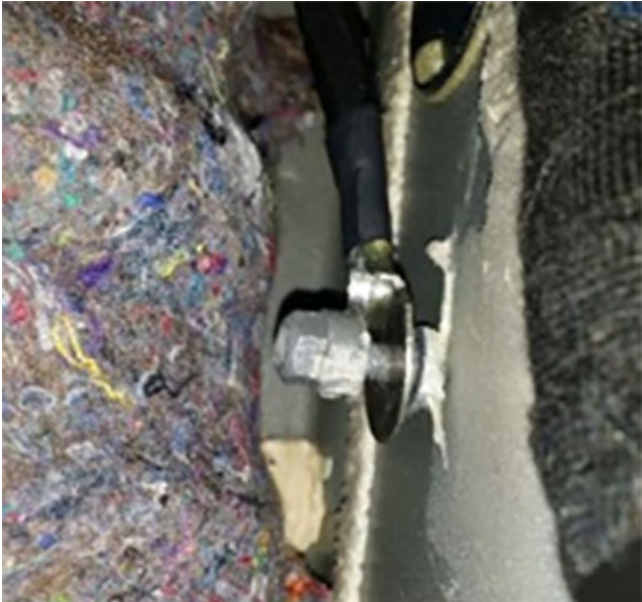
Example of loose ground G302:

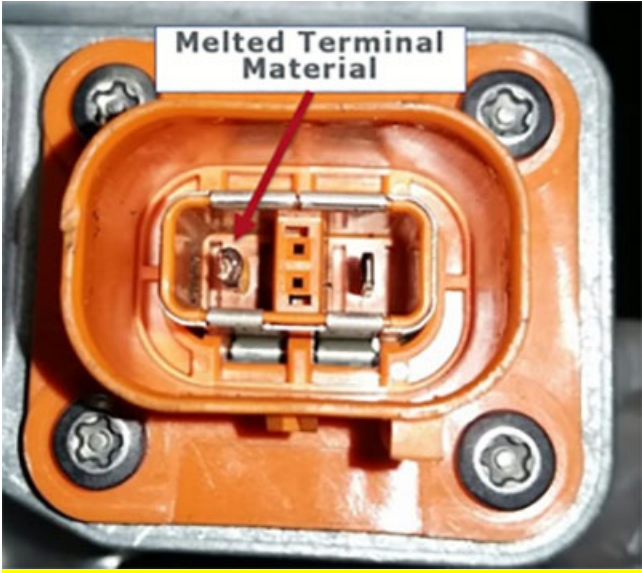
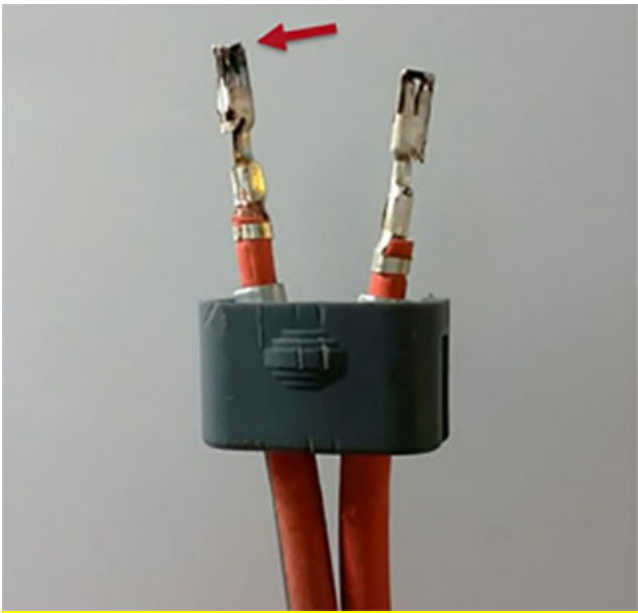
This is expected to be a less common category for P1AEE and P1AEF. If one of the parameters is near but not equal to zero, properly inspect each of the orange high voltage connectors on the vehicle for a loose connection on the high voltage bus.

Example of a loose connector X2 at the K10 Coolant Heater Control Module:
