# Service Bulletin

**Subject:** Information On Identifying Duramax™ Diesel Overpower Engine Breakdown or Non-Function Due to Aftermarket Power-Up Devices vs. Non Overpower Engine Non-Function of Pistons, Cylinders, Valvetrain Components, DTC P003A or P111D Set

**Models:** 2001–2013 Chevrolet Silverado  
2003–2009 Chevrolet Kodiak  
2006–2013 Chevrolet Express  
2001–2013 GMC Sierra  
2003–2009 GMC TopKick  
2006–2013 GMC Savana  
Equipped With Duramax™ Turbocharged Diesel Engine RPO LB7, LBZ, LLY, LML, LMM, or LGH

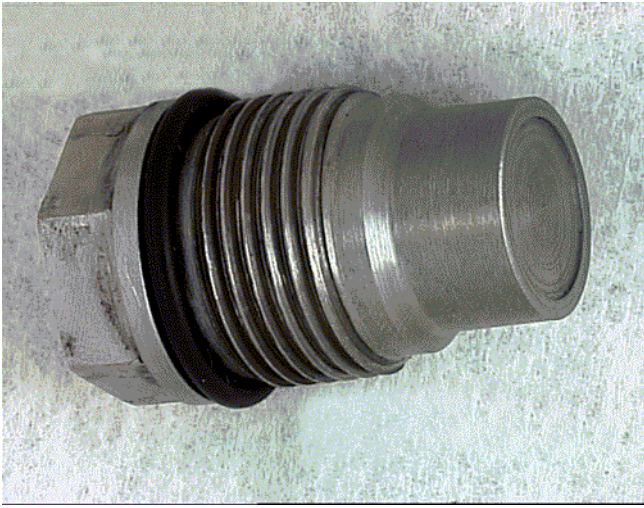
Aftermarket companies have developed a performance pressure relief fuel valve for Duramax™ diesel engines. Refer to above graphic illustration. The performance pressure relief fuel valve attaches to the fuel rail in place of the OEM valve and will not allow any fuel return to the tank, giving 100% of the fuel to be available for additional engine performance. This may cause additional fuel related driveability concerns and may set the following DTCs:

- DTC P1093 Fuel Rail Pressure (FRP) Low During Power Enrichment
- DTC P0087 Fuel Rail Pressure (FRP) Too Low

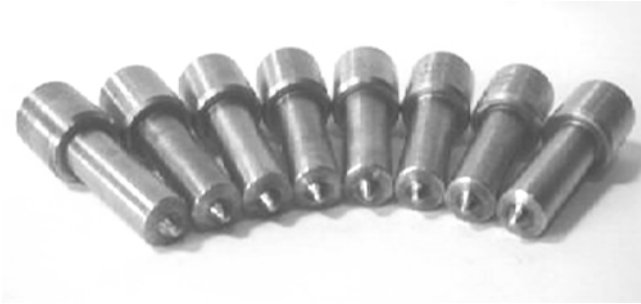
Aftermarket companies have developed a replacement performance/economy fuel injector nozzle. Refer to above illustration. The performance/economy fuel injector nozzles replace the OEM fuel injector nozzles. The aftermarket companies claim increased horsepower, improved fuel atomization, lower exhaust gas temperatures and increase fuel economy. This may cause additional fuel related driveability concerns and may cause internal engine damage to the pistons and fuel injector nozzles.

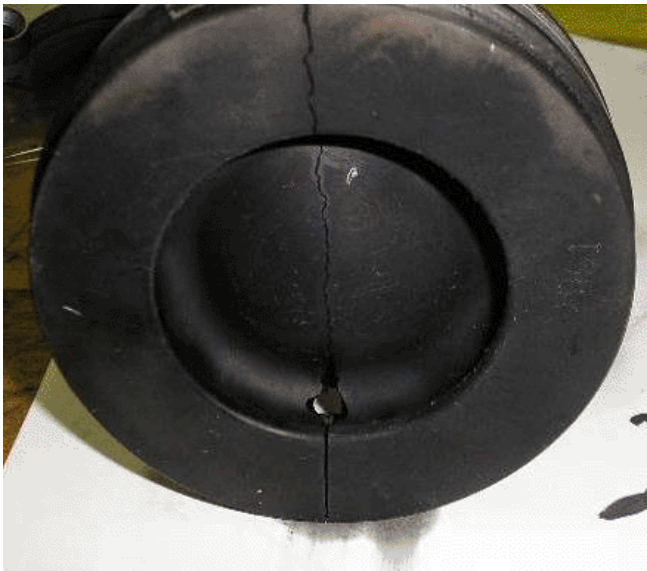
- Pistons will be cracked in the lip area, or a hole in the pistons.

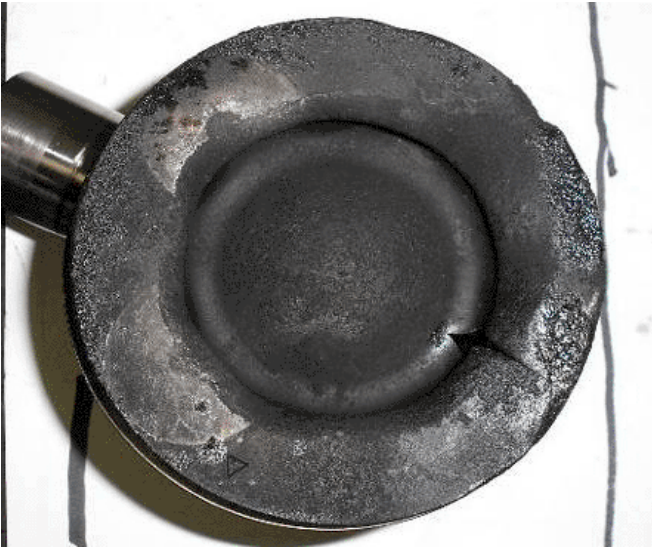
- Pistons can also be melted on the lip of the combustion bowl, or the top of the pistons can be melted.

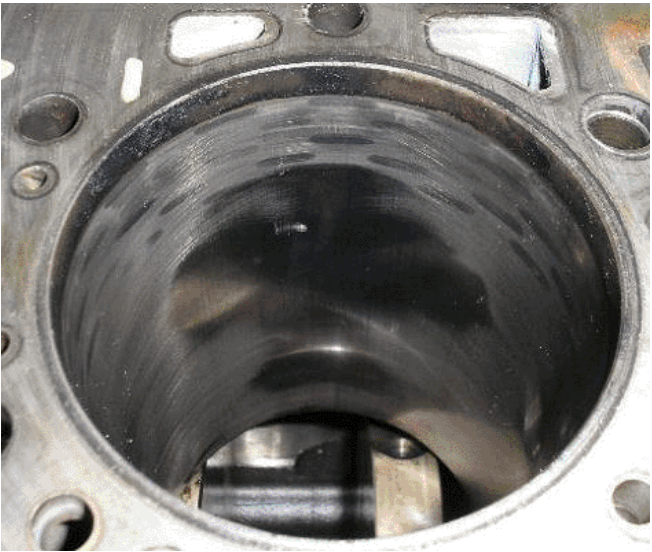
- Crosshatch will be polished off the cylinder wall in the major thrust face of cylinder below ring belt travel.

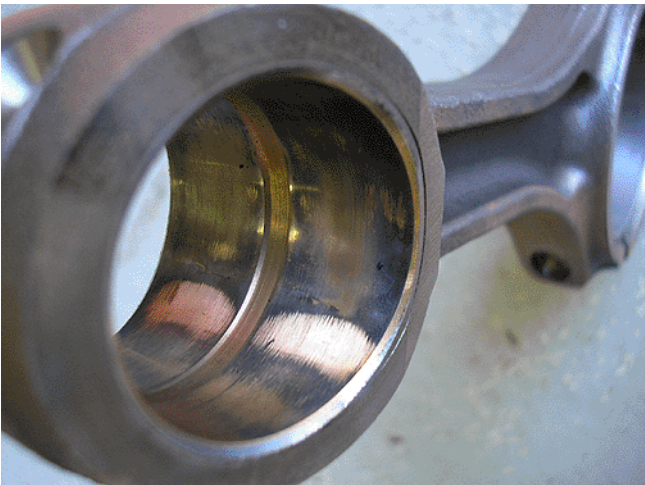
- Piston pin bore will show signs of scoring, the wrist pins will be discolored, and can have oil coking on them. The connecting rod bushing surface will have accelerated wear. The above illustration shows a connecting rod bushing.

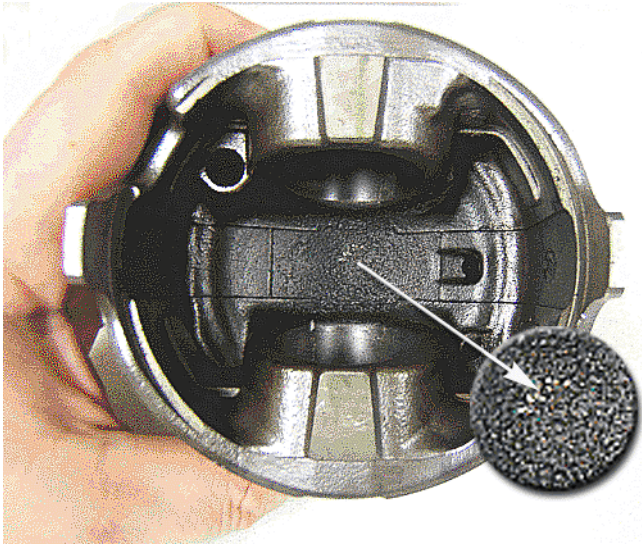
- Oil coking on the underside of the piston between the wrist pin bosses.

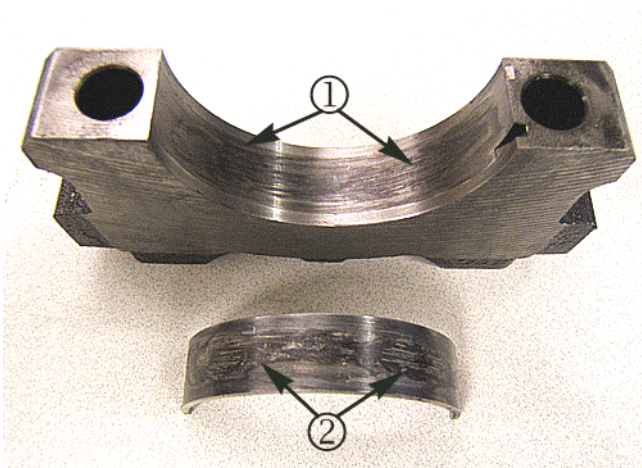
- Signs of bearing fretting will also be noticed on the connecting rod and main bearing caps. Refer to the above illustration for fretting of main bearing cap 1 and back side of connection rod bearing 2.

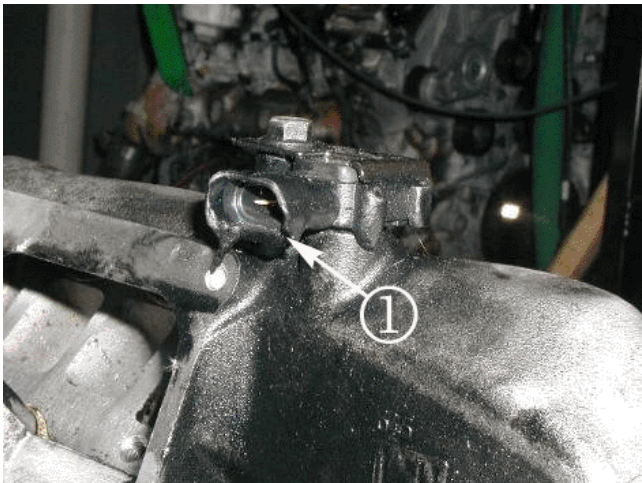
- Excessive heat in engine compartment caused by overpower device. Refer to above illustration (1).

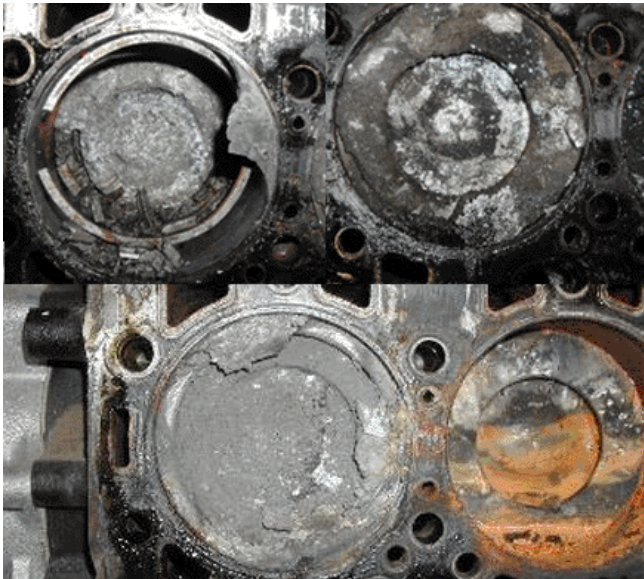
Overheat can be caused by a loss of coolant or a general cooling system failure. Some of the indicators of overheat are:

- Melted pistons.
- Head gasket breakdown or non-function.
- Warped cylinder heads.
- Crankshaft and connecting rod discolored.

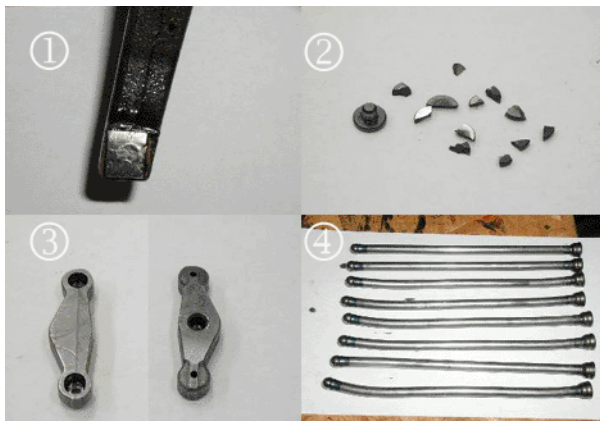
- Valve train damage.
- Pushrods that are bent (4).
- Broken valve bridge buttons after cylinder head removal (2).
  - Rocker arm tip damage (1).
  - Dry or rusted cylinders from the use of ether, propane or nitrous oxide.

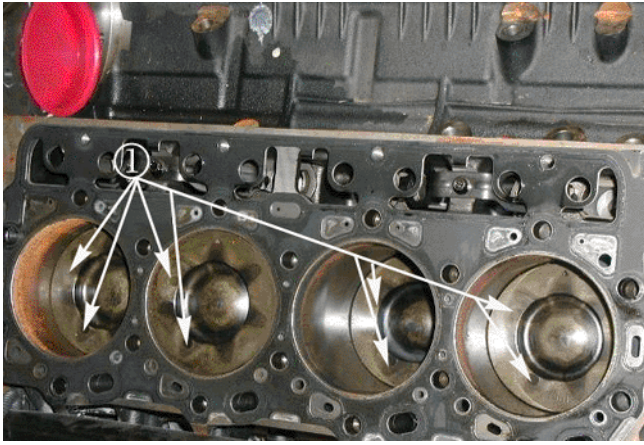
- Piston to valve contact.
- Cam gear pin shear.

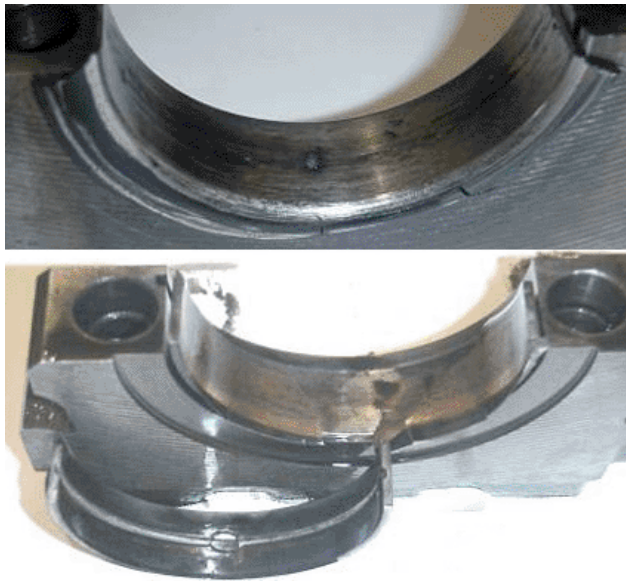
Lack of lubrication causes rapid bearing wear or bearing to seize.

Bearing failure. Spun main bearings.

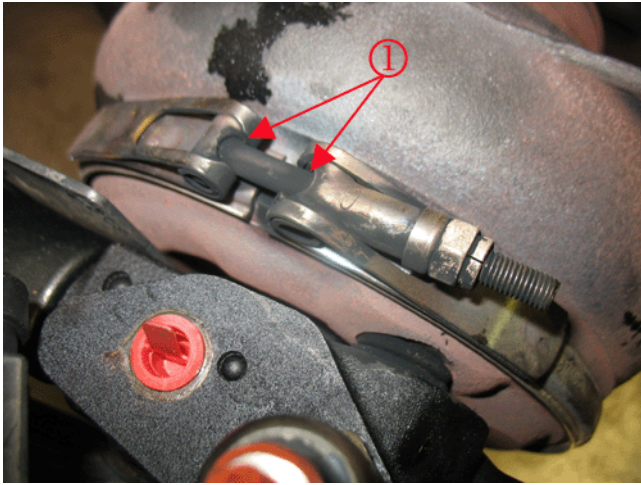
General Motors has identified a turbocharger (TC) failure mode involving Power-Up Kits that causes soot leakage and DTC P003A to be set. The Power-Up Kits create an over temperature condition from the increased exhaust gas temperatures that results in a permanent and excessive turbine housing distortion at the TC case halves.

2. If DTC P003A is found as Current or in History, **OR** there is evidence of soot leakage (1) in the area of the V-band clamp (1), then technicians **MUST** verify if the engine control module (ECM) has a Power-Up Kit aftermarket calibration installed or an aftermarket hardware device has been installed.

**Refer to the latest version of Corporate Bulletin Number #08-06-04-006 for the calibration verification information and procedures.**
