EC17-031

ITB17-050

## 2016-2017 Q50 AND 2017 Q60; MIL IS ON WITH DTC STORED

APPLIED VEHICLES: 2016-2017 Q50 (V37)  
2017 Q60 (V37)  
APPLIED ENGINE: VR30DDTT

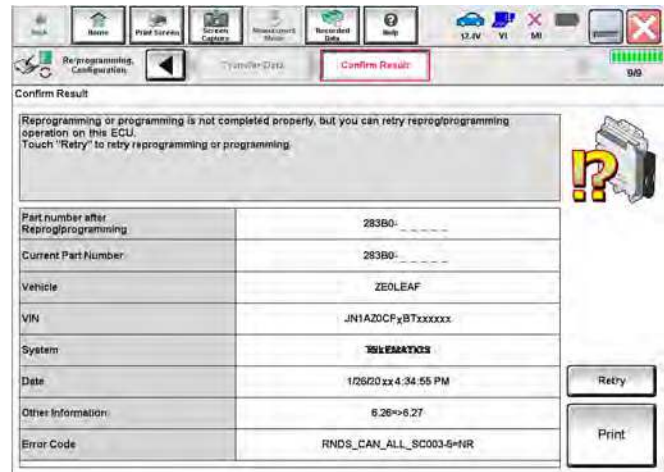
Figure 5

If reprogramming does not complete and the “!?” symbol displays as shown in Figure 5:

- Check battery voltage (12.0 – 15.5V).
- Ignition is ON, engine is OFF.
- External Bluetooth® devices are OFF.
- All electrical loads are OFF.
- Select Retry and follow the on screen instructions.

NOTE: Retry may not go through on first attempt and can be selected more than once.

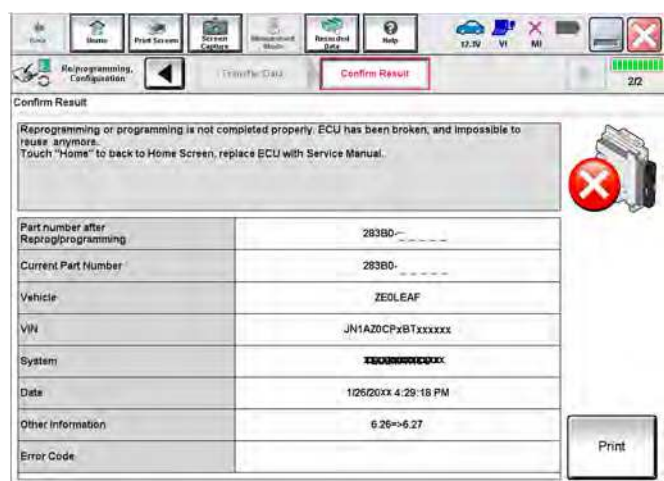
Figure 6

If reprogramming does not complete and the “X” symbol displays as shown in Figure 6:

- Check battery voltage (12.0 – 15.5V).
- CONSULT A/C adapter is plugged in.
- Ignition is ON, Engine is OFF.
- Transmission in Park.
- All C-III plus / plus VI cables are securely connected.
- All C-III plus updates are installed.
- Select Home, and then restart the reprogram procedure from the beginning.
