| | GROUP<br><b>ENG</b> | MODEL<br><b>2016-2017MY<br/>Optima (JF)<br/>2017MY<br/>Sportage (QL)</b> |
| | NUMBER<br><b>175</b> | DATE<br><b>August 2017</b> |
| <b>TECHNICAL SERVICE BULLETIN</b> | | |
| <b>SUBJECT: SERVICE ACTION: E-CVVT COVER INSPECTION<br/>AND MOTOR PLUG REPLACEMENT (SA305)</b> | | |

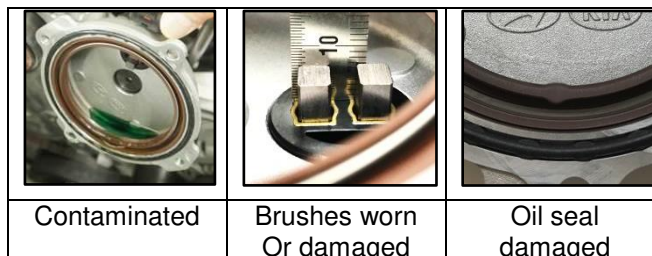
10. Inspect the E-CVVT cover.
- If there is no sign of oil leakage, contamination, and/or damage, replace only the cover O-ring.
  - If there is an oil leak, contamination, and/or damage, replace the cover.

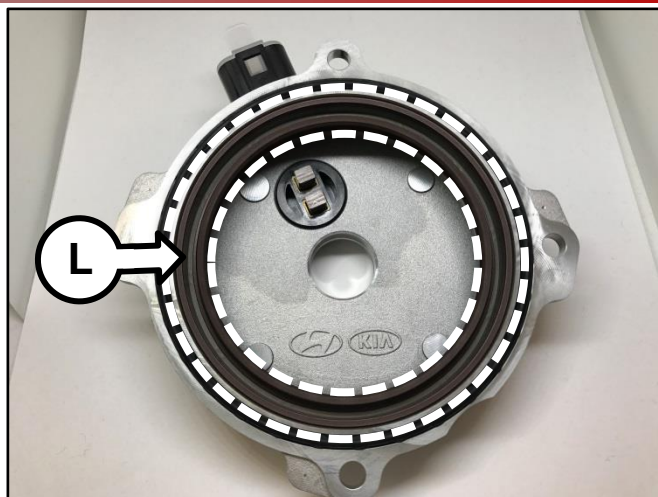
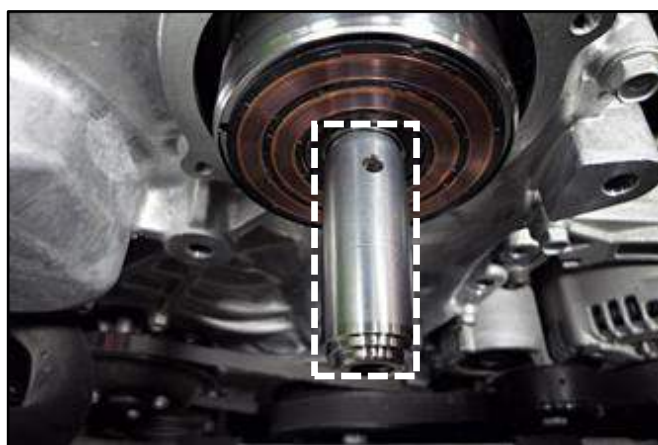
SST INSERTED  
INCORRECTLY

SST INSERTED  
CORRECTLY

11. Apply oil to the oil seal lip (L) of the E-CVVT cover and install the SST "B" to the E-CVVT motor as shown.

When installing the cover, correctly insert the end of the SST to the motor shaft as shown below. Ensure that the SST hole faces towards the motor shaft.

Use caution not to fold the oil seal when installing the cover.
