EC16-035

July 21, 2017

## INFINITI; DTC P0456 CAUSED BY EVAP LEAK AT VENT CONTROL VALVE O-RING

APPLIED VEHICLES: 2017-2018 QX30 (H15)  
2014-2017 QX50 (J50)  
2016-2017 QX60 and QX60 Hybrid (L50)

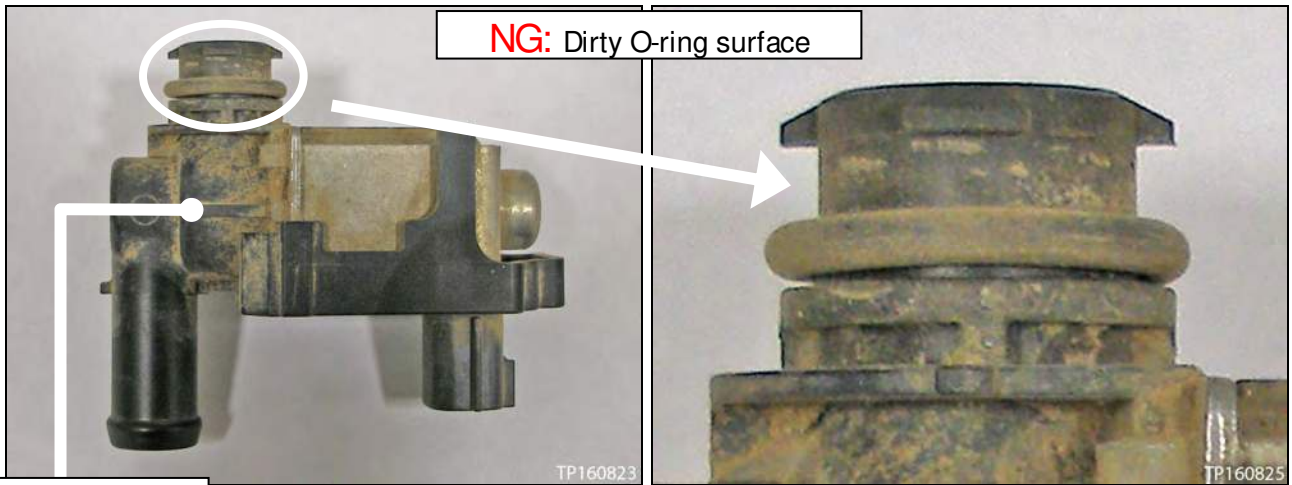
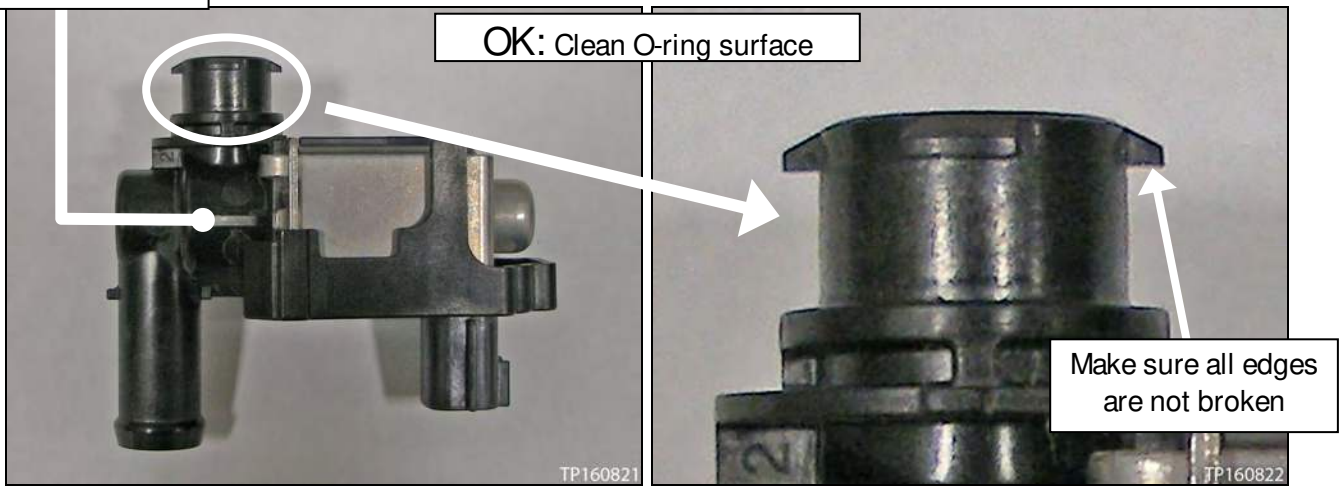
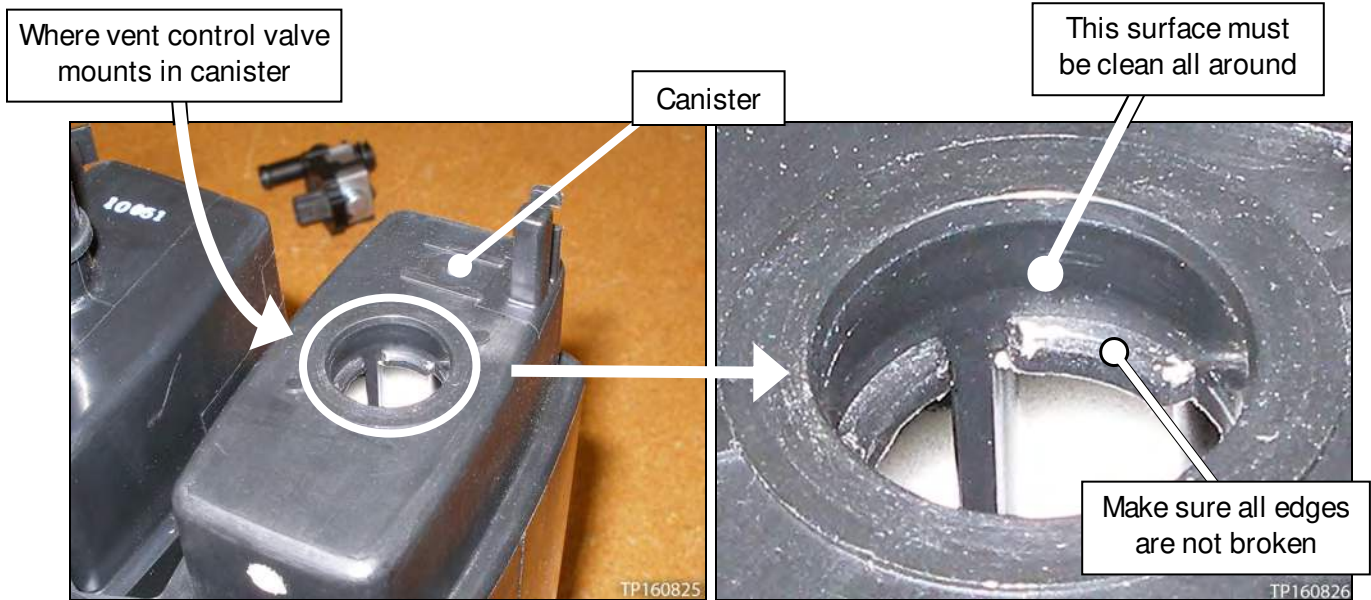
- DTC P0456 is not caused by a loose fuel fill cap (refer to ITB13-044).
- An EVAP leak has been detected where the vent control valve mounts to the canister.
- The vent control valve O-ring seal is determined to be the cause.

- To access the O-ring, refer to the appropriate section in the Electronic Service Manual (ESM) of the APPLIED VEHICLE for vent control valve removal and installation.
- This O-ring is now available separately (see PARTS INFORMATION).
- When installing, do not add any lubrication to the O-ring.
- Seat the O-ring all the way down as shown on page 4, Figure 7.
  - Having the O-ring seated all the way down will assure it is not twisted or rolled over.
- Refer to the pictures on pages 3 and 4 for additional installation information.

- Make sure the surfaces that the O-ring comes in contact with are clean.
- When installed, make sure the O-ring is not twisted or rolled over.
- Verify the repair is complete by checking for leaks with a “smoke” leak detection machine or CONSULT-III plus (C-III plus).
  - If a “smoke” leak detection machine is used, follow the manufacturer’s operating instructions.
  - If C-III plus is used:
    1. Confirm the fuel filler cap is secure.
    2. Connect Essential Tool J-42909 to the EVAP service port.
    3. Using Active Test, close the vent control valve.
    4. Apply pressure using J-42909 until the bar graph reaches about halfway.
    5. Monitor the bar graph for 10 minutes.
