## SERVICE BULLETIN

EC16-036

November 30, 2016

### 2016-2017 ALTIMA; MIL ON WITH A/F RATIO SENSOR DTC(s)

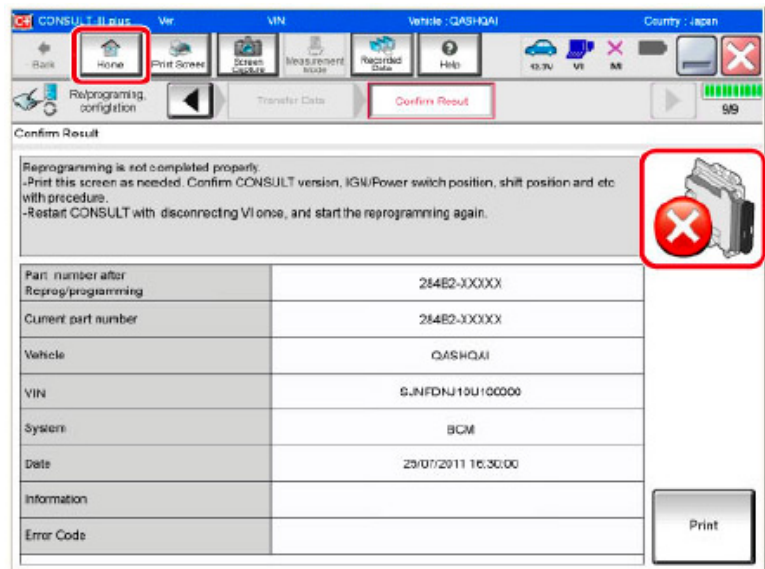
Figure 6

If reprogramming does not complete and the “X” icon displays as shown in Figure 6:

- Check battery voltage (12.0 – 15.5 V).
- CONSULT A/C adapter is plugged in.
- Ignition is ON, engine OFF.
- Transmission is in Park.
- All C-III plus / VI cables are securely connected.
- All C-III plus updates are installed.
- **Select Home, and restart the reprogram procedure from the beginning.**
