## SERVICE BULLETIN

EC16-034

### NISSAN; DTC P0456 CAUSED BY EVAP LEAK AT VENT CONTROL VALVE O-RING

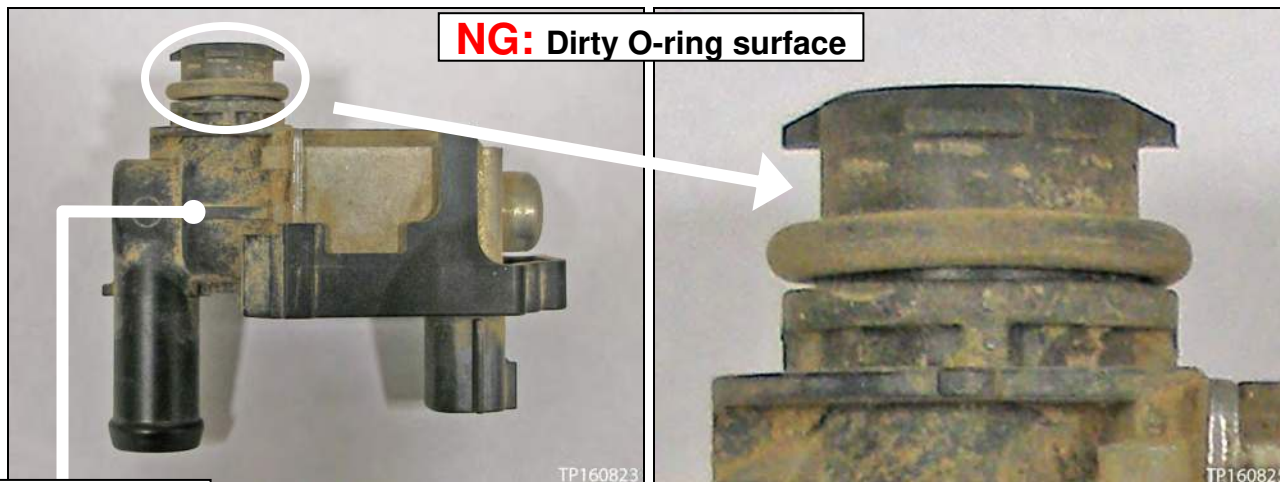
Figure 1

Vent control valve

- To access the O-ring, refer to the appropriate section in the Electronic Service Manual (ESM) of the **APPLIED VEHICLE** for vent control valve removal and installation.
- This O-ring is now available separately (see **PARTS INFORMATION**).
- When installing, do not add any lubrication to the O-ring.
- Seat the O-ring all the way down as shown on page 4, Figure 7.
  - Having the O-ring seated all the way down will assure it is not twisted or rolled over.
- Refer to the pictures on pages 3 and 4 for additional installation information.

- Make sure the surfaces that the O-ring comes in contact with are clean.
- When installed, make sure the O-ring is not twisted or rolled over.
- Verify the repair is complete by checking for leaks with a “smoke” leak detection machine or CONSULT-III plus (C-III plus).
  - If a “smoke” leak detection machine is used, follow the manufacturer’s operating instructions.
  - If C-III plus is used:
    1. Confirm the fuel filler cap is secure.
    2. Connect Essential Tool J-42909 to the EVAP service port.
    3. Using Active Test, close the vent control valve.
    4. Apply pressure using J-42909 until the bar graph reaches about halfway.
    5. Monitor the bar graph for 10 minutes.

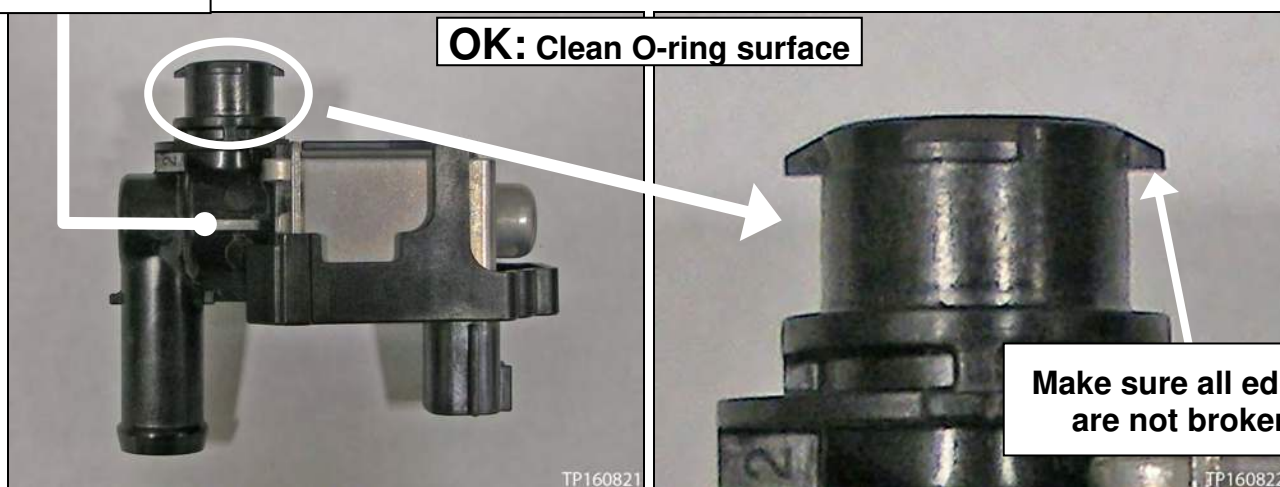
Figure 3

Where vent control valve  
mounts in canister

Canister

This surface must  
be clean all around
