**NUMBER:** 08-007-17 REV. F

UAS, UCQ, UDQ, UJQ and UAQ Radio Enhancements

This bulletin involves inspecting and if required, updating the radio software.

**MODELS:**

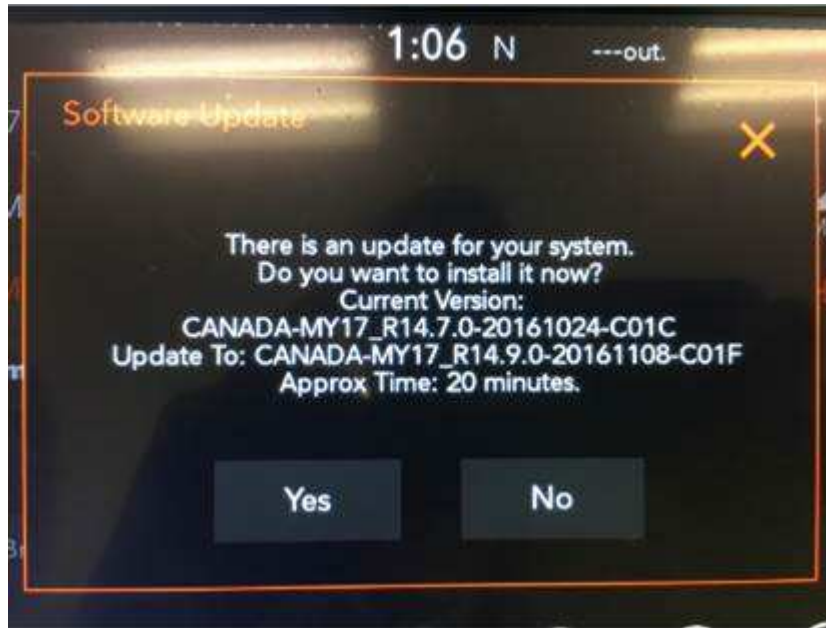
Fig. 6

**Software Levels (The figure is for reference only, actual software levels will be 16.8 to 16.11)**

11. The next screen display will have the old and new software levels (Fig. 6) . The radio will be updated to 16.11.

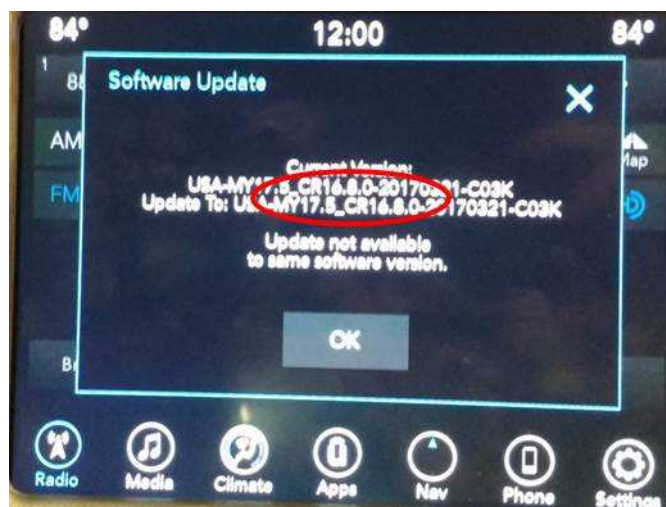
Fig. 9

Software Levels After Radio Restart Screen (The figure is for reference only, actual software levels will be 16.11)

14. After the update is done the screen will display the software levels again and the message that an update is not available to the same software version (Fig. 9) .
