# Technical Service Bulletin

**SCBS / SBS, LAS / LDWS, MASTER AND/OR HBC WARNING LIGHTS  
ON WITH DTC U3000:98 STORED DURING HOT WEATHER**

**Bulletin No.:** 15-006/17

**Last Issued:** 10/06/2017

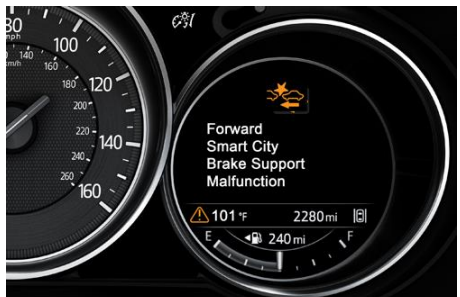
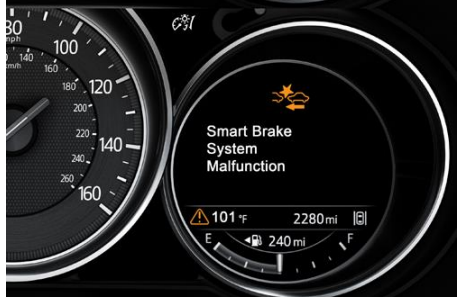
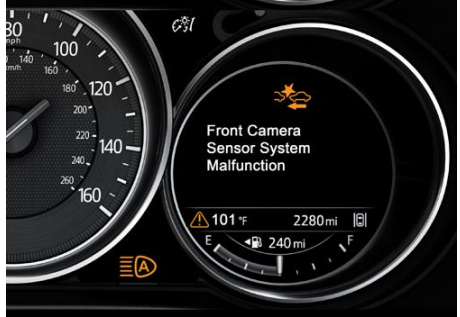
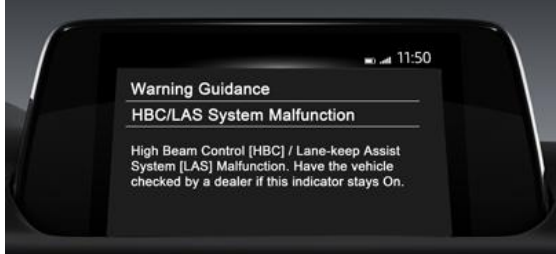
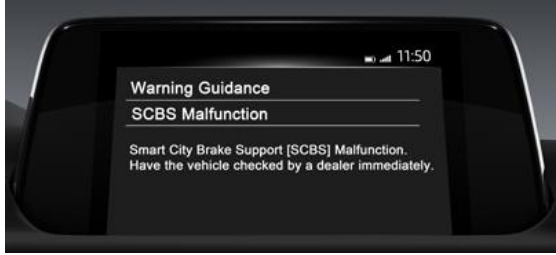
**Before FSC Reprogram or Replacement**

This condition may be caused by FSC control logic that is too sensitive. When the FSC detects DTC U3000:98 during high temperature, it stops the internal communication and stores DTC U3000:04. DTC U3000:04 will not clear and SCBS/SBS, LAS/LDWS, and/or HBC functions will not resume until the ignition switch has been turned OFF even if the temperature of the FSC cools.

The warning lights/messages will be displayed until the FSC cools and the ignition is turned OFF, then back ON.

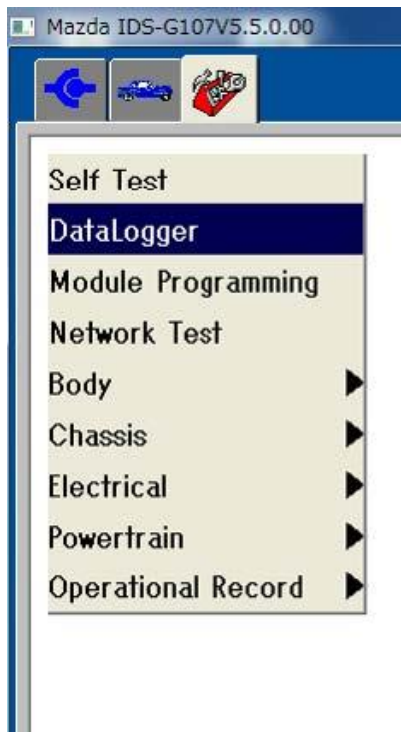
4. If the FSC seems to be hot (approx. 60 °C [140 F] or higher), cool it down by parking in the shade with the ignition OFF.

**NOTE:** If the FSC is hot, the FSC reprogramming process may fail. The FSC temperature can be monitored by the data logger function of the M-MDS.

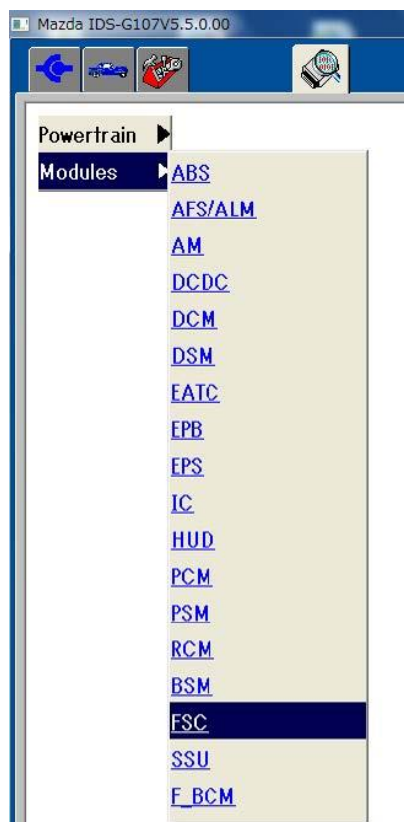
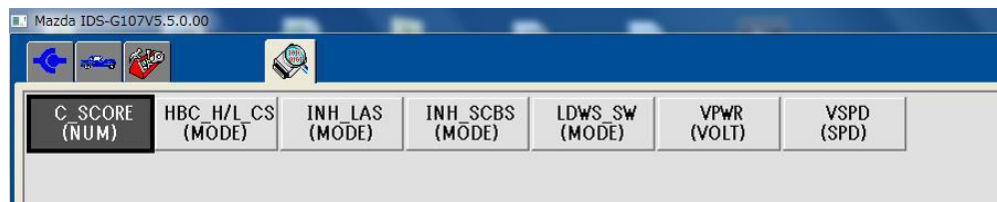
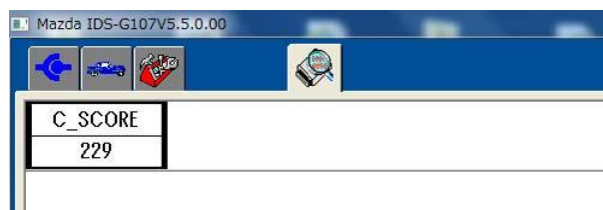
“C\_SCORE” has to be 174 or higher to perform the FSC reprogramming.

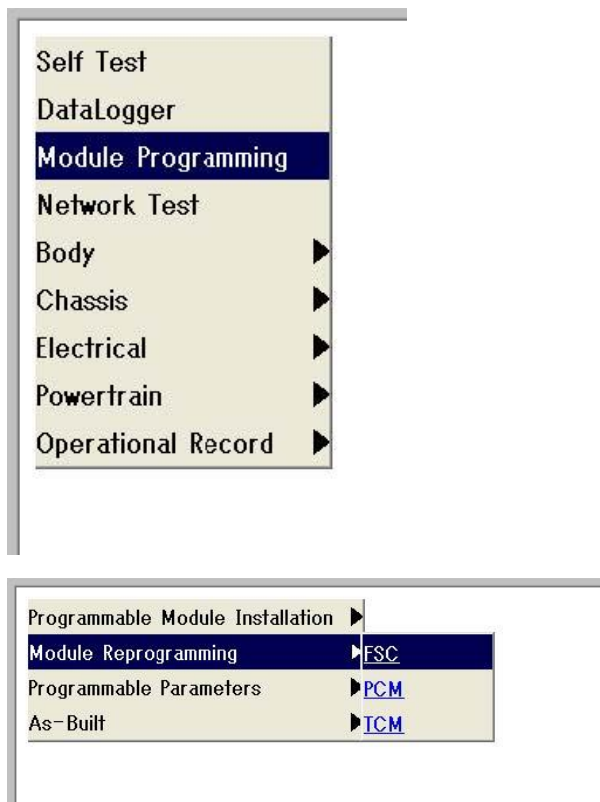
6. Select "Module Reprogramming", then select "FSC".

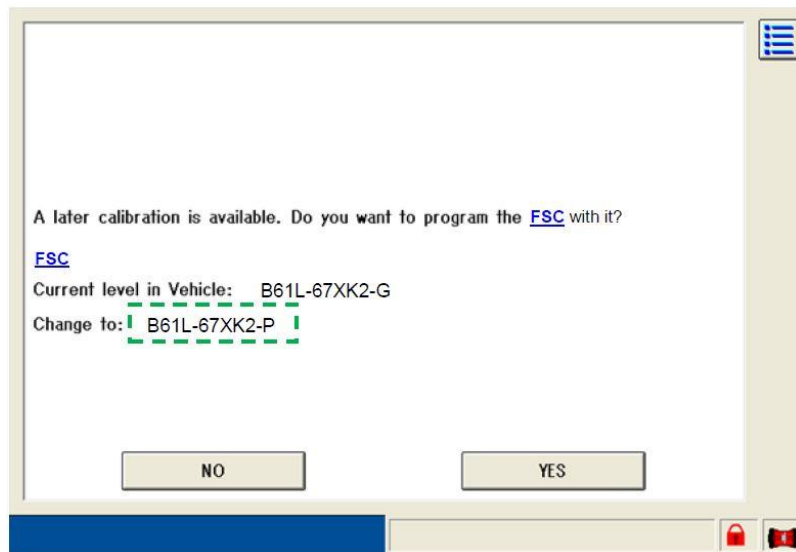
7. The following screen will be displayed:

Click "YES" and follow the M-MDS instructions to reprogram the FSC.

If the message "No later calibration is available on the system for this FSC" is displayed, the FSC is already at the latest calibration. "Current level in Vehicle" will show the new file name.

If "Current level in Vehicle" does not show B61L-67XK2-G, -I, -K or -M, this reprogramming process does not apply. Confirm if the part number is B61L-67XCX-B.

**NOTE:** The calibration level does not match to the part number level.

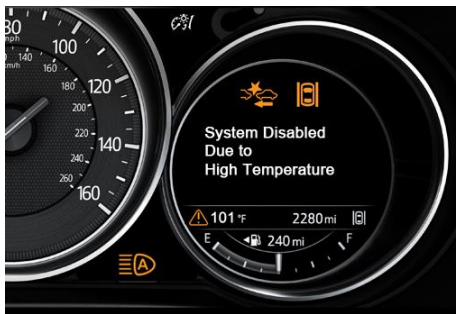
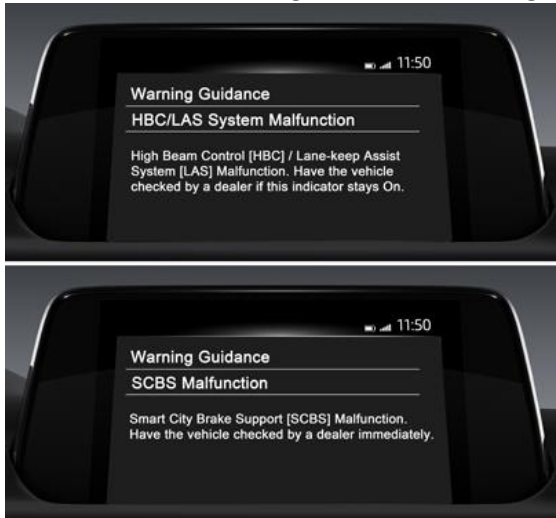
**After FSC Reprogram or Replacement**

The warning lights/messages will be displayed until the FSC cools (No need to turn the ignition OFF).
