# Service Bulletin

## PRELIMINARY INFORMATION

**Subject:** Service ABS / TCS / Power Steering and/or Suspension Message DTC U0077 U0121 U0126 U0131 U0139 U0401 U0415 U0428 (Circuit 5986 High Resistance)

**Models:** 2015 Cadillac Escalade Models  
2014 Chevrolet Silverado 1500  
2015 Chevrolet Silverado, Suburban, Tahoe  
2014 GMC Sierra 1500  
2015 GMC Sierra, Yukon Models

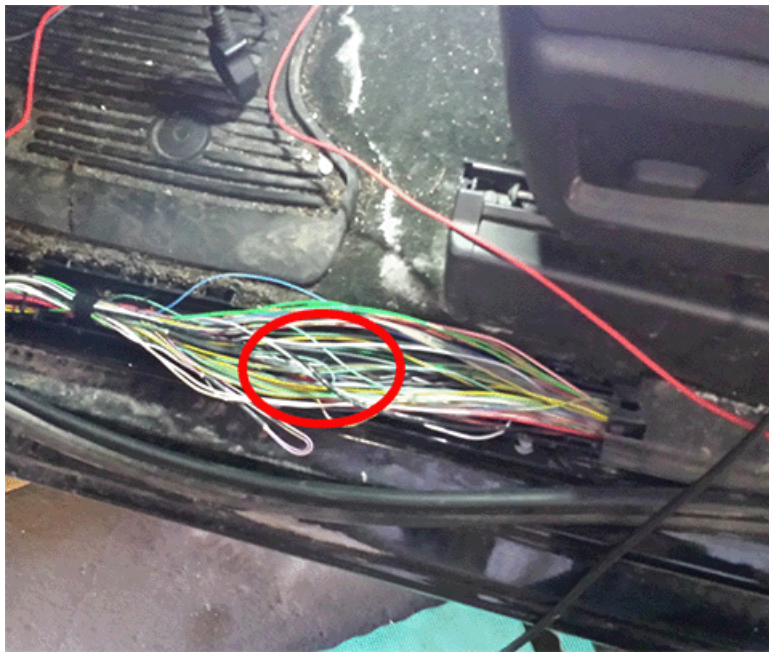
These concerns could be caused by high resistance/open in the Communication Enable circuit 5986. The BCM activates this circuit when the ignition key is in ACC, ON, and START positions (There will be voltage present in the OFF position only for a short time until the BCM goes to sleep). The communication enable circuit wakes up the module for serial data bus communication. Circuit 5986 will have approximately 12 volts and should light a test light, but is not designed to handle heavier electrical loads like a headlight bulb. Shown below are two known areas where circuit 5986 has been found to be open or have high resistance:

1. Under the driver's sill plate
2. Splice J365 located under the passenger front sill plate

Monitor the voltage on the communication enable circuit 5986 at any of the modules affected, example EBCM, PSCM, and/or SCM. If low voltage or no voltage is present when the concern occurs, inspect for high resistance under the driver's or passenger's sill plate area. Repair any opens or high resistance in the circuit.
