MODEL  
2017MY  
Niro (DE HEV)

NUMBER  
PS553

### HEV WARNING LIGHT AND DTC P1B25/P1B77

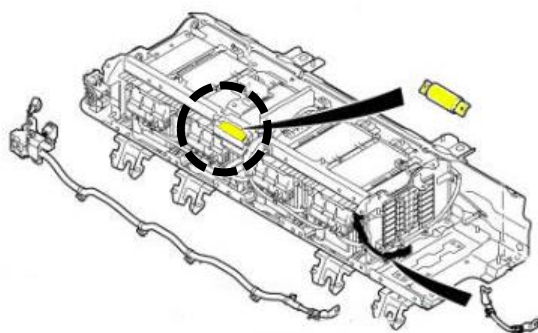
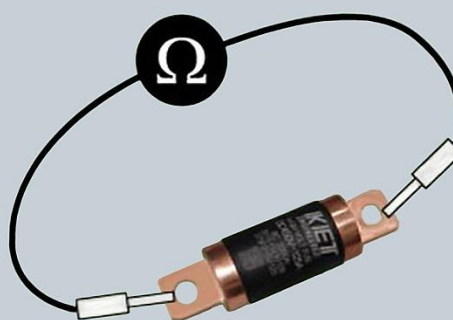
Hi-Voltage Battery Fuse

When addressing a concern related to the Niro HV warning light ON, and KDS detects a primary DTC P1B25 (HV Path Fault) and secondary DTC P1B77 (HV Pre-Charge Fault), then the 125 Amp High Voltage Battery Fuse should be inspected for an intermittent and/or an open condition.

**Measure the resistance while tapping on the fuse (less than  $<1\Omega$  resistance).**

**Specification:**  $1\Omega$  or less ( $68^{\circ}\text{F}$ )

If the measured resistance is not within specification, or the P1B25 DTC is intermittent, replace the 125 Amp main HV battery fuse with the newer 170 Amp main HV battery fuse.  
(Refer to EPC 37-371)
