**NUMBER:** 18-028-14 REV. C

Flash: MIL Illumination - Diagnostic and System Improvements

2014 (DS) Ram Pickup (1500)

**NOTE: This bulletin applies to vehicles equipped with a 3.0L diesel engine (sales code EXF) built on or before September 08, 2014 (MDH 0908XX).**

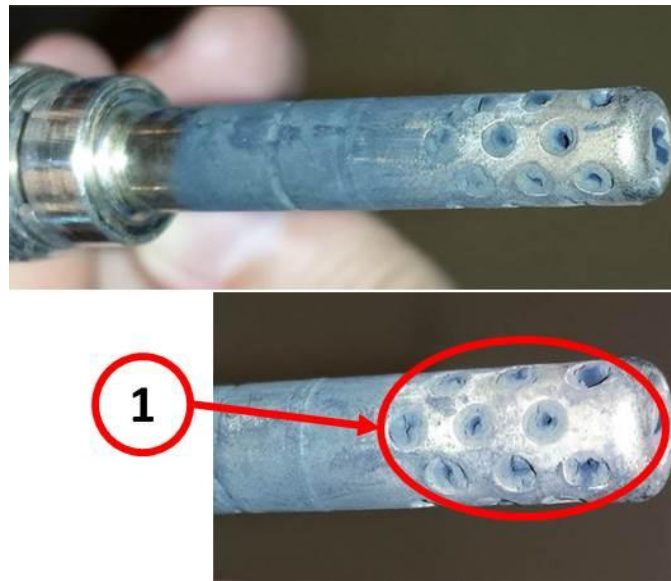
**Fig. 1 EGT Sensor Bank 1 Sensor 2**

10. Inspect the sensor body and probe for any signs of damage or excessive soot. Refer to (Fig. 1).

1 - Excessive soot blocking sensor ports.

- 
11. Was excessive soot found on the sensor?
- Yes>>> Proceed to [Step #12](#).
  - No>>> Proceed to [Step #13](#).
12. Using shop air set to a maximum of 80 psi, clean all excessive soot from the sensor probe.

13. Using a suitable multi-meter with appropriate test probes, test the resistance between the sensor connector terminals 1 and 2. With the sensor at room temperature, 65-75 °F (18-25 °C), the resistance should measure between 200 and 240 ohms.

14. Is the temperature sensor resistance within specifications?
- Yes>>> Install the original EGT sensor 1/2. Refer to detailed installation procedures available in DealerCONNECT> TechCONNECT> Service Info Section 11 - Exhaust System> Sensor, Exhaust Temperature> Installation> Exhaust Gas Temperature Sensor 1/2.

- No>>> Install a new EGT sensor 1/2. Refer to detailed installation procedures available in DealerCONNECT> TechCONNECT> Service Info Section 11 - Exhaust System> Sensor, Exhaust Temperature> Installation> Exhaust Gas Temperature Sensor 1/2.
