## SERVICE BULLETIN

EL18-018

June 21, 2018

### 2011-2015 LEAF; 12 VOLT BATTERY LOSES CHARGE AND/OR TELEMATICS SERVICES DO NOT WORK

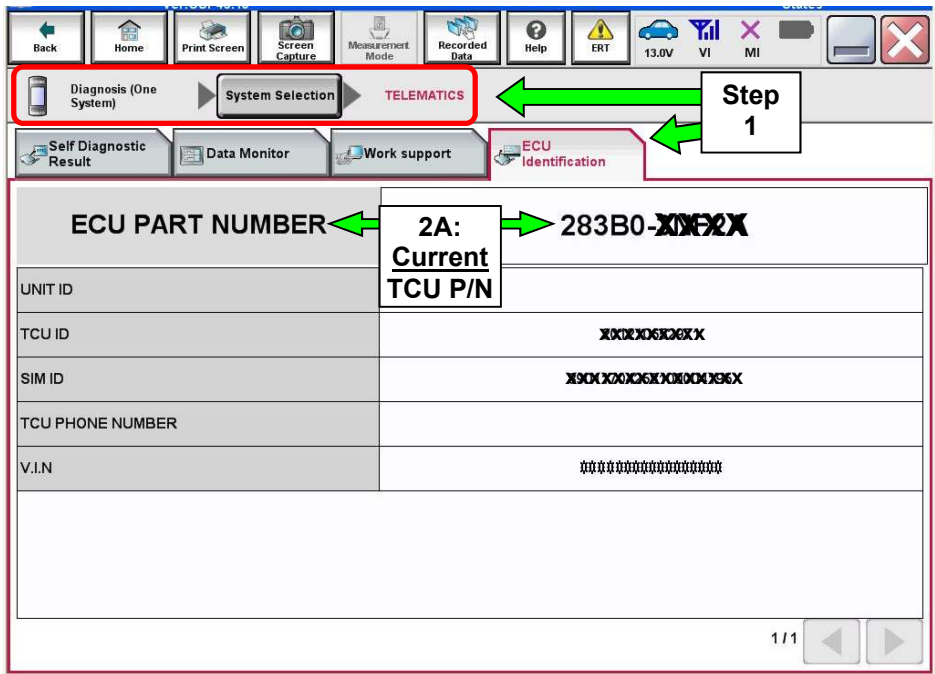
Figure 1

- With CONSULT-III plus (C-III plus), go to **Diagnosis (One System) > System Selection > TELEMATICS > ECU identification**.
- When you get to the screen shown in Figure 1, confirm this bulletin applies as follows.
  - Find the TCU **Part Number** and write it on the repair order.

**NOTE:** This is the current TCU Part Number (P/N).

- Compare the P/N you wrote down to the numbers in the **Current TCU Part Number** column in **Table A** below.
  - If there is a match, this bulletin applies. Go to **TCU Reprogramming (includes turning OFF the TCU)** on the next page.
  - If there is not a match, this bulletin does not apply. Refer to ASIST for further diagnostic and repair information.

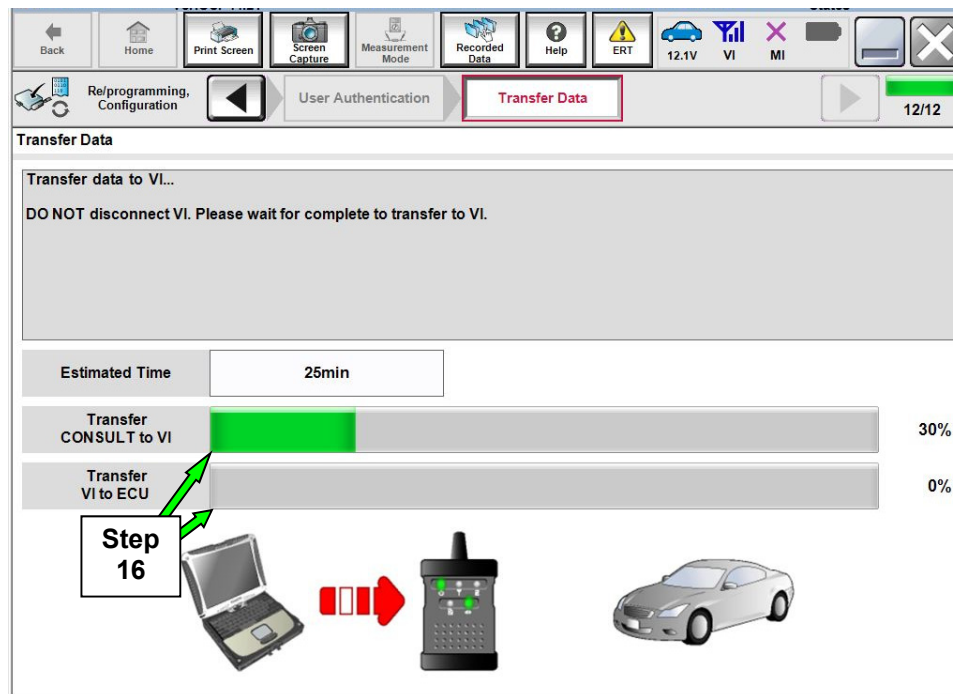
Figure 25

16. The progress bar (Figure 25) should go to approximately 10%, and then the error message in Figure 26 should appear. This is normal.

**NOTE:** If a different error message displays, go to **Electronic Control Unit Recovery** on the next page.

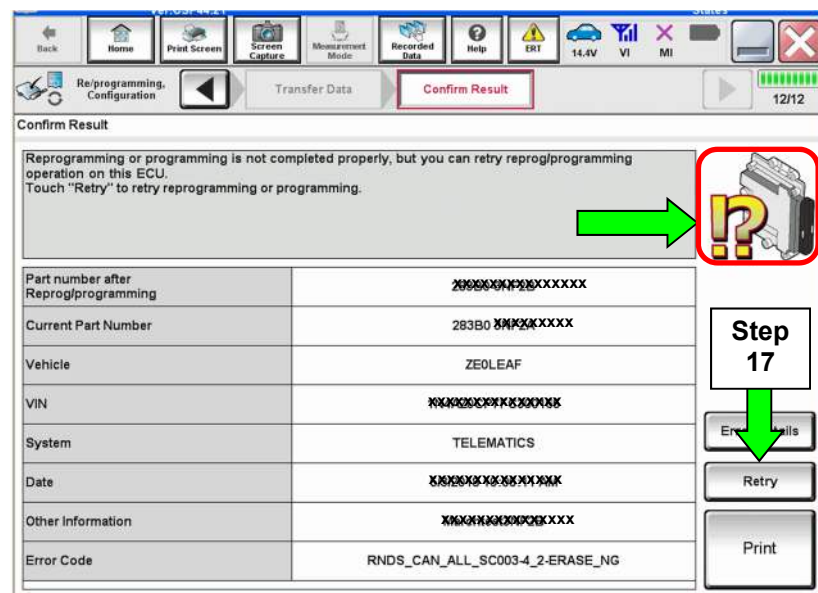
17. When the screen in Figure 26 displays, verify the following, and then select **Retry**.

- Check battery voltage (12.0–15.5 V).
- Ignition is ON, engine OFF.
- External Bluetooth® devices are OFF.
- All electrical loads are OFF.
- **Select Retry and follow the on screen instructions.**
- “Retry” may not go through on the first attempt and can be selected more than once.

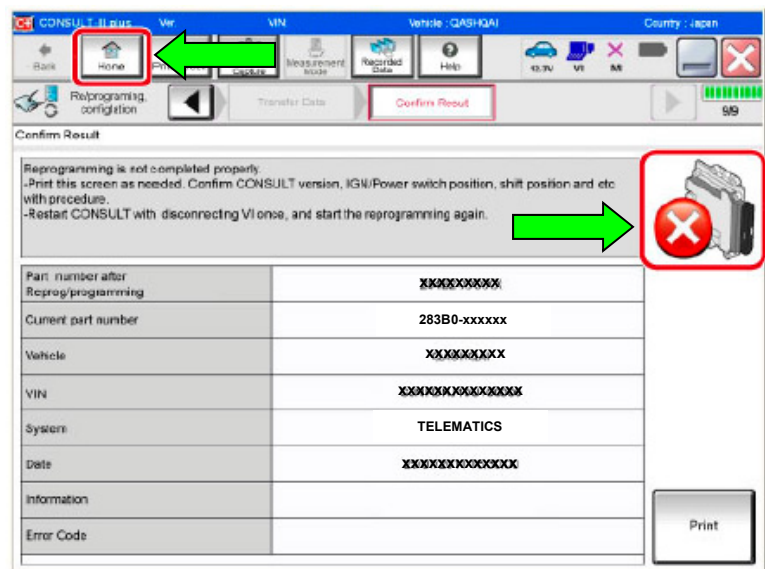
Figure 27

If reprogramming does not complete and the “X” icon displays as shown in Figure 27:

**Do not disconnect the plus VI or shut down C-III plus if reprogramming does not complete.**

- Check battery voltage (12.0 – 15.5 V).
- CONSULT A/C adapter is plugged in.
- Ignition is ON, engine OFF.
- Transmission is in Park.
- All C-III plus / VI cables are securely connected.
- All C-III plus updates are installed.
- **Select Home, and restart the reprogram procedure from the beginning.**

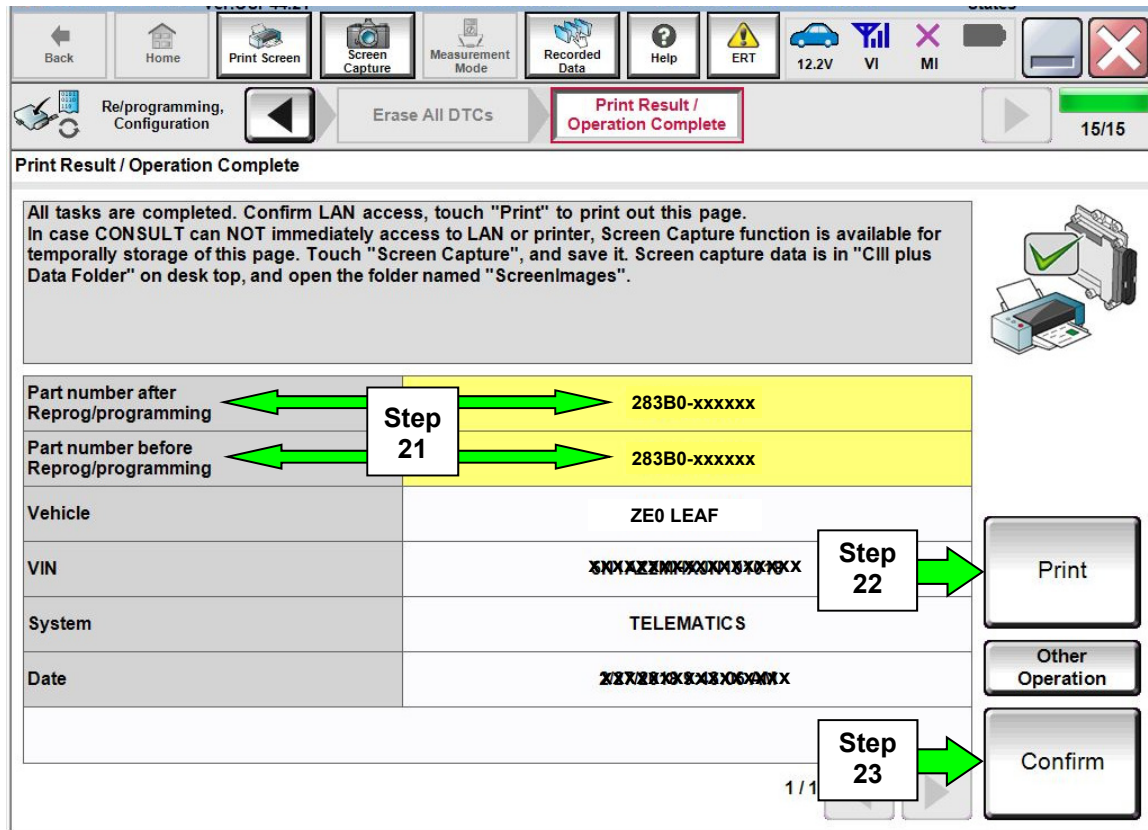
20. When the entire reprogramming process is complete, the screen in Figure 31 will display.
21. Verify the before and after part numbers are different.
22. Print a copy of this screen (Figure 31) and attach it to the repair order for warranty documentation.
23. Select **Confirm**.
