Preliminary Information

PIP5571 MIL / SES Lamp On After Engine Repairs, P0016 Set and Rough Idle

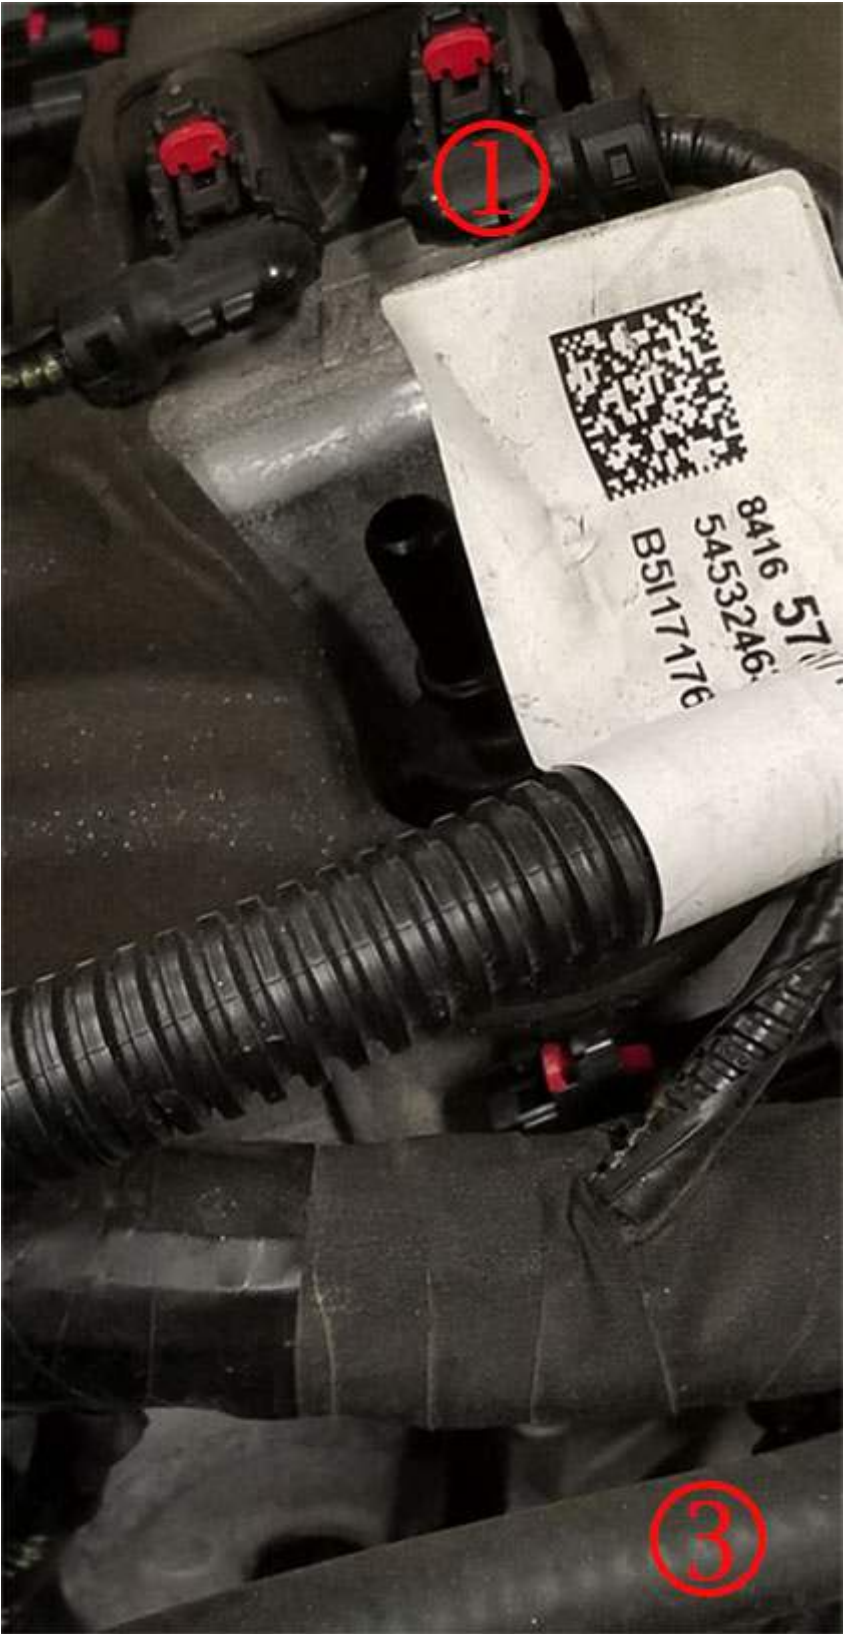
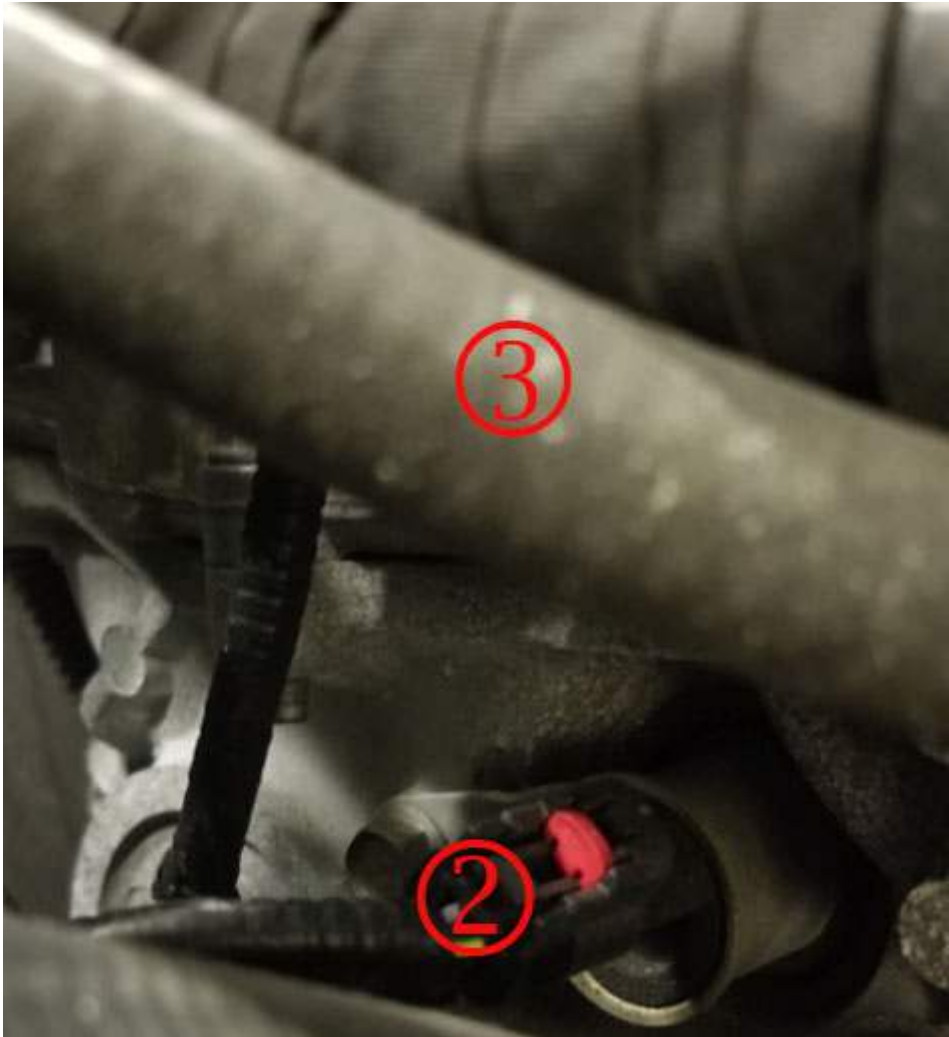
| Cause | What we are seeing is the wiring connectors for the intake camshaft actuator solenoid bank one on top of the engine and the connector for the intake actuator park lock solenoid in the front of the engine for bank one, have been swapped.<br>These two connectors are identical and can only be identified by wire color in the connector. |

**1) Bank 1 intake actuator**  
2) Bank 1 intake park lock solenoid  
3) Same hose in both pictures for relativity.

**Remove the connector and look at the schematic in eSI to compare and ensure the correct connector is plugged into the actuator and lock solenoid. (See pictures below)**

If they are incorrect swap them back and clear the code to verify repair.  
If they are already in the correct places then refer to the correct eSI diagnostics for this code.
