**NUMBER:** 18-021-15

Flash: 3.0L Powertrain Diagnostic And System Enhancements

2014 (DS) RAM 1500 Pickup

**NOTE: This bulletin applies to vehicles equipped with a 3.0L diesel engine (sales code EXF).**

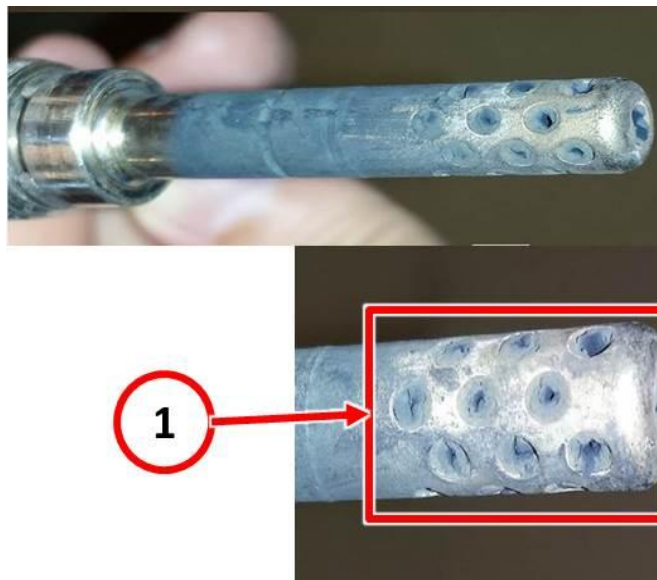
**Fig. 1 EGT Sensor Bank 1 Sensor 1**

9. Replace the O2 sensor. Refer to detailed repair procedures available in DealerCONNECT> TechCONNECT> Service Info Section 14 - Fuel System> Fuel Injection, Diesel> Sensor, Oxygen> Removal/Installation. Proceed to [Step #10](#).
10. Remove the EGT Sensor 1/2 located in the inlet of the Diesel Particulate Filter (DPF)/Diesel Oxidation Catalyst (DOC) assembly. Refer to detailed removal procedures available in DealerCONNECT> TechCONNECT> Service Info Section 11 - Exhaust System> Sensor, Exhaust Temperature> Removal> Exhaust Gas Temperature Sensor 1/2.
11. Inspect the sensor body and probe for any signs of damage or excessive soot. See ([Fig. 1](#)).

1 - Excessive soot blocking sensor ports

- 
12. Was excessive soot found on the sensor?
    - a. Yes>>> Proceed to [Step #13](#).
    - b. No>>> Proceed to [Step #14](#).
  13. Using shop air set to a maximum of 80 psi, clean all excessive soot from the sensor probe.

14. Using a suitable multi-meter with appropriate test probes, test the resistance between the sensor connector terminals 1 and 2. With the sensor at room temperature, 65-75 °F (18-25 °C), the resistance should measure between 200 and 240 ohms.
15. Is the temperature sensor resistance within specifications?
  - a. Yes>>> Install the original EGT sensor 1/2. Refer to detailed installation procedures available in DealerCONNECT> TechCONNECT> Service Info Section 11 - Exhaust System> Sensor, Exhaust Temperature> Installation> Exhaust Gas Temperature Sensor 1/2.
  - b. No>>> Install a new EGT sensor 1/2. Refer to detailed installation procedures available in DealerCONNECT> TechCONNECT> Service Info Section 11 - Exhaust System> Sensor, Exhaust Temperature> Installation> Exhaust Gas Temperature Sensor 1/2.
16. Verify all engine systems are operating as designed. The bulletin is now complete.
