**NUMBER:** 07-004-15

Malfunction Indicator Lamp (MIL) Illuminated DTC P1D73 Active Grill Shutter (AGS) Performance

This bulletin involves inspecting and securing the AGS actuator motor case housing.

| 2014 - 2015 | (DS) | Ram 1500 Pickup |

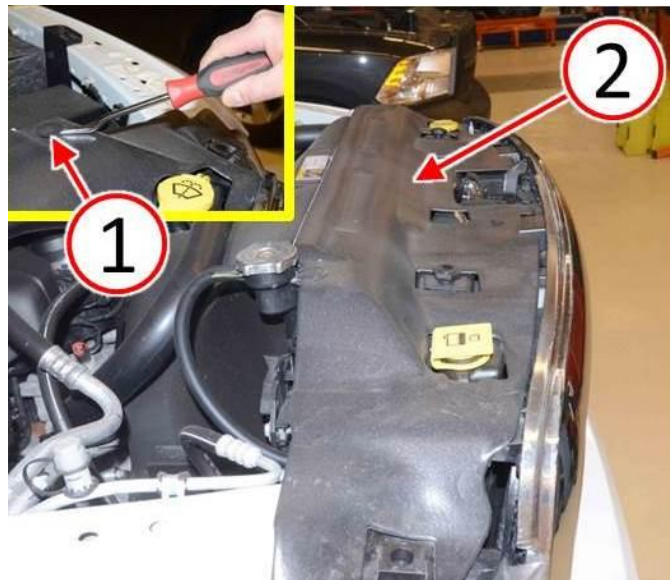
**Fig. 1 Remove Upper Radiator Seal**

- 1 - Push Pin Fasteners
  - 2 - Upper Radiator Seal
-

1. Remove the six push pin fasteners (1) from upper radiator seal (Fig. 1).
2. Remove the upper radiator seal (2) (Fig. 1).

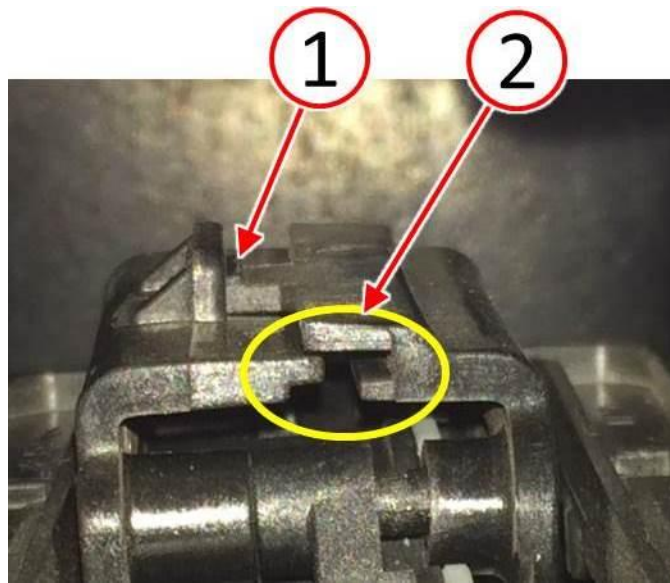
**Fig. 3 Inspect Actuator Motor Case Housing For Separation**

- 
4. Inspect the AGS actuator motor case housing for unlocked retainer (1) and separation (2) of the actuator motor case housing halves ([Fig. 3](#)).
  5. Is an unlocked retainer (1) and/or housing separation (2) visible? As shown in ([Fig. 3](#)).
    - a. Yes >>> Proceed to [Step #8](#).
    - b. No >>> Continue to [Step #6](#).

- 1 - Retainer Unlocked
- 2 - Housing Separation
