**NUMBER:** 08-004-15

FLASH: Battery Electric Vehicle, Multiple System Enhancements

2013 - 2015                      (FF)                      Fiat 500e

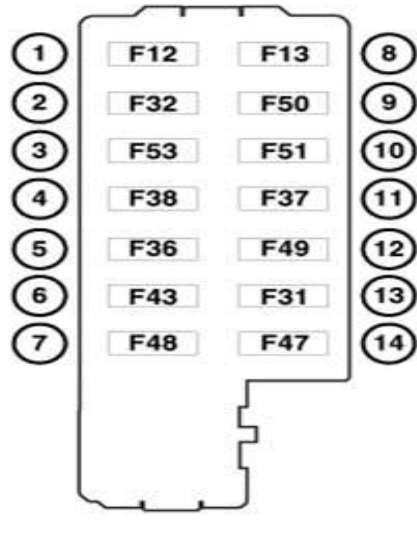
**Fig. 1 Interior Fuse Panel Located By The Left Kick Panel.**

**NOTE: Sometimes when updating the software on these modules, the CTM may stop communicating and/or U11F6-00 is set as an active fault. Pulling the fuse for the CTM will regain communication with that module and change U11F6-00 to a stored DTC.**

15. Is U11F6-00 set as an active fault?
  - a. Yes >>> Proceed to [Step #16](#).
  - b. No >>> Proceed to [Step #18](#).
16. Turn off the ignition and pull fuse F36 for 10 seconds. It is located in the interior fuse panel, which is part of the BCM, see ([Fig. 1](#)).
17. Turn the ignition back on and check if U11F6-00 is now set as a stored fault?
  - a. Yes >>> Proceed to [Step #16](#).
  - b. No >>> This bulletin has been completed. Perform normal diagnostic, Follow TechConnect > U11F6-00-LOST COMMUNICATION WITH CONVERGENCE TELEMATICS MODULE.
18. Clear any DTCs that may have been set in other modules due to reprogramming. The wiTECH application will automatically present all DTCs after the flash and allow the tech to clear them.

13. Is U11F6-00 set as an active fault?
  - a. Yes >>> Proceed to [Step #14](#).
  - b. No >>> Proceed to [Step #16](#).
14. Turn off the ignition and pull fuse F36 for 10 seconds. It is located in the interior fuse panel, which is part of the BCM, see ([Fig. 1](#)).

Remove fuse F36 .
