**NUMBER:** 18-021-15 REV. A

Flash: 3.0L Powertrain Diagnostic And System Enhancements

2014 (DS) RAM 1500 Pickup

**NOTE: This bulletin applies to vehicles equipped with a 3.0L diesel engine (sales code EXF).**

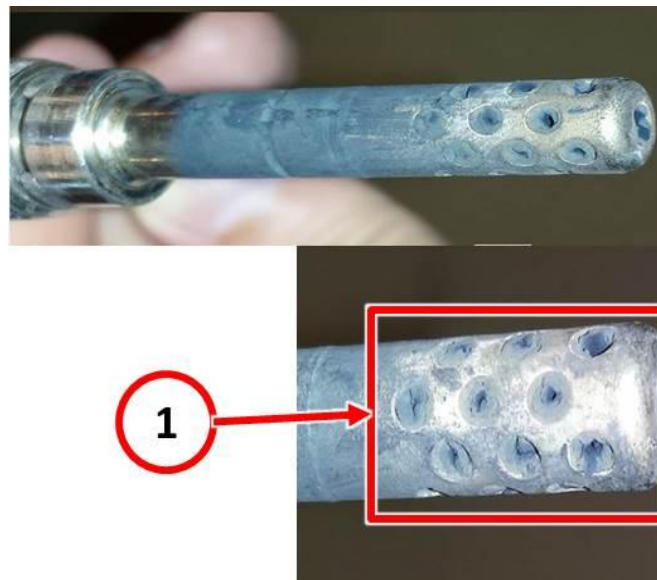
**Fig. 1 EGT Sensor Bank 1 Sensor 1**

9. Replace the O2 sensor. Refer to detailed repair procedures available in DealerCONNECT> TechCONNECT> Service Info Section 14 - Fuel System> Fuel Injection, Diesel> Sensor, Oxygen> Removal/Installation. Proceed to [Step #10](#).
10. Remove the EGT Sensor 1/2 located in the inlet of the Diesel Particulate Filter (DPF)/Diesel Oxidation Catalyst (DOC) assembly. Refer to detailed removal procedures available in DealerCONNECT> TechCONNECT> Service Info Section 11 - Exhaust System> Sensor, Exhaust Temperature> Removal> Exhaust Gas Temperature Sensor 1/2.
11. Inspect the sensor body and probe for any signs of damage or excessive soot. See ([Fig. 1](#)).

1 - Excessive soot blocking sensor ports

- 
12. Was excessive soot found on the sensor?
    - a. Yes>>> Proceed to [Step #13](#).
    - b. No>>> Proceed to [Step #14](#).
  13. Using shop air set to a maximum of 80 psi, clean all excessive soot from the sensor probe.

14. Using a suitable multi-meter with appropriate test probes, test the resistance between the sensor connector terminals 1 and 2. With the sensor at room temperature, 65-75 °F (18-25 °C), the resistance should measure between 200 and 240 ohms.
15. Is the temperature sensor resistance within specifications?
  - a. Yes>>> Install the original EGT sensor 1/2. Refer to detailed installation procedures available in DealerCONNECT> TechCONNECT> Service Info Section 11 - Exhaust System> Sensor, Exhaust Temperature> Installation> Exhaust Gas Temperature Sensor 1/2.
  - b. No>>> Install a new EGT sensor 1/2. Refer to detailed installation procedures available in DealerCONNECT> TechCONNECT> Service Info Section 11 - Exhaust System> Sensor, Exhaust Temperature> Installation> Exhaust Gas Temperature Sensor 1/2.
16. Verify all engine systems are operating as designed. The bulletin is now complete.
